# INSPECTION REPORT

For the Property at:  
**PORT WASHINGTON, NY 11050**

Inspection Date: Wednesday, May 29, 2024

Prepared by:  
**East Coast Commercial Property Inspections, LLC**

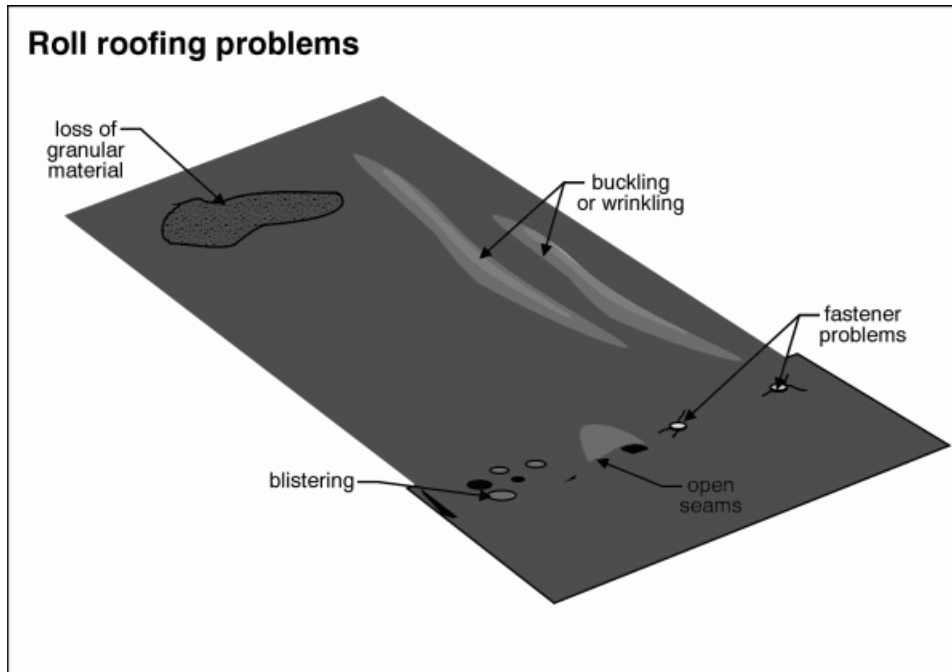
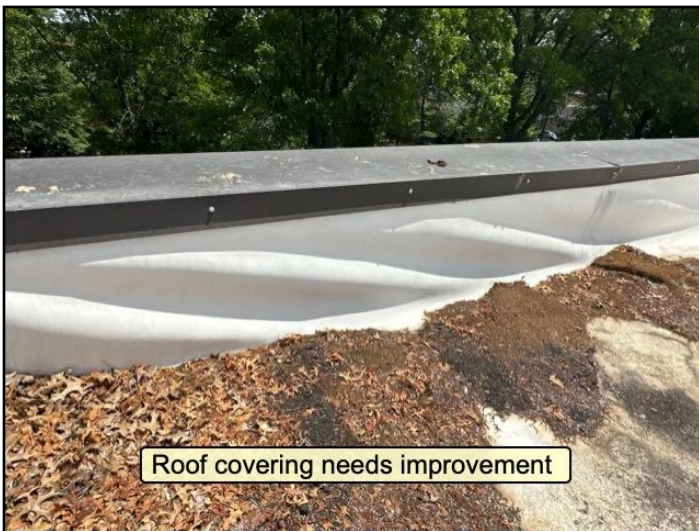
#### 1. Condition: • [Buckling or wrinkling](#)

**Implication(s):** Chance of water damage to structure, finishes and contents

*Buckling or wrinkling*

**Task:** Improve

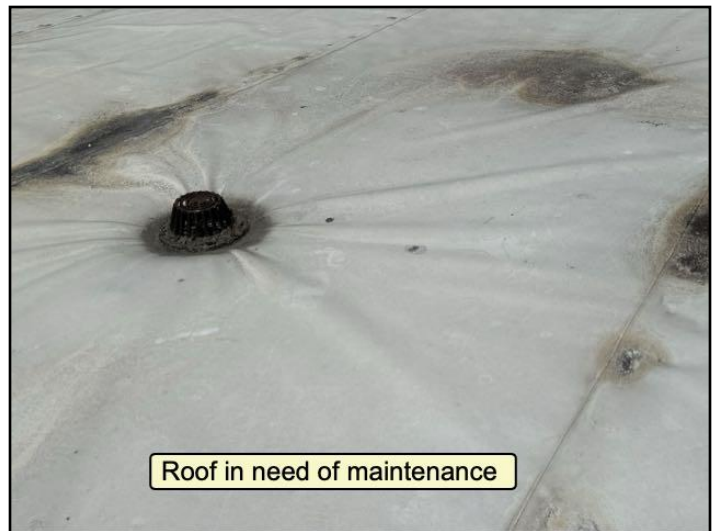
*Buckling or wrinkling*

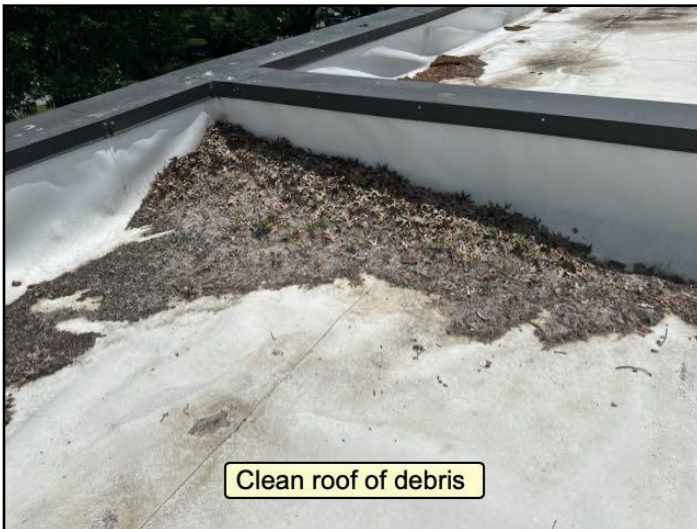
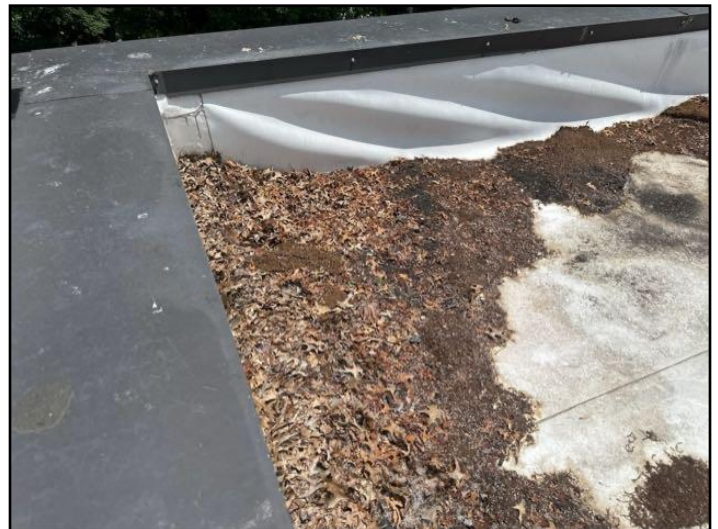
#### 2. Condition: • CLEAN ROOF OF DEBRIS

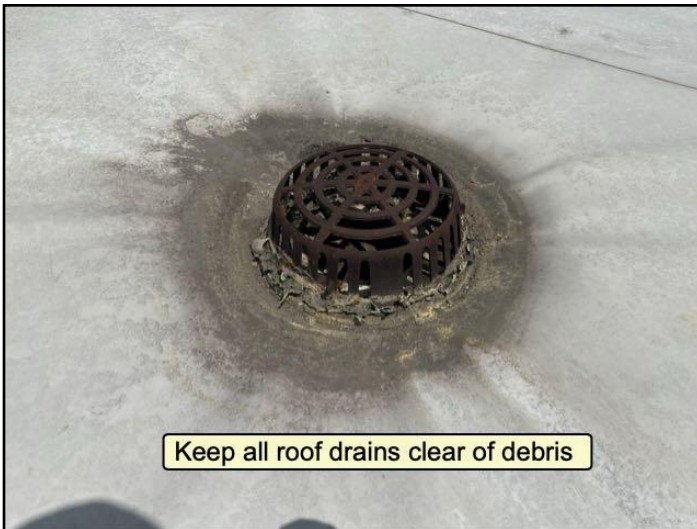
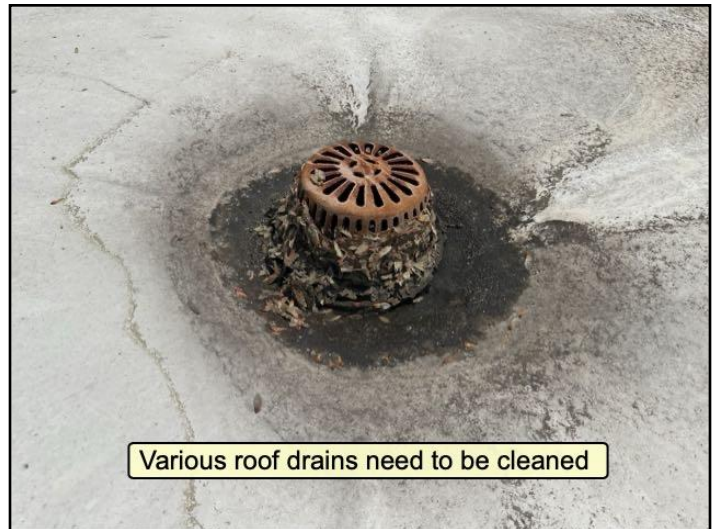
**FLAT ROOFING \ General notes****3. Condition:** • Keep drains clear of debris**Location:** Throughout

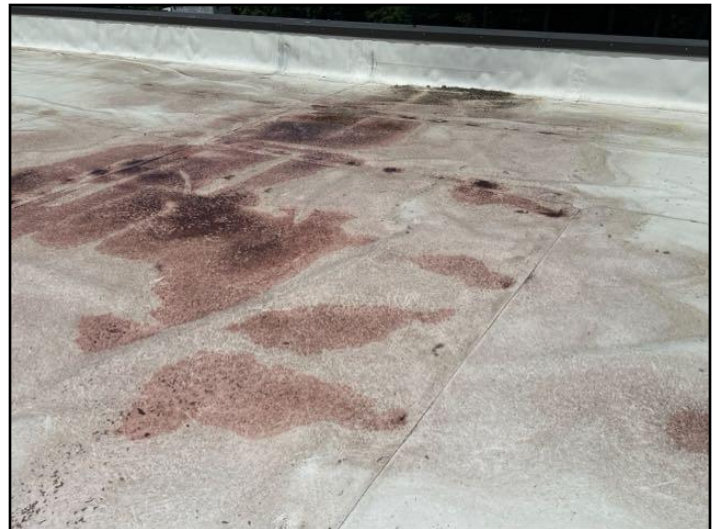
**Flat roofing material:** • RUBBER ROOF EPDM -PONDING AND PUDDLE ARE DRAIN

Ponding and puddling in various location

Roof drainage needs to be improved

Have licensed roofer improve drainage

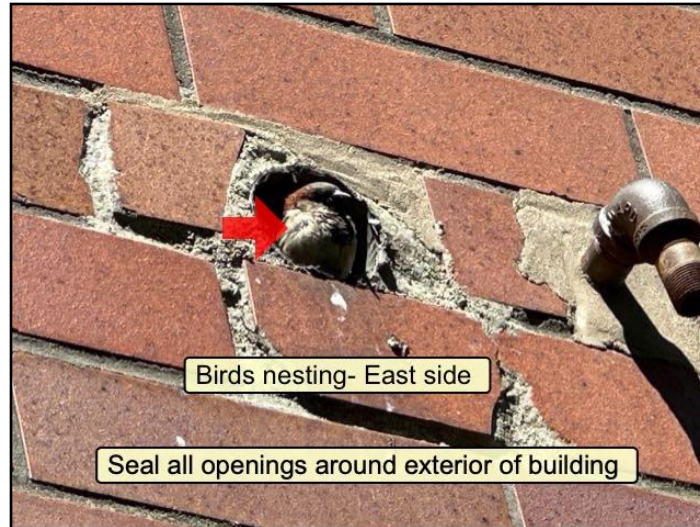
4. Condition: • Birds nesting

*Birds nesting*

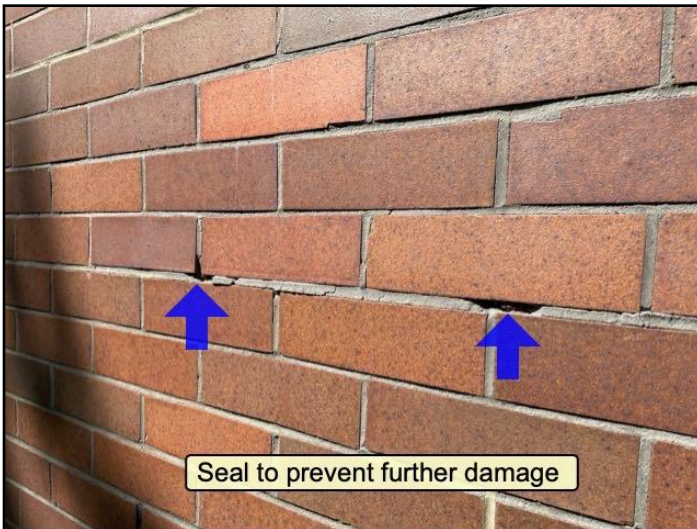
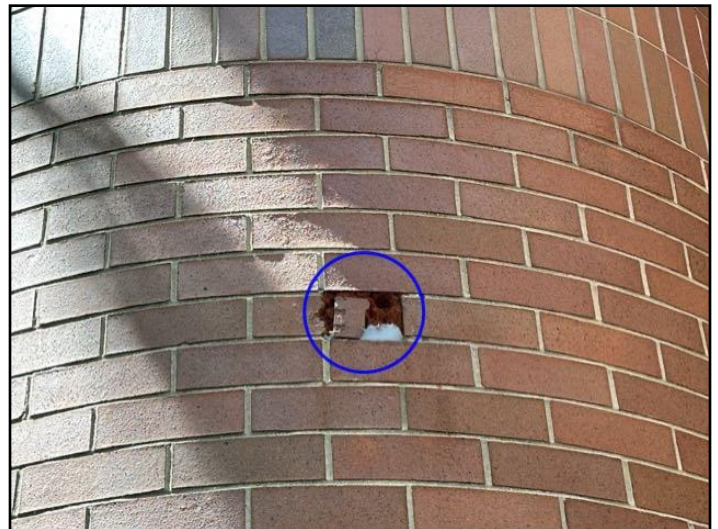
5. Condition: • [Mortar deterioration](#)

Implication(s): Chance of water entering building | Weakened structure | Chance of structural movement

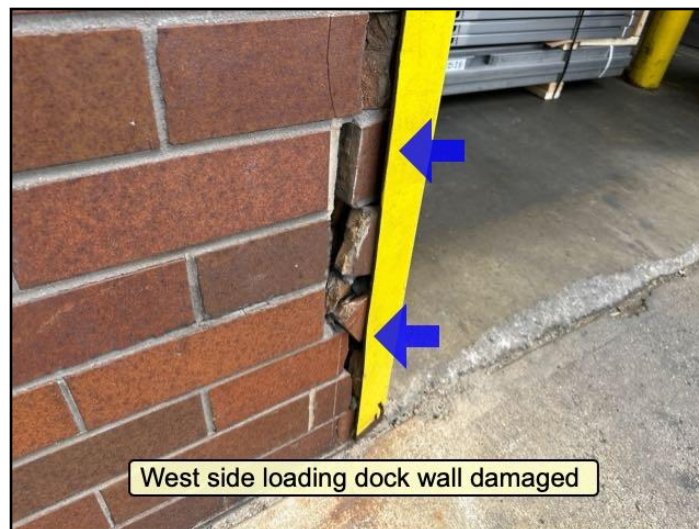
**6. Condition:** • Damaged**Location:** West

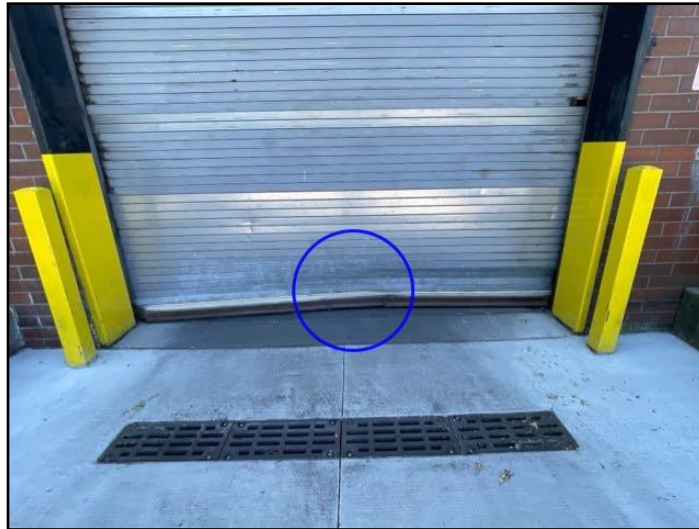
**DOORS \ Doors and frames****7. Condition:** • [Damage](#)**Implication(s):** Chance of damage to finishes and structure | Poor security**Location:** NORTH LOADING DOCK DOOR

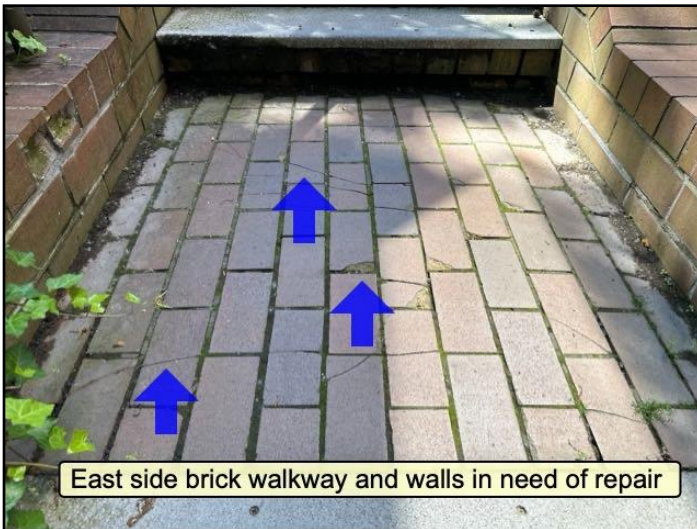
*Masonry or concrete cracking*

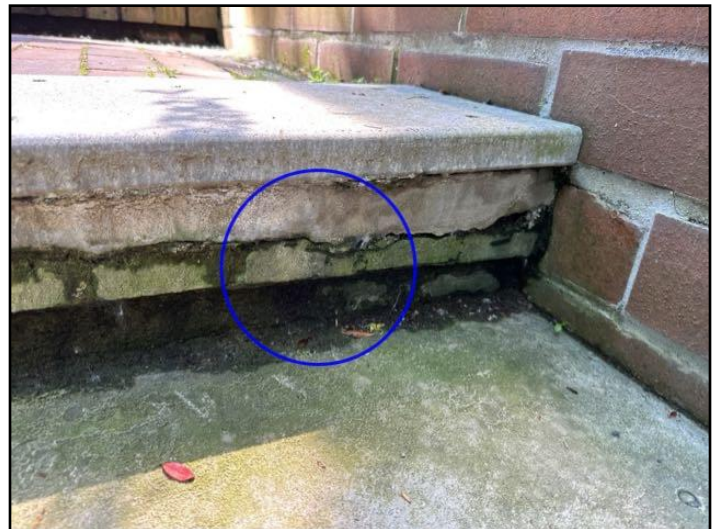
*Masonry or concrete cracking*

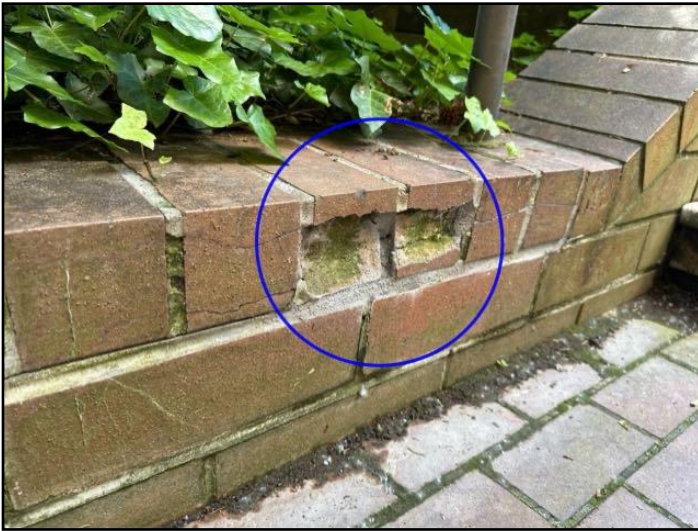
Masonry or concrete cracking

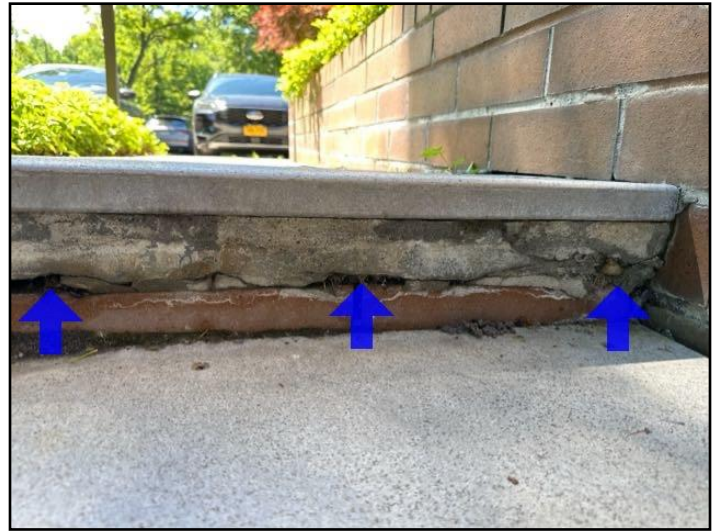
Masonry or concrete cracking

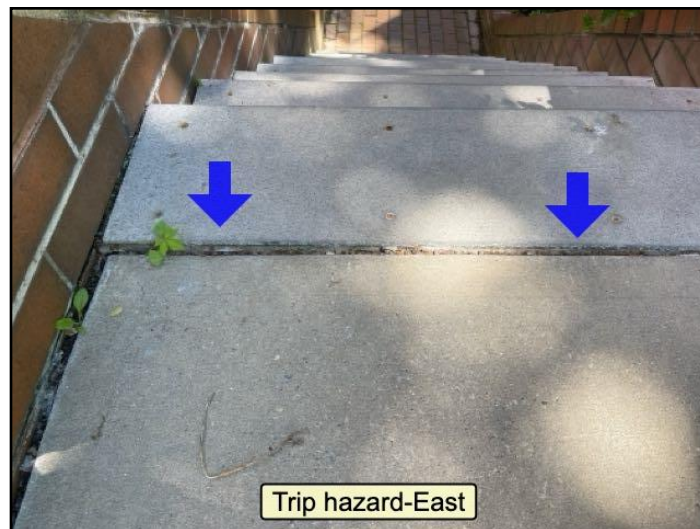
**9. Condition:** • Trip hazard**Implication(s):** Trip or fall hazard**Location:** EAST

Trip hazard

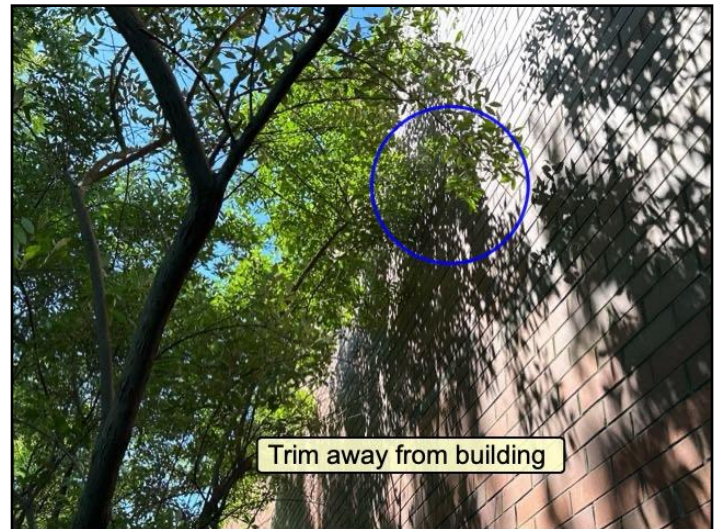
**LANDSCAPING \ #General notes****10. Condition:** • [Trees or shrubs too close to building](#)**Implication(s):** Chance of water damage to structure, finishes and contents | Chance of pests entering building | Material deterioration**Location:** East

*Trees or shrubs too close to building***LANDSCAPING \ #Retaining wall****11. Condition:** • [Rot](#)**Implication(s):** Weakened structure | Material deterioration**Location:** East

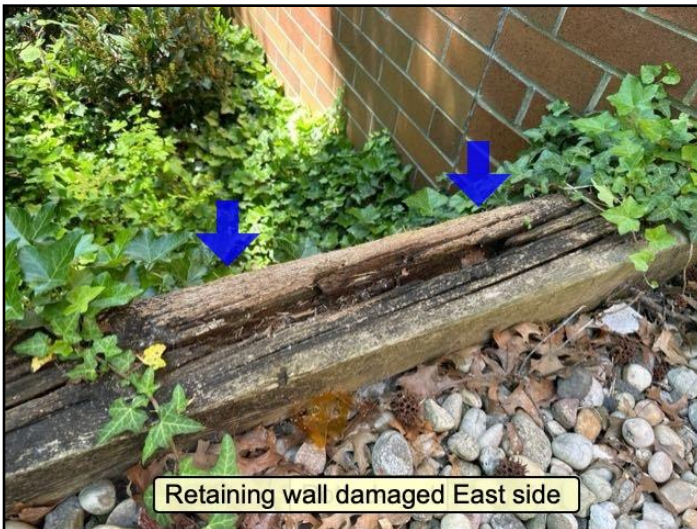
*Rot*

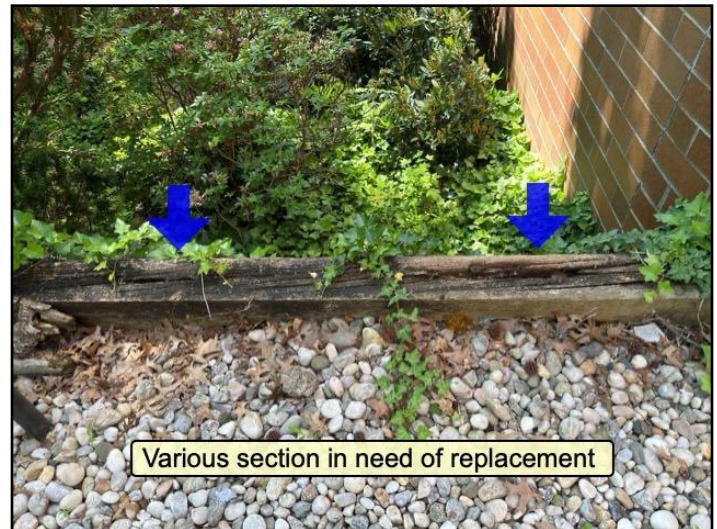
*Rot*

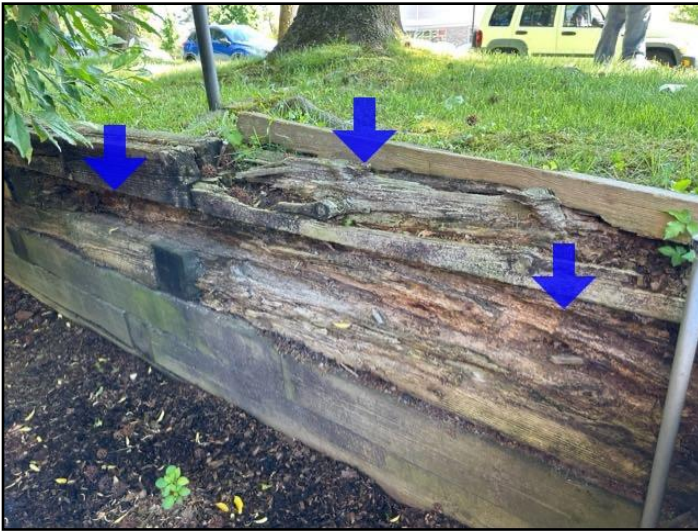
Rot

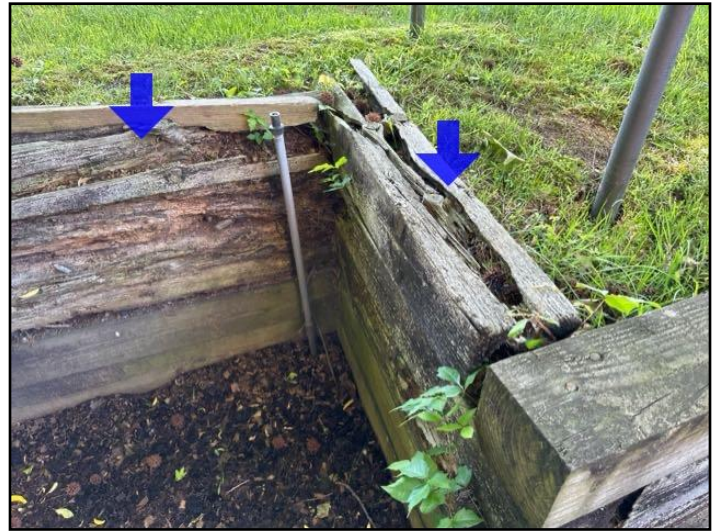
Rot

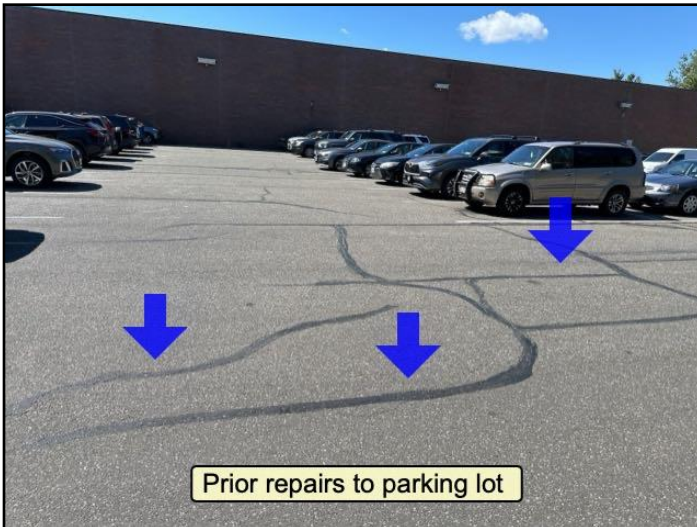
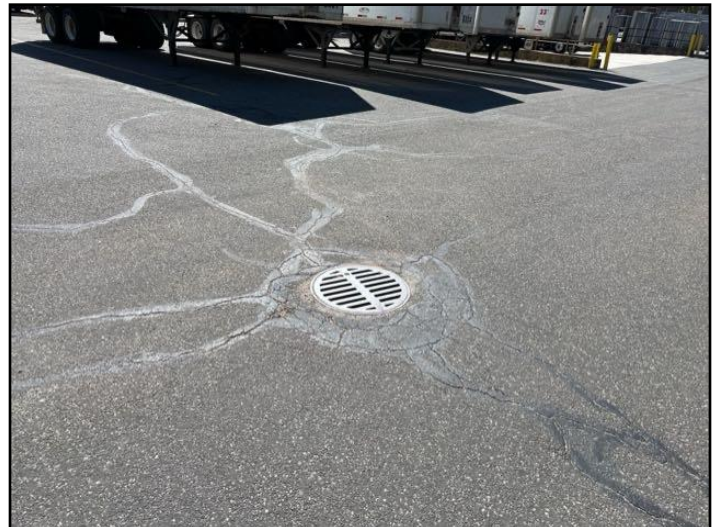
**General:** • PARKING LOT AND CURBS DAMAGED

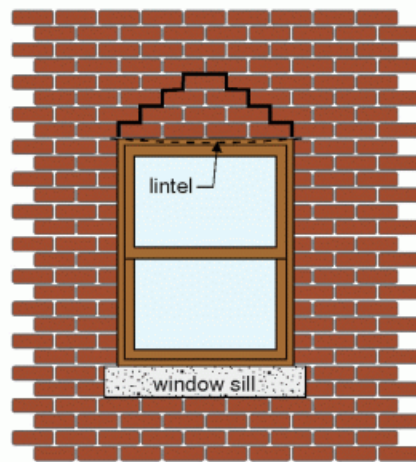
crack pattern commonly associated with sagging lintels due to undersizing or deterioration

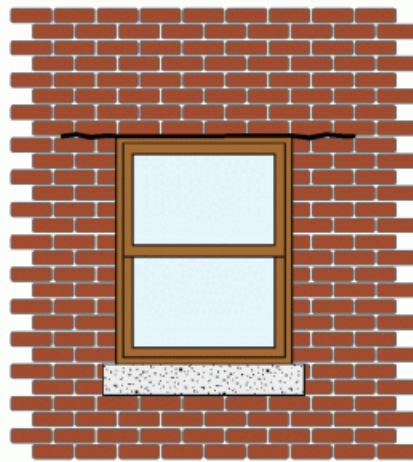
horizontal crack often caused by rusting steel lintels expanding

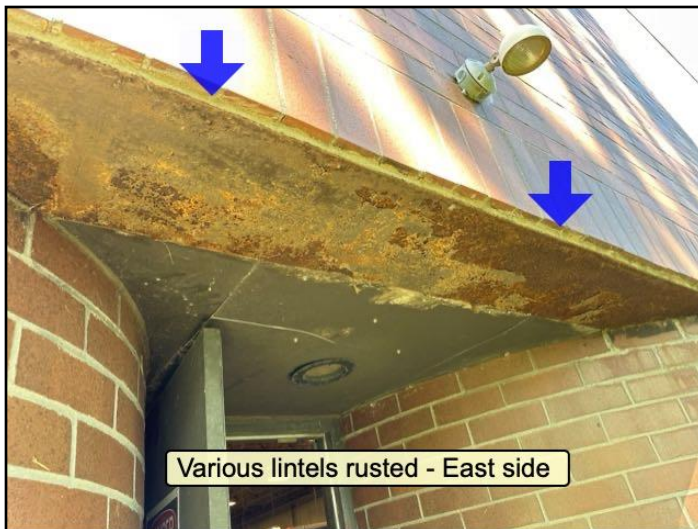
12. Condition: • [Rust](#)

Implication(s): Weakened structure | Chance of structural movement

Rust

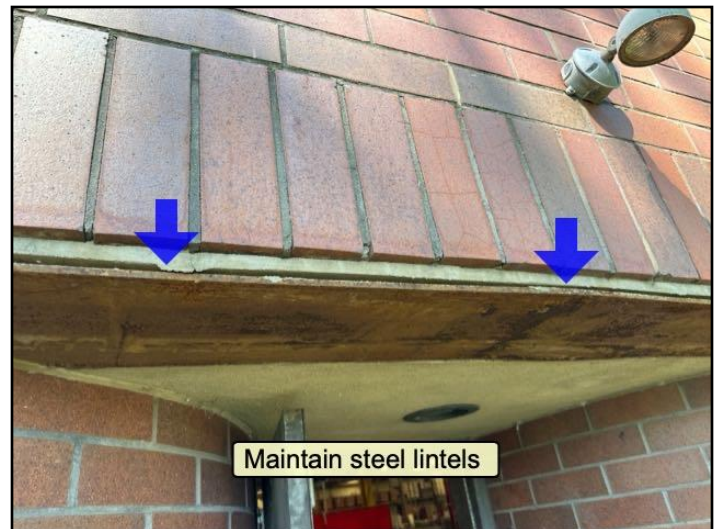
Rust

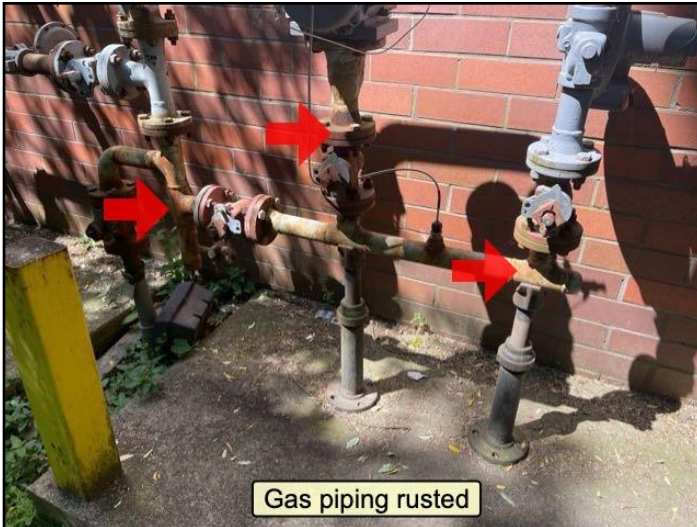
**13. Condition:** • [Rust](#)**Implication(s):** Material deterioration | Fire hazard**Location:** EAST

*Rust*

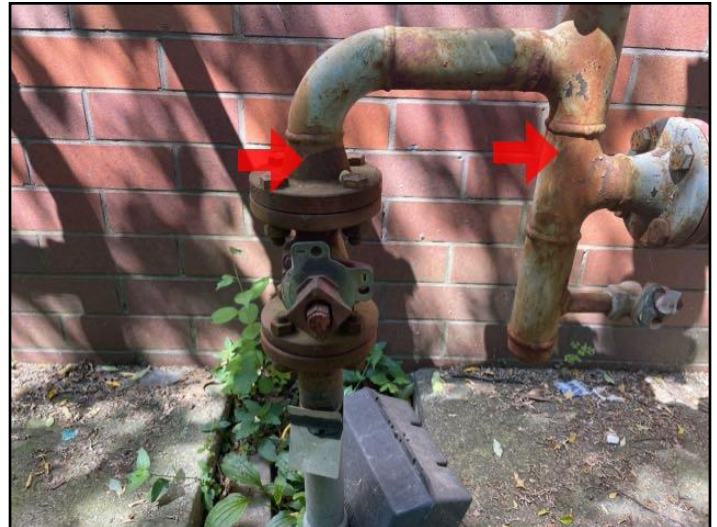
*Rust*
