# INSPECTION REPORT

***For the Property at:  
19 Laurel Ave  
HEMPSTEAD, NY 11550***

**Prepared by:** East Coast Commercial Inspections

**Date of Inspection:** March 15, 2026

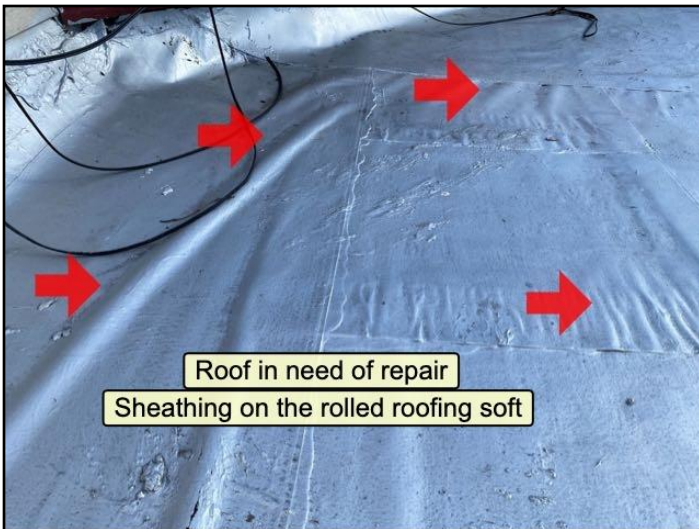
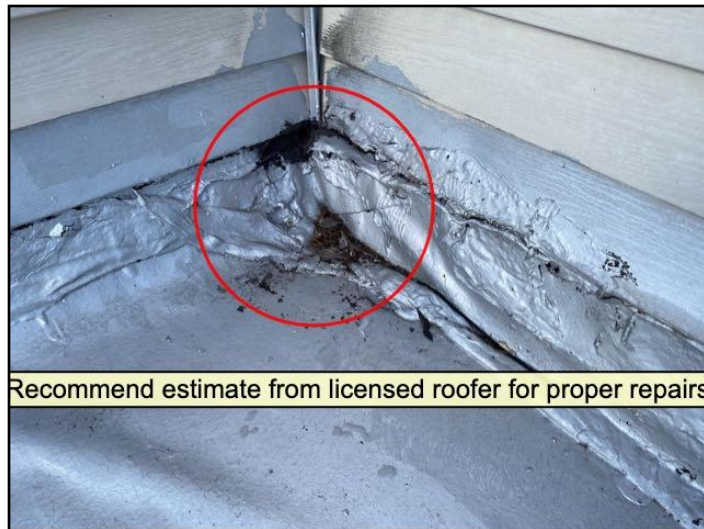
Licensed Roofing Contractor

Recommend licensed roofing contractor provide estimate for repairs needed to roof

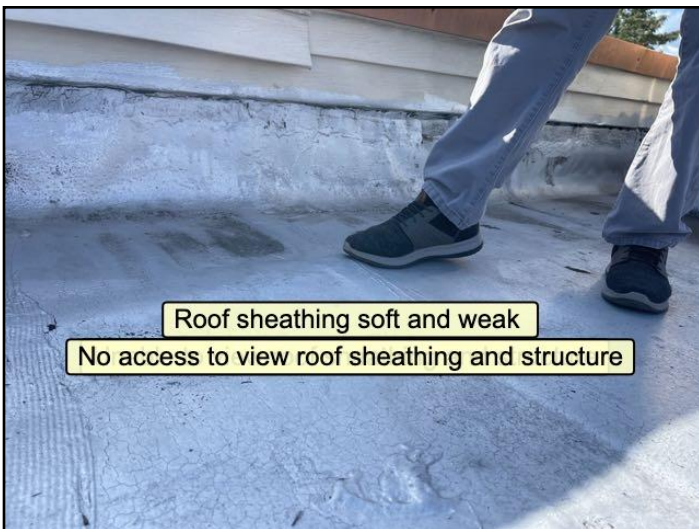
Blisters

Recommend licensed roofing contractor provide estimate for repair or replacement of flat roof prior to contract signing

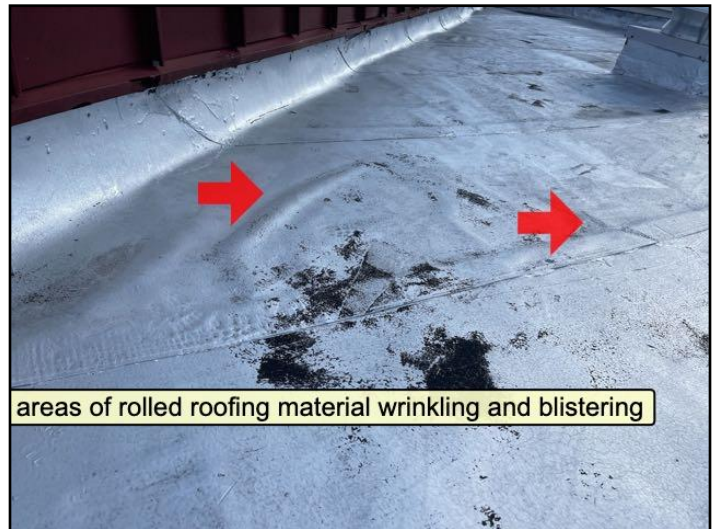
areas of rolled roofing material wrinkling and blistering

*Blisters*

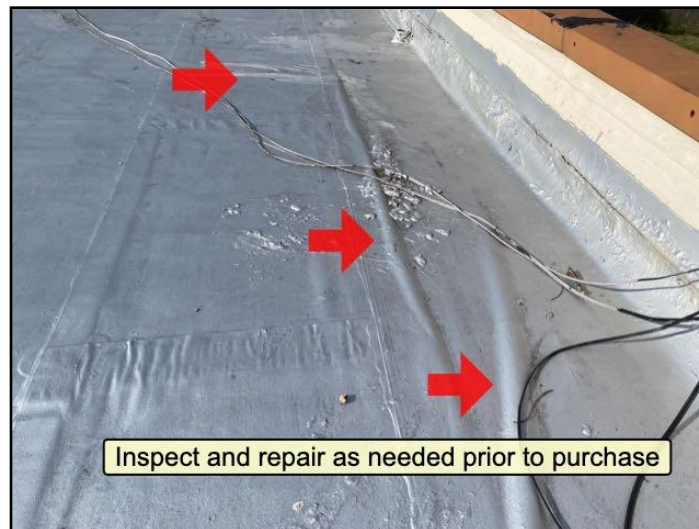
Inspect and repair as needed prior to purchase

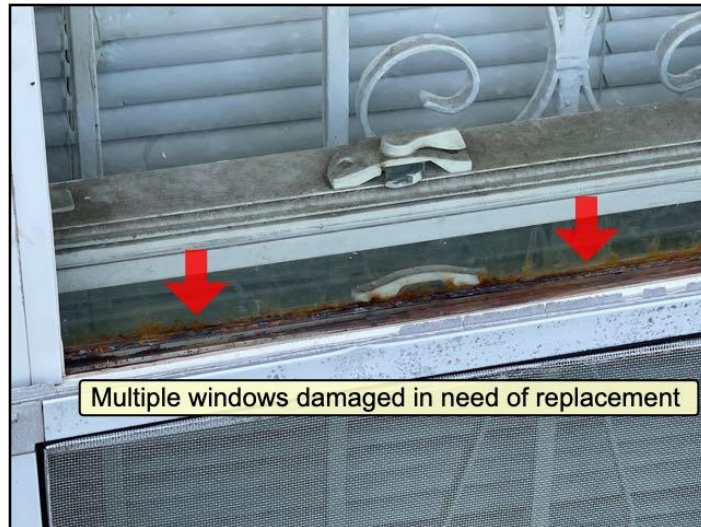
Multiple windows and framing in need of replacement

*Rust*

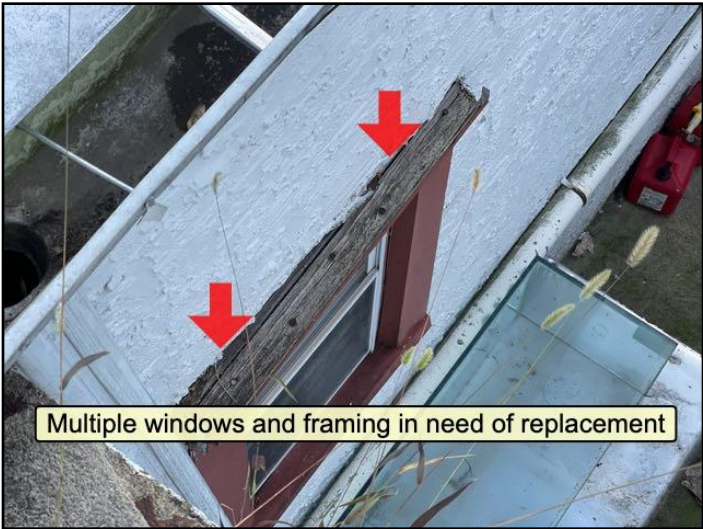
Flashing loose, missing or deteriorated

Recommend licensed contractor check for hidden moisture damage behind stucco and around windows. Multiple areas of stucco are cracked and deteriorated potential for hidden moisture damage.

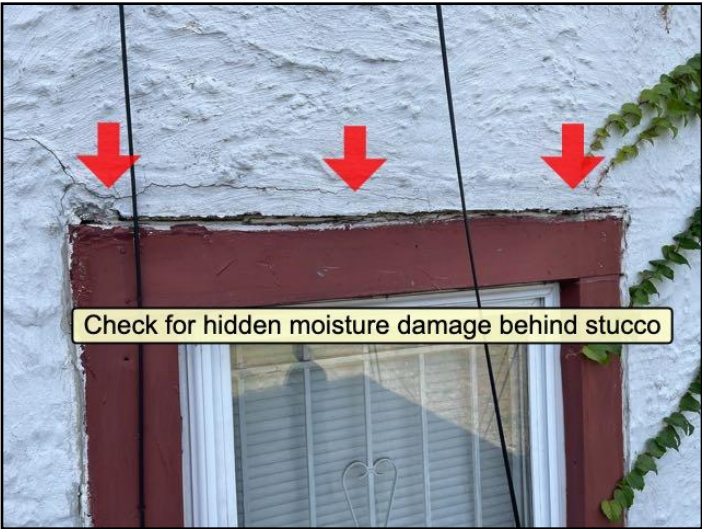
Flashing loose, missing or deteriorated

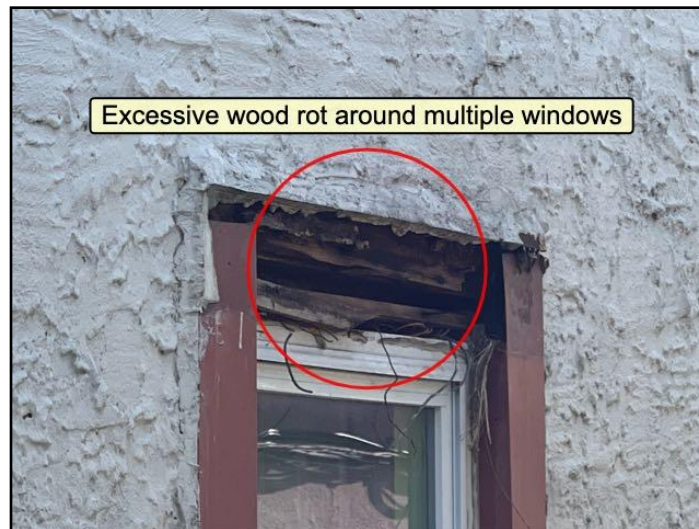
Flashing loose, missing or deteriorated

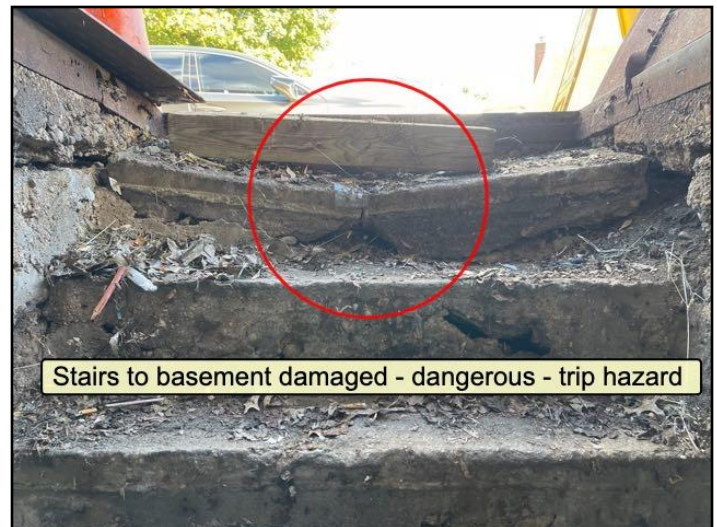
Masonry or concrete cracking

Recommend getting an estimate from a mason to properly repair front and rear steps to basement

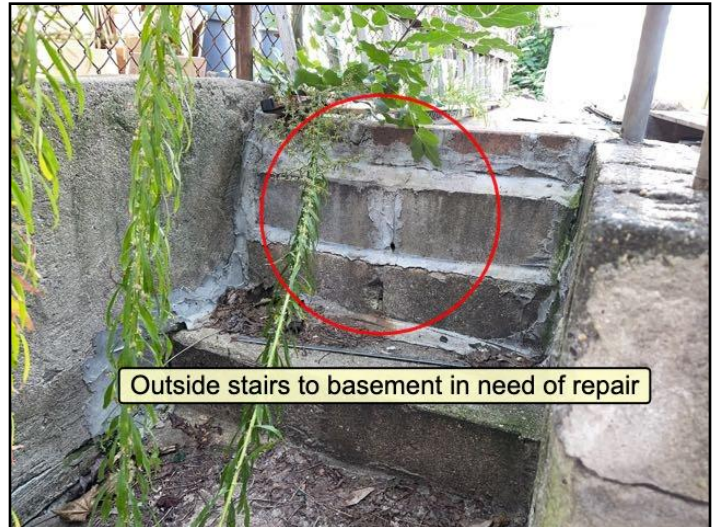
Outside stairs to basement in need of repair

Masonry or concrete cracking

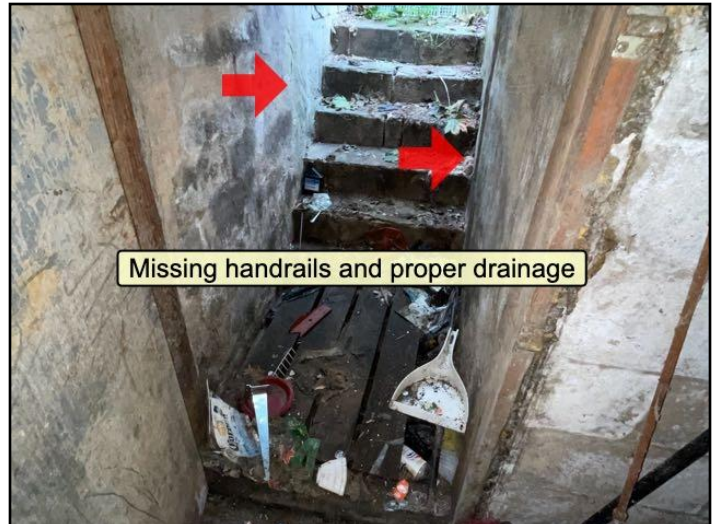
Missing handrails and proper drainage

Masonry or concrete cracking

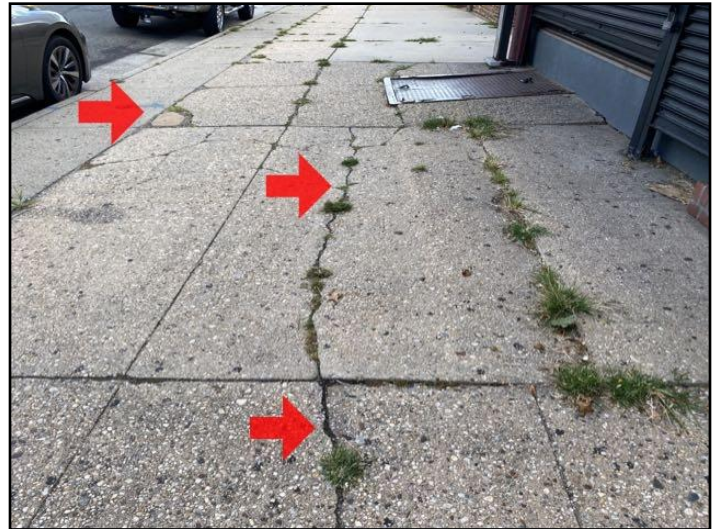
*Cracked or damaged surfaces***COMMENTS \ Additional**

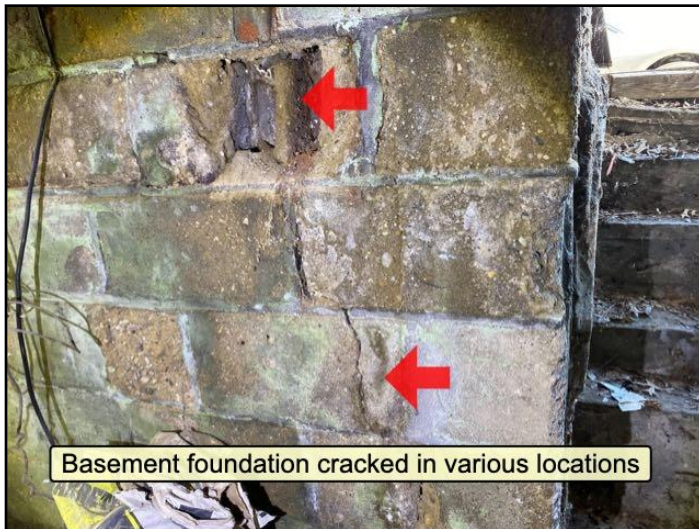
*Bowed, bulging or leaning*

Recommend licensed contractor and / or structural engineer to further evaluate and provide estimate for repair as needed.

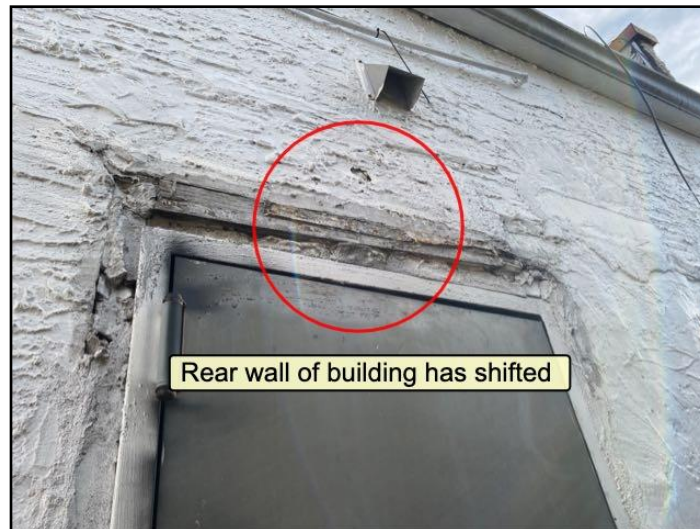
*Bowed, bulging or leaning*

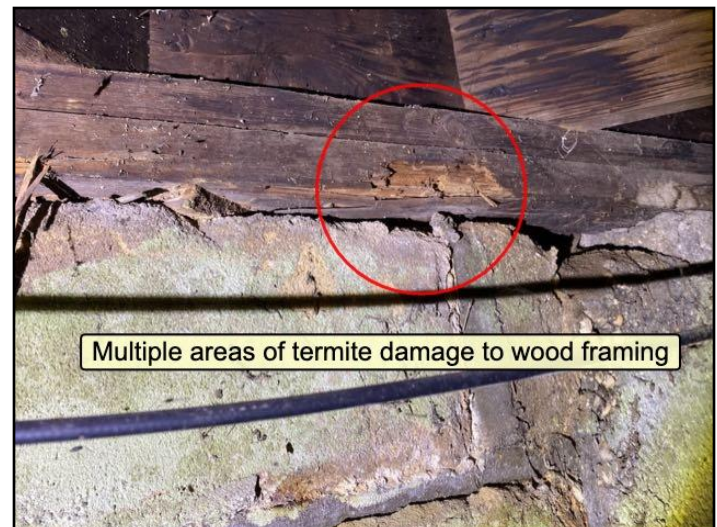
Excessive termite damaged to floor joists, sub flooring, sill plates and main support beam. Recommend consulting with a structural engineer for proper repairs prior to contract signing.

*Termite damage*

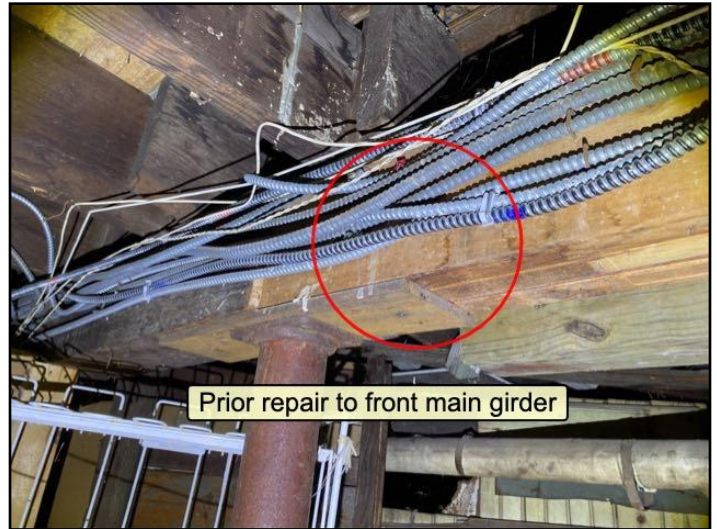
Prior repairs

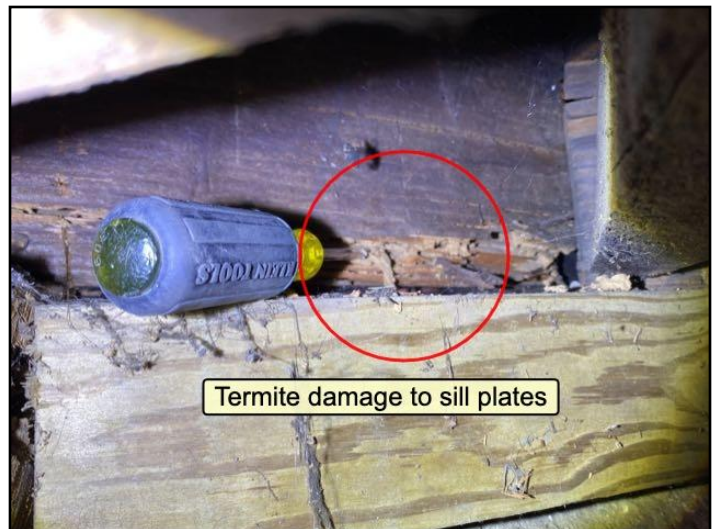
Termite damage to sill plates and rim joists in basement. Recommend further evaluation by a licensed contractor to determine if any hidden damaged exists. Get estimate for repair prior to purchase.

Termite damage

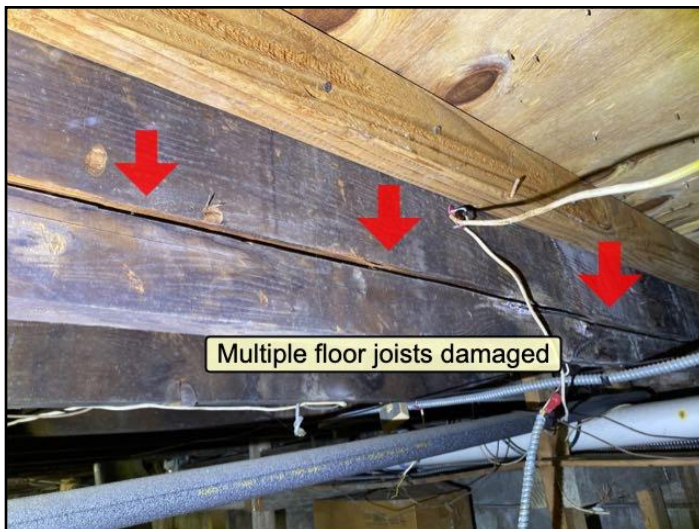
Split or damaged

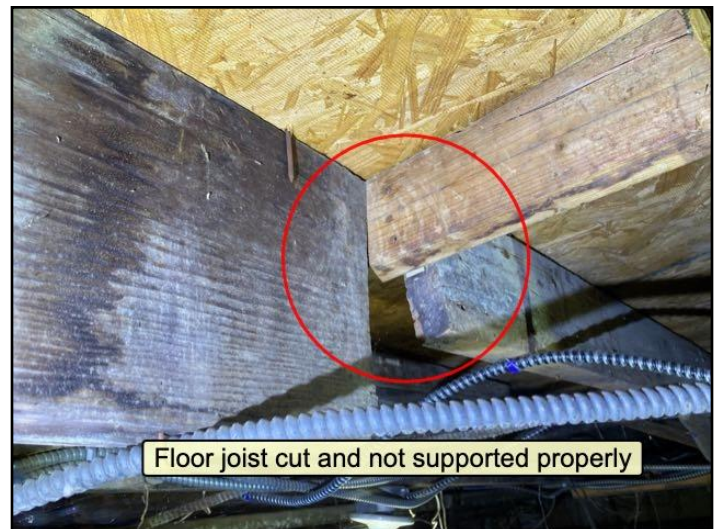
Split or damaged

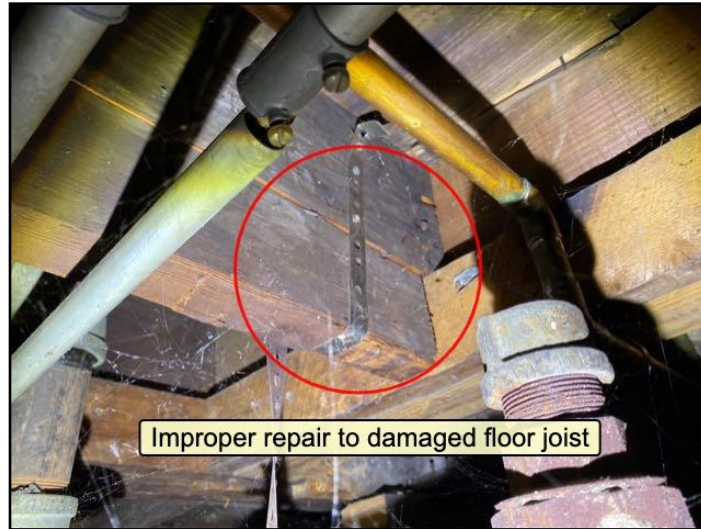
*Split or damaged*

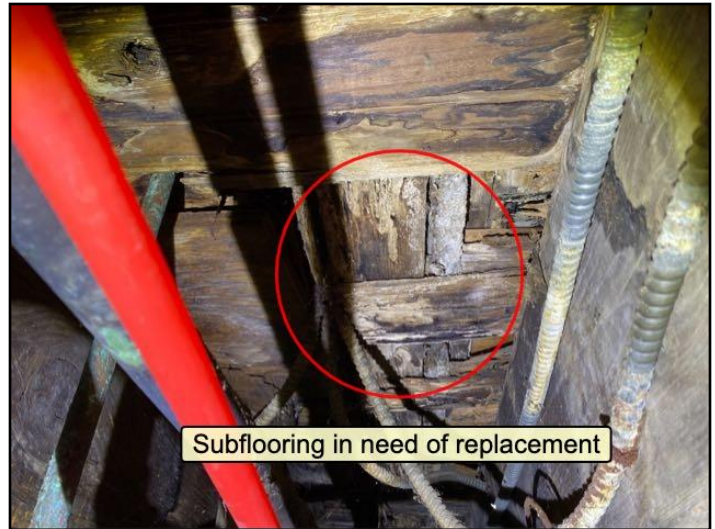
*Damaged*

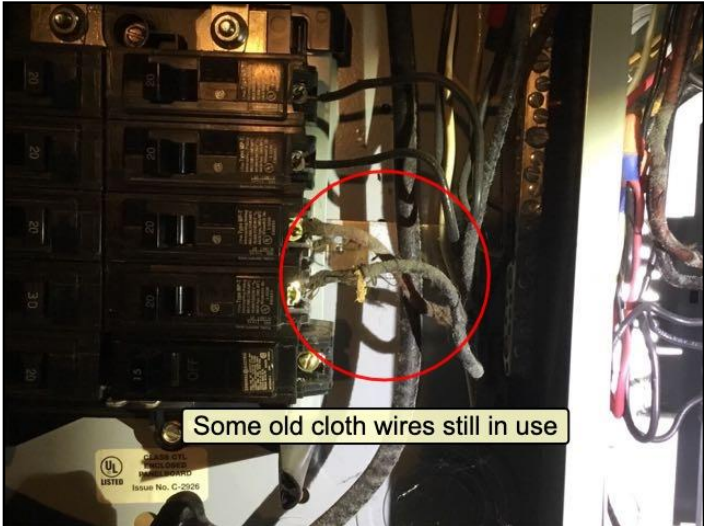
19. Condition: • Old cloth wires have tendency to dry out an loose there insulation. Recommend upgrading

Old cloth wires have tendency to dry out an...

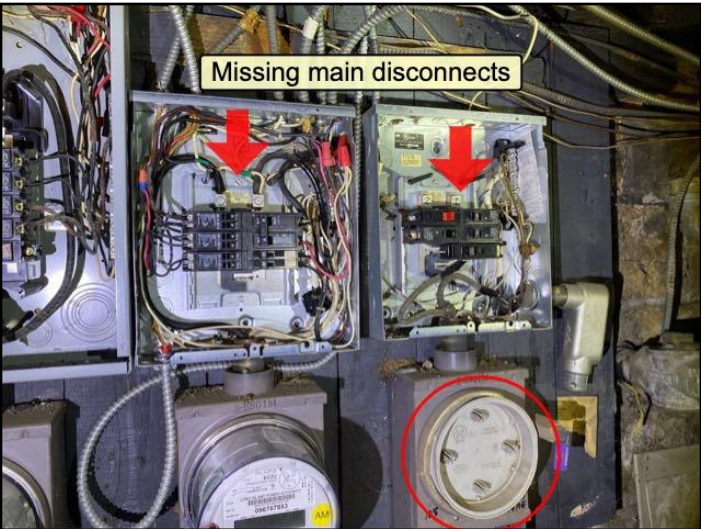
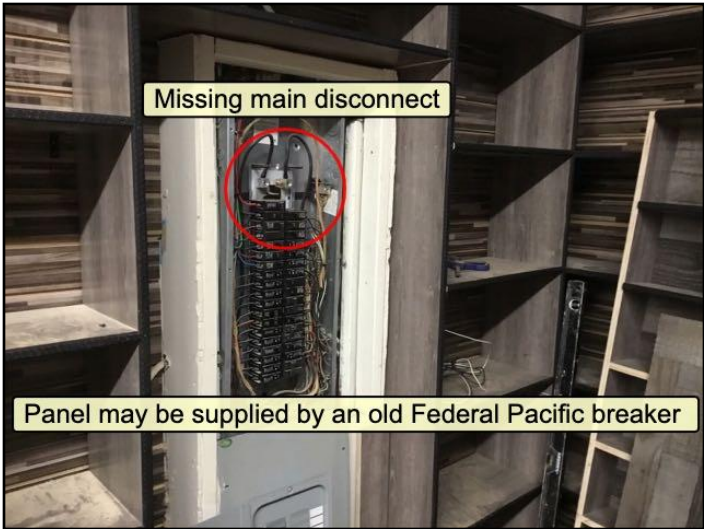
Licensed electrician

\*\*\*\*RECOMMEND LICENSED ELECTRICIAN FURTHER EVALUATE AND CORRECT ALL WIRING AND SAFETY CONCERNS PRIOR TO PURCHASE\*\*\*\*.

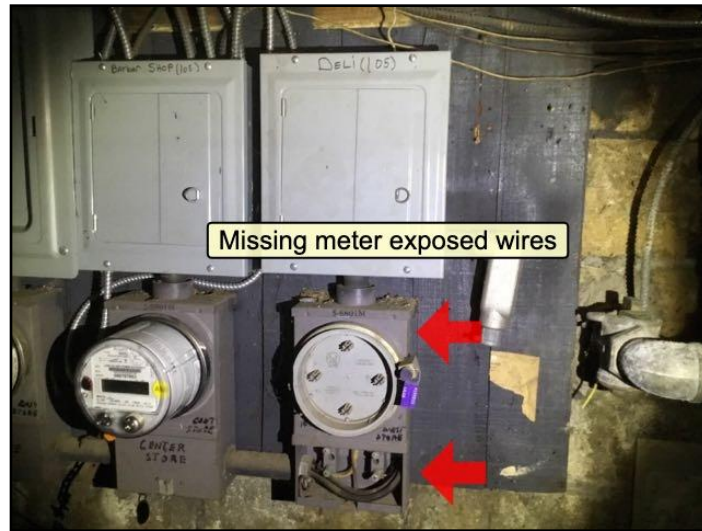
Unprotected openings

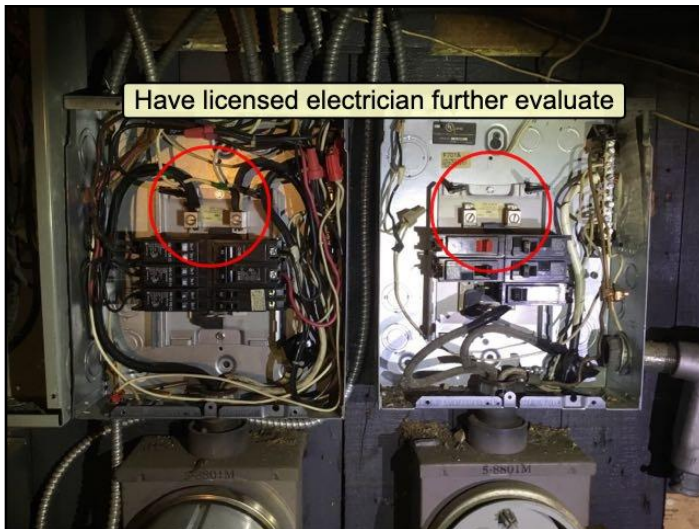
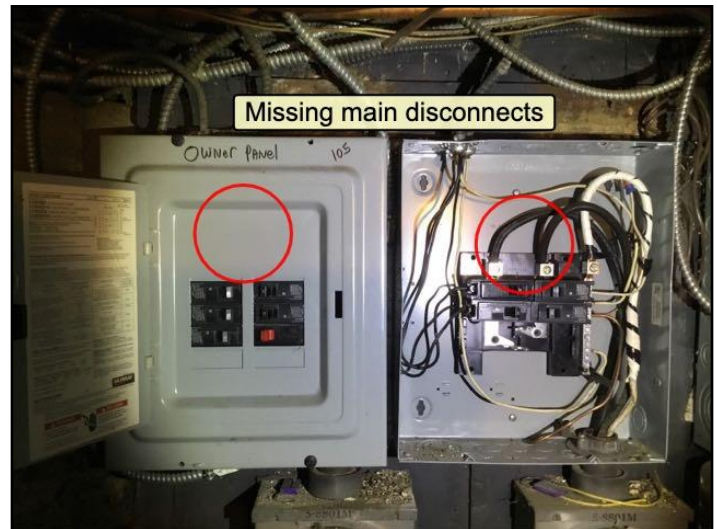
**MAIN PANEL \ Breaker / wire****22. Condition:** • Missing main disconnect

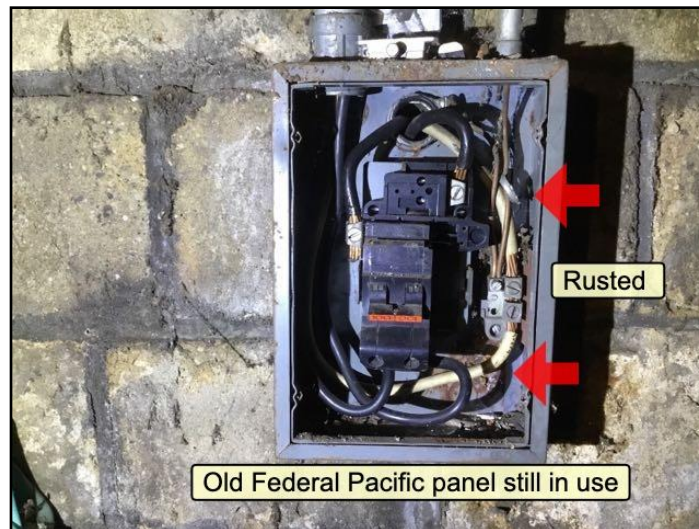
**23. Condition:** • Federal Pacific service panels can fail to trip in response to over current leading to electrical fires. Federal Pacific company no longer in business. Recommend licensed electrician replace panel.

*Federal Pacific service panels can fail to...*

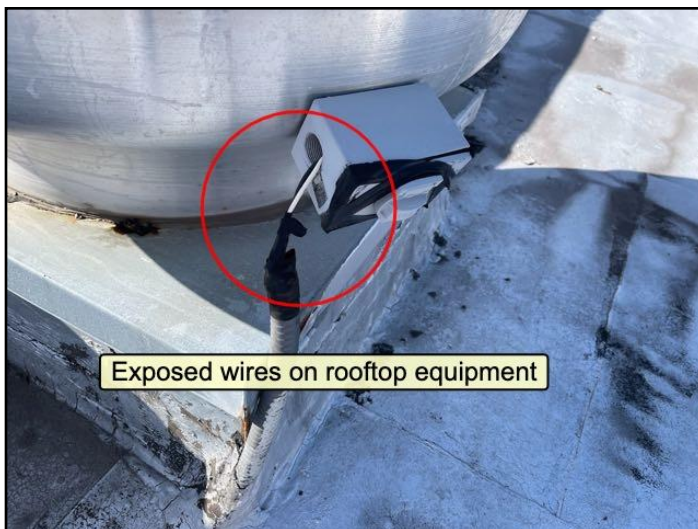
WIRES EXPOSED

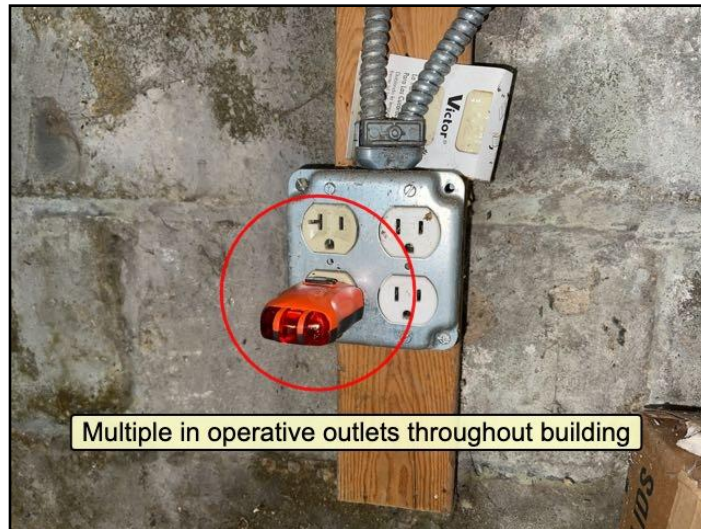
Inoperative

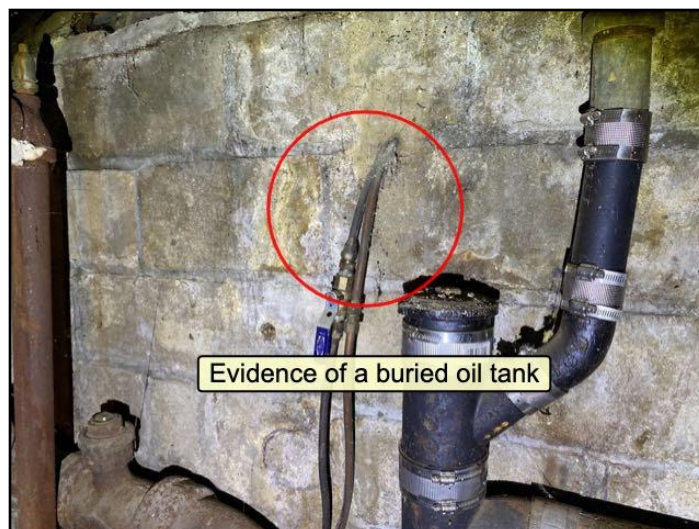
**29. Condition:** • An underground oil storage tank exists on property. Request proper paperwork from seller to determine if tank was abandoned properly. Buried oil tanks are an environmental risk. Oil tank abandonment /removal costs vary depending on the extent of work required. An oil tank specialists should be consulted to evaluate and estimated cost prior to contract signing.

*Recommend asking seller if a buried oil tan...*

Recommend asking seller for proper abandonment paperwork prior to closing. Consult with your attorney.

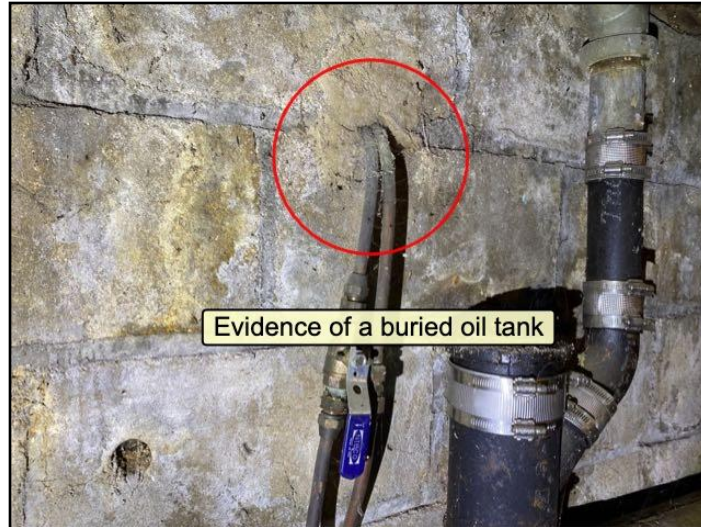
Evidence of a buried oil tank

*Oil tank abandoned according to home owner....*

\*\*\*\*RECOMMEND ATTORNEY REQUEST PROPER ABANDONMENT PAPERWORK PRIOR TOM CONTRACT SIGNING\*\*\*\*

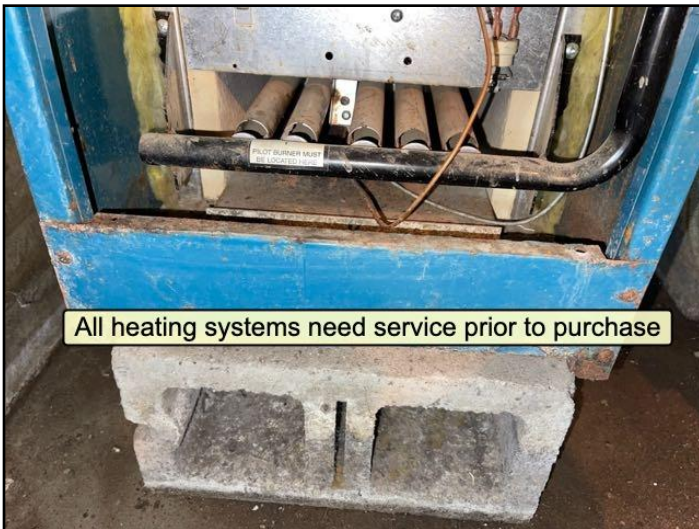
**31. Condition:** • Rust - recommend further evaluation for all heating systems in basement budget for repair and or replacement

All heating systems need service prior to purchase

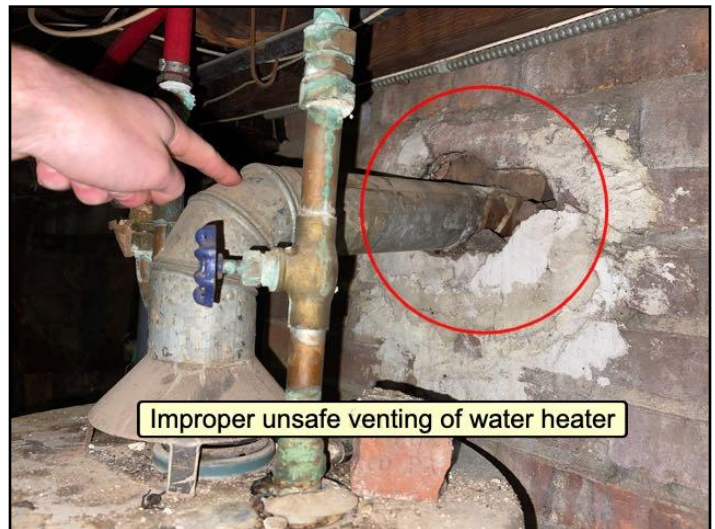
Poor connections

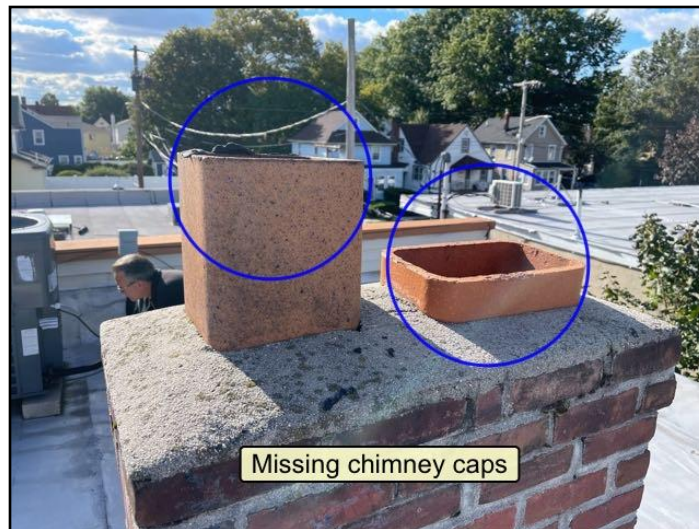
Missing chimney cap

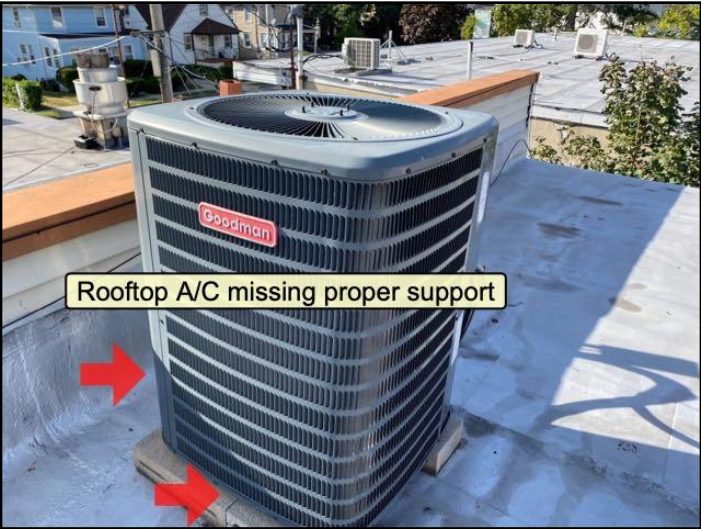
Rooftop air-conditioning needs to be properly supported. Consult with licensed HVAC company to properly support and secure rooftop air-conditioning.

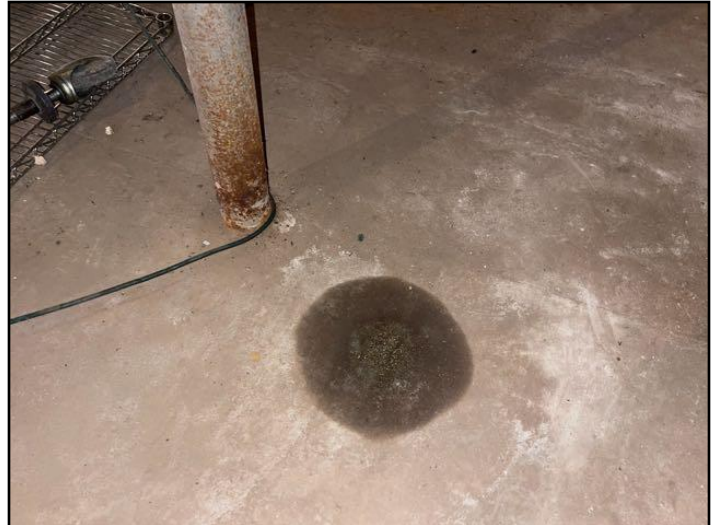
Leak

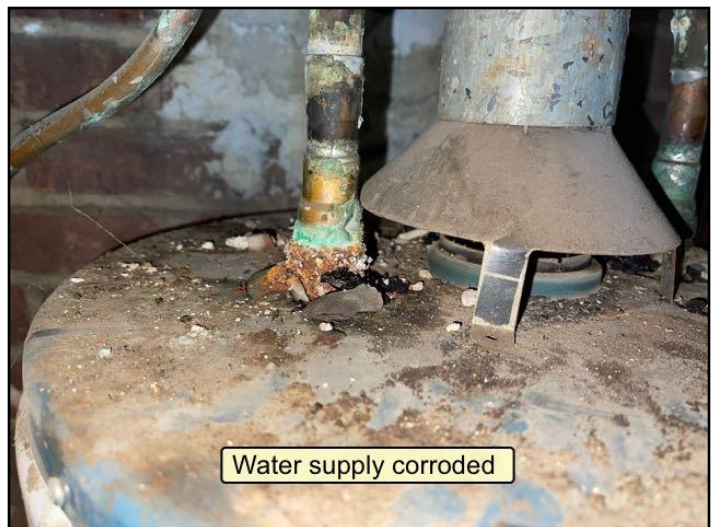
Rust

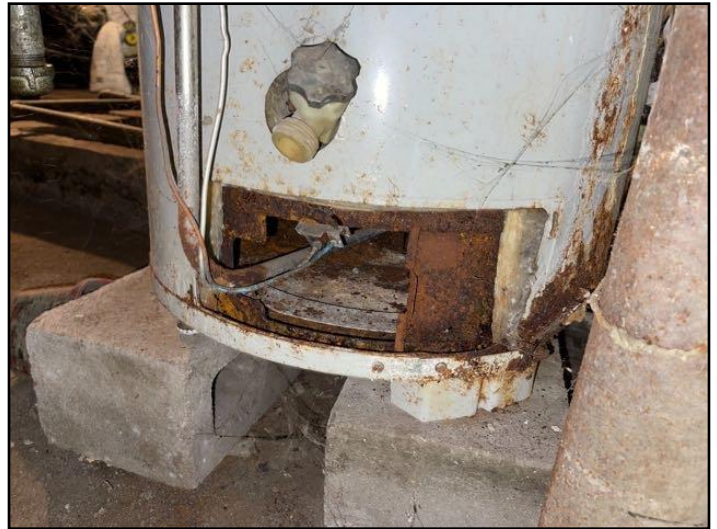
Rust

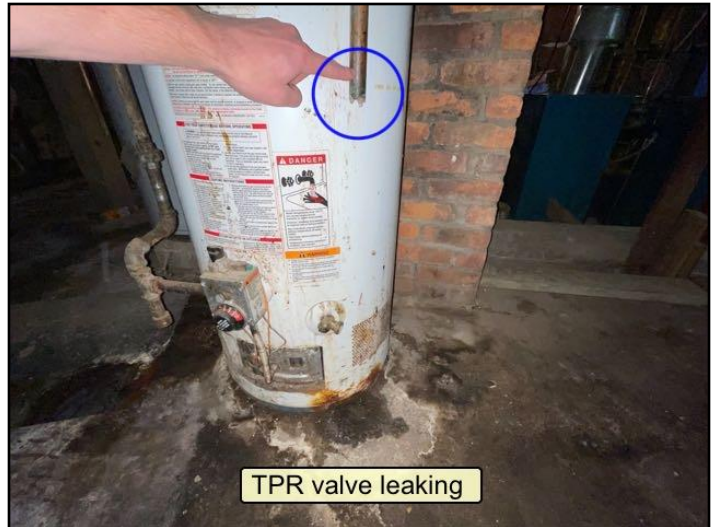
TPR valve leaking

Rust

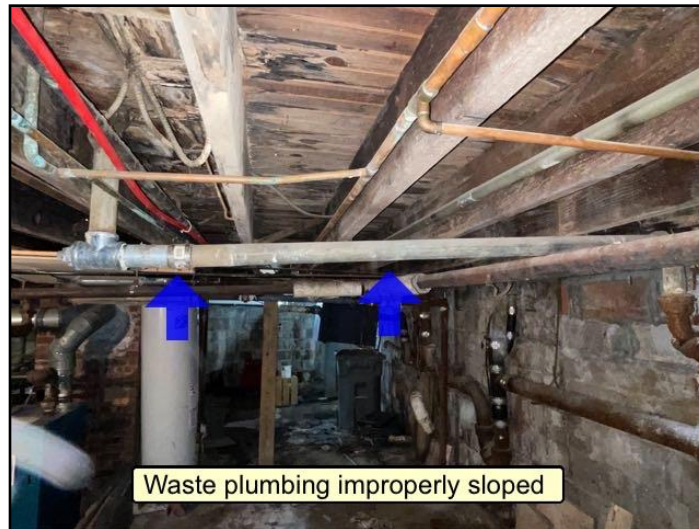
*Poor slope*

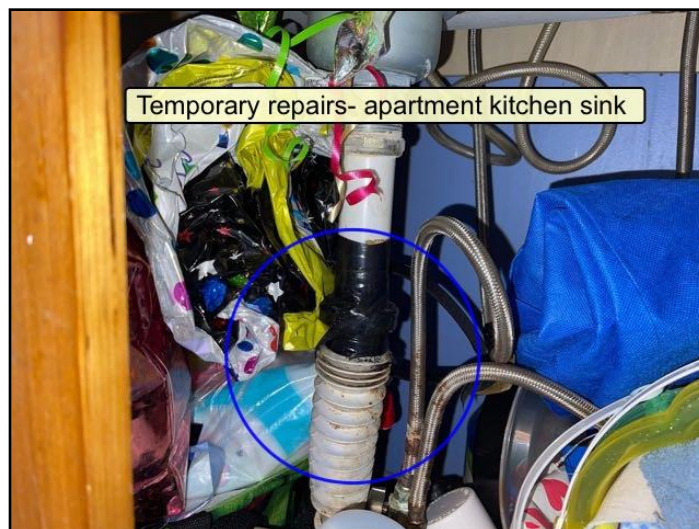
Apartment kitchen sink

*Nonstandard materials and patches*

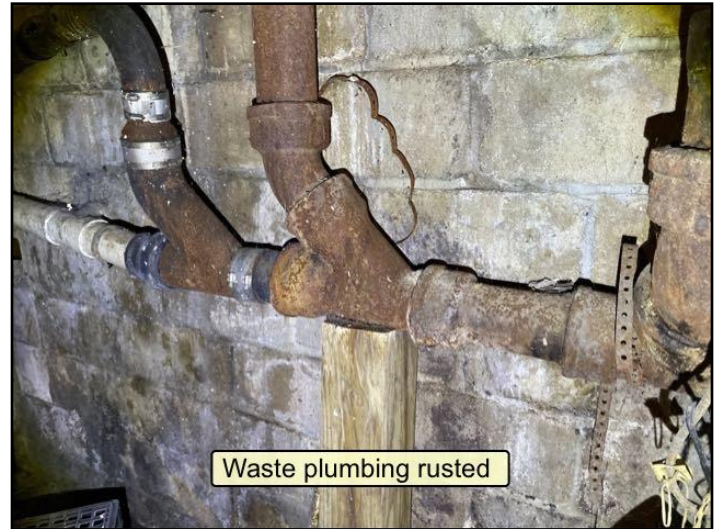
*Split, rusted or damaged*

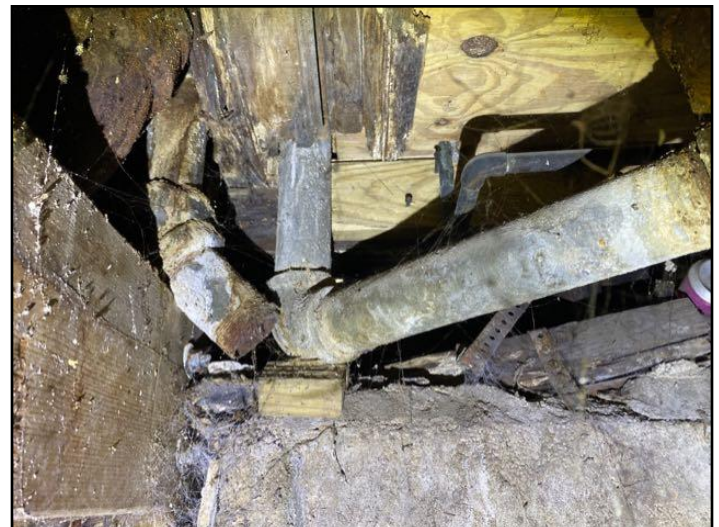
*Old galvanized pipes rust from inside out....*

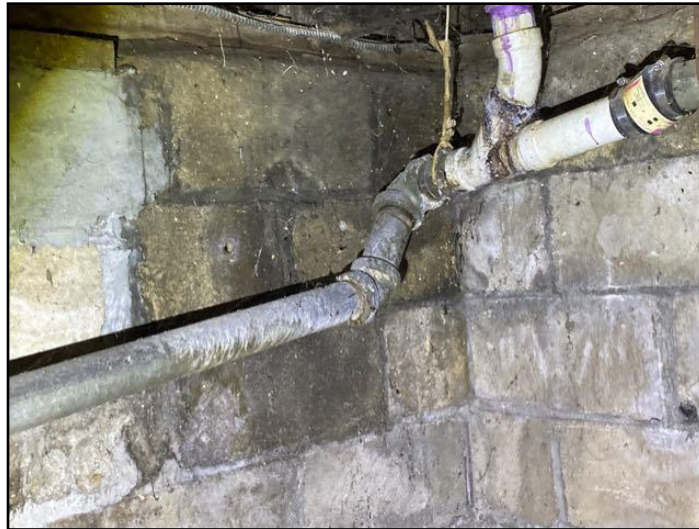
*Old galvanized pipes rust from inside out....*

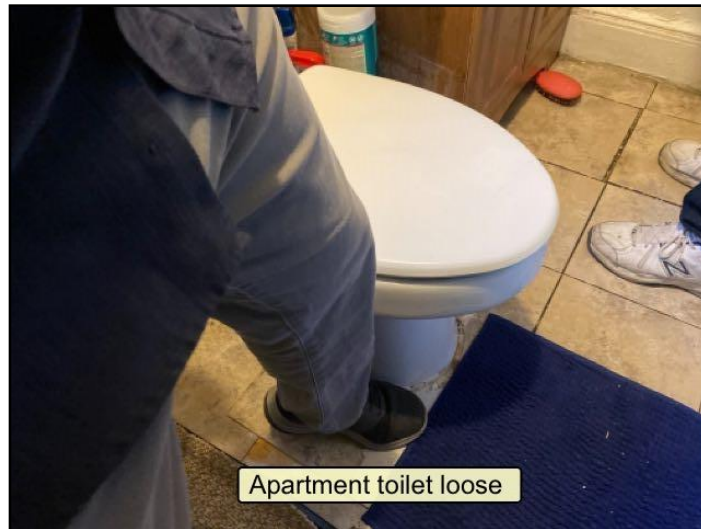
*Loose*

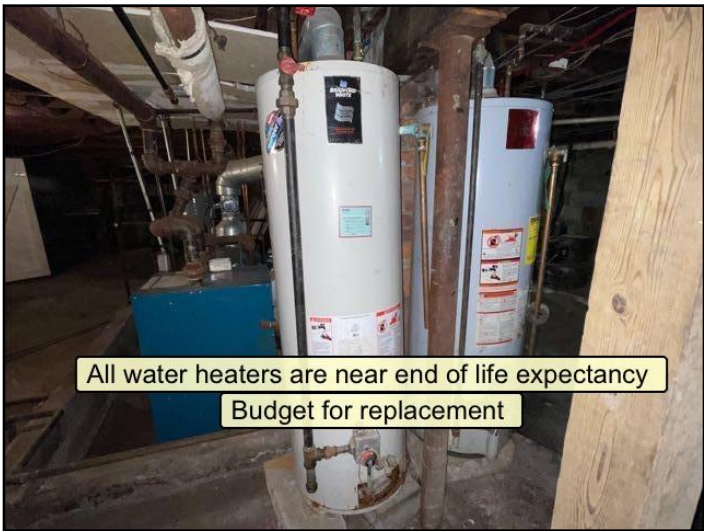
All water heaters are near end of life expectancy  
Budget for replacement

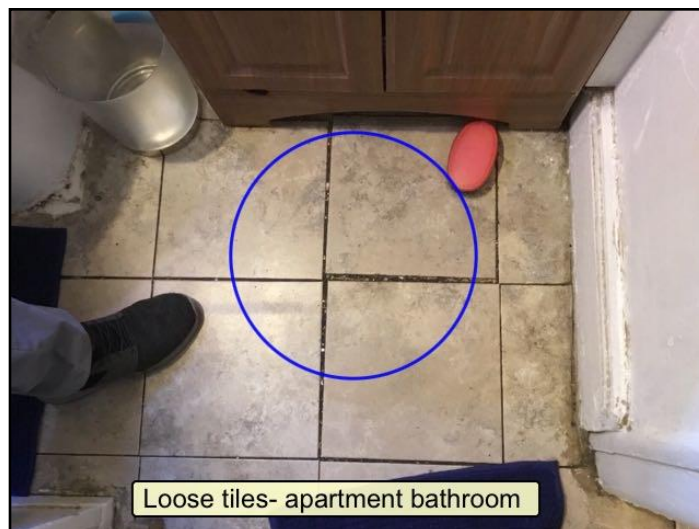
Tiles loose

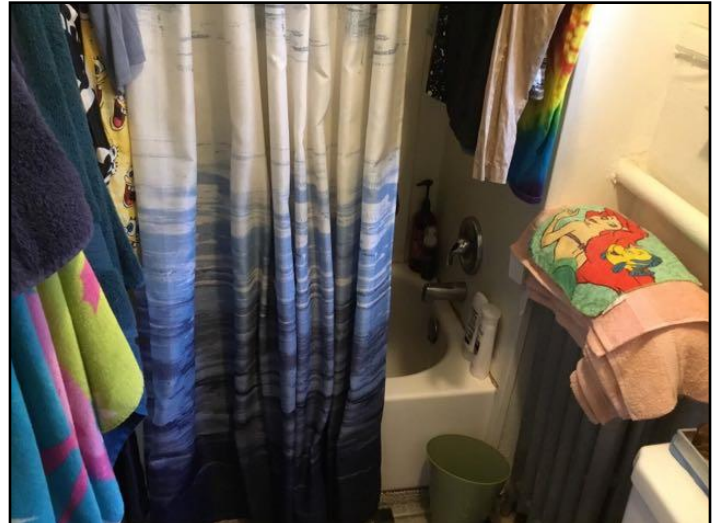
*Bathroom in need of upgrading. Recommend...*

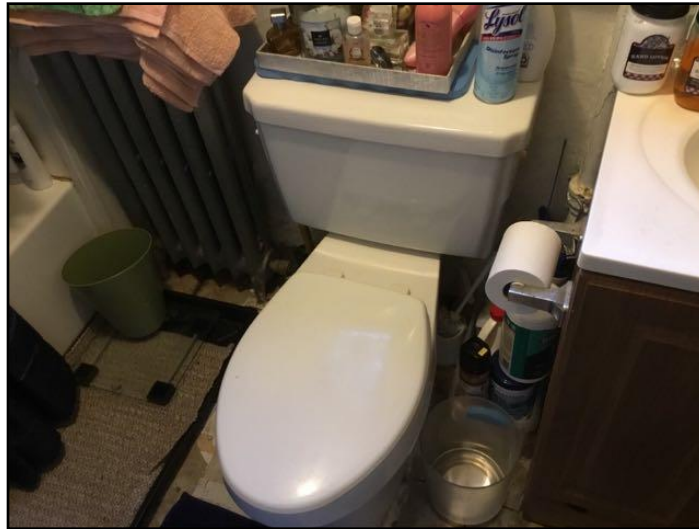
*Bathroom in need of upgrading. Recommend...*
