# INSPECTION REPORT

***New York City Brownstone Apartments  
145 Heritage Place  
New York, NY 10024***

**Prepared by:** East Coast Commercial Inspections  
**Prepared for:** Julian Perez  
**Inspection:** April 20, 2026  
**Date of Report:** April 22, 2026

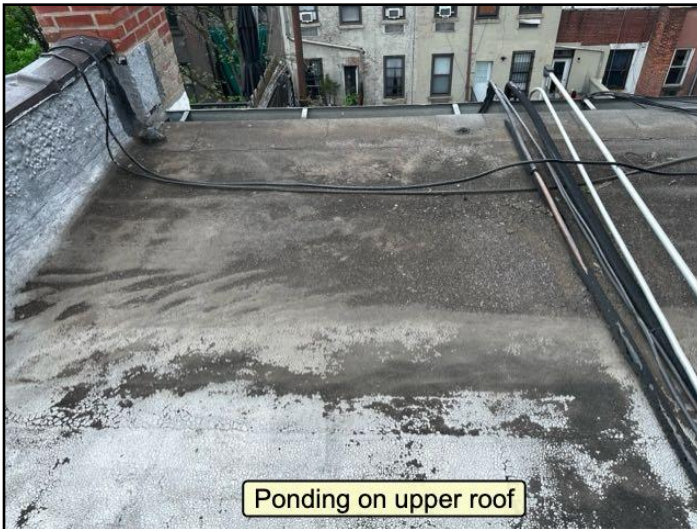
**2. Condition:** • [Ponding](#)

**Implication(s):** Chance of water damage to structure, finishes and contents

Ponding on upper roof

Ponding

**Task:** Replace

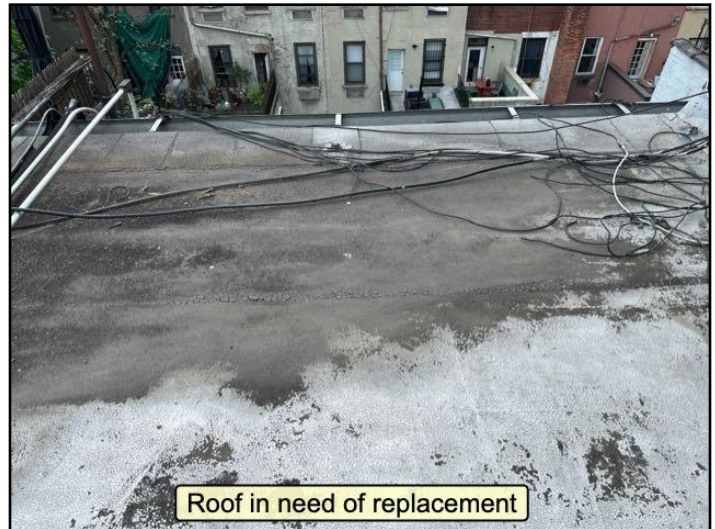
Roof in need of replacement

Ponding

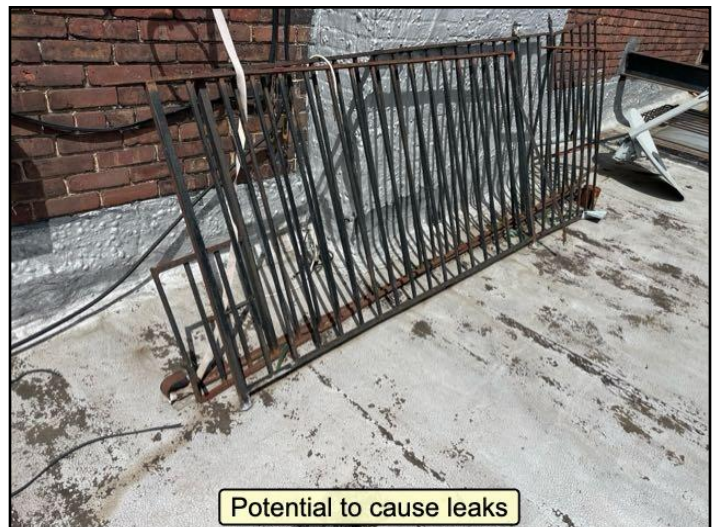
**3. Condition:** • Debris/ Moss

Potential to cause leaks

Debris/ Moss

Recommend asking seller to remove all debris from roof

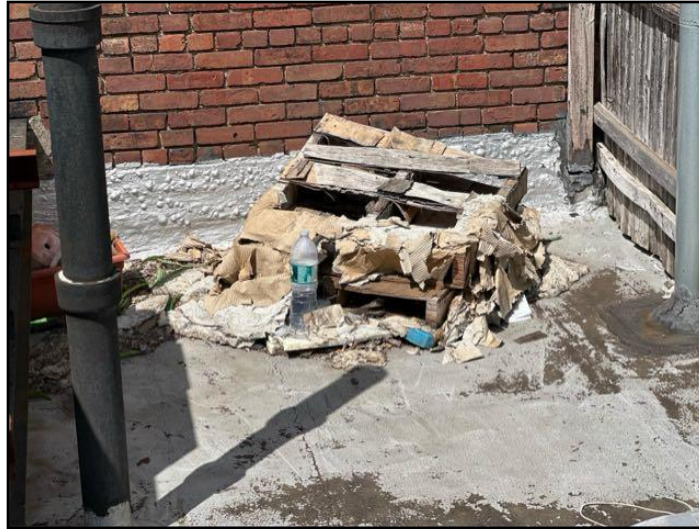
Debris/ Moss

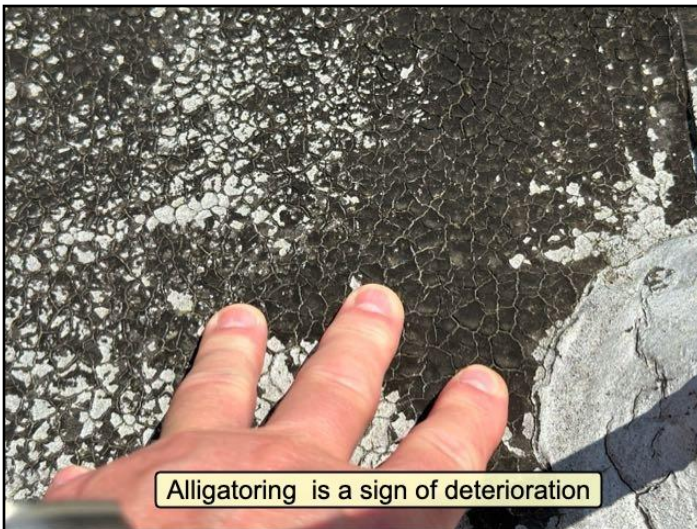
## 4. Condition: • Alligatoring

Alligatoring

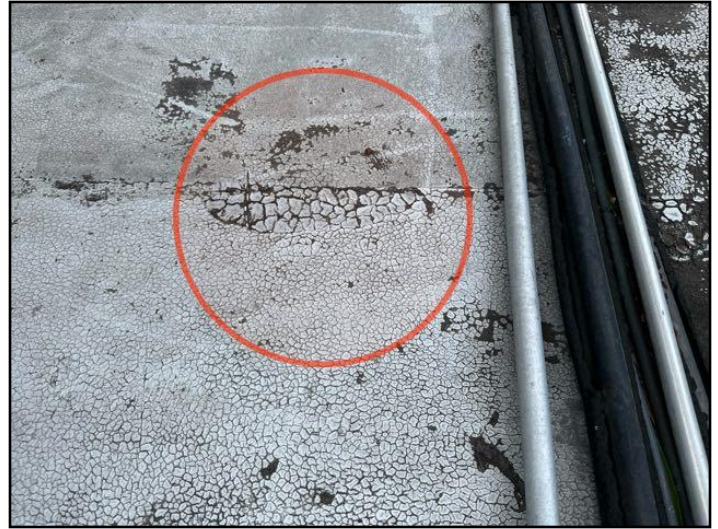
Alligatoring

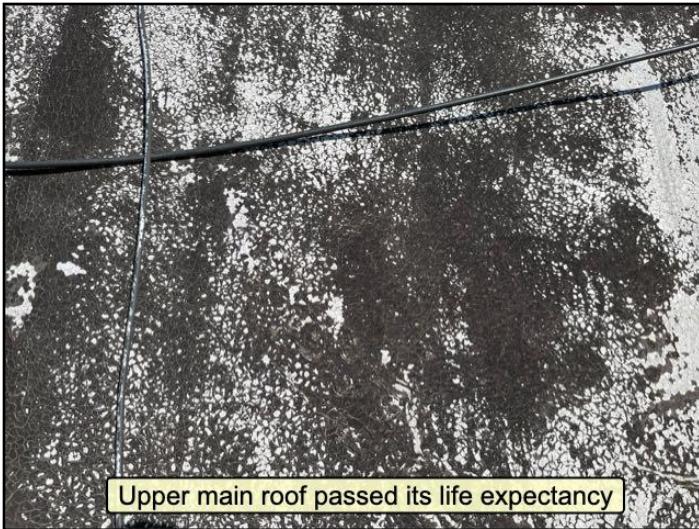
**5. Condition:** • Past life expectancy

Past life expectancy

**Task:** Replace

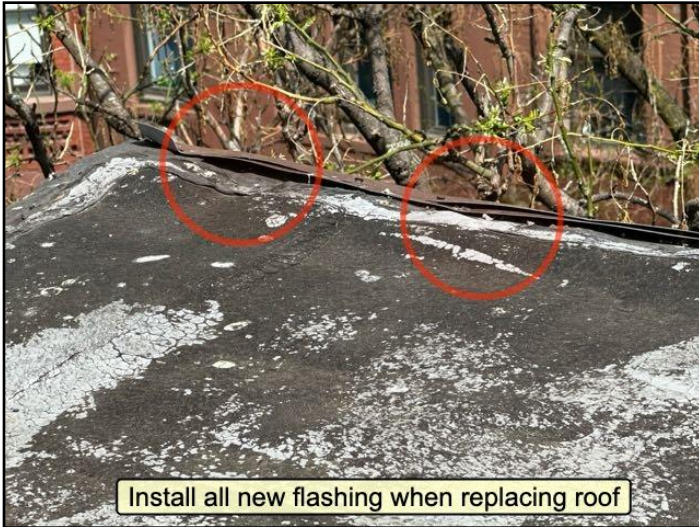
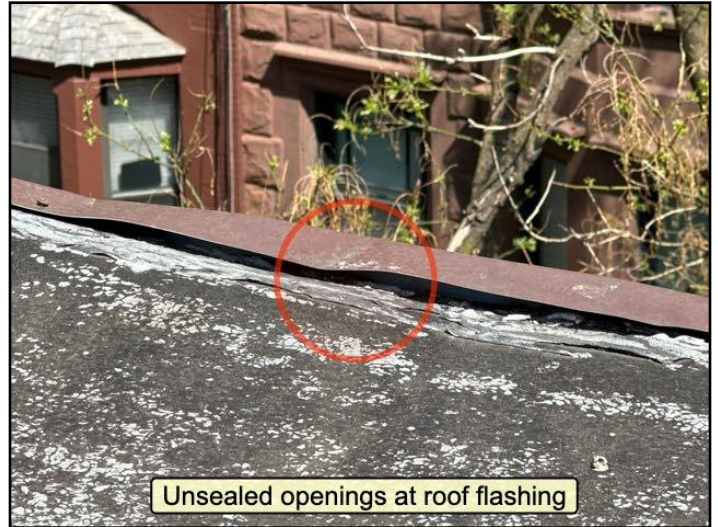
**6. Condition:** • Replace when re-roofing

**Implication(s):** Chance of water damage to structure, finishes and contents

*Replace when re-roofing*

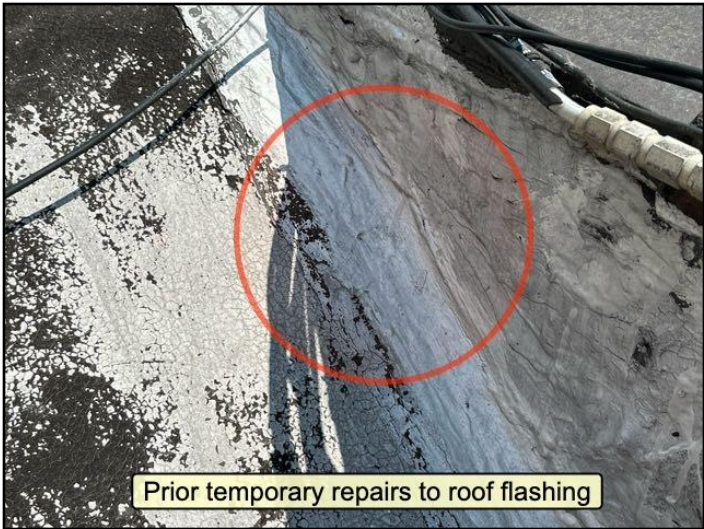
**7. Condition:** • Prior temporary repairs

Prior temporary repairs to roof flashing

Prior temporary repairs

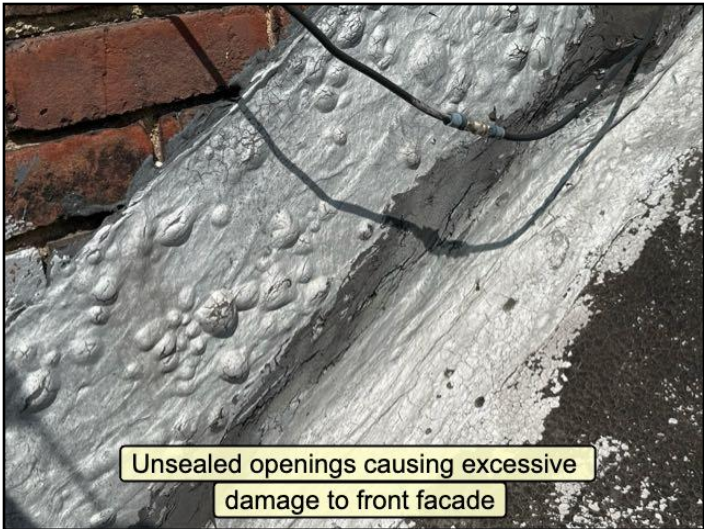
Unsealed openings causing excessive damage to front facade

Prior temporary repairs

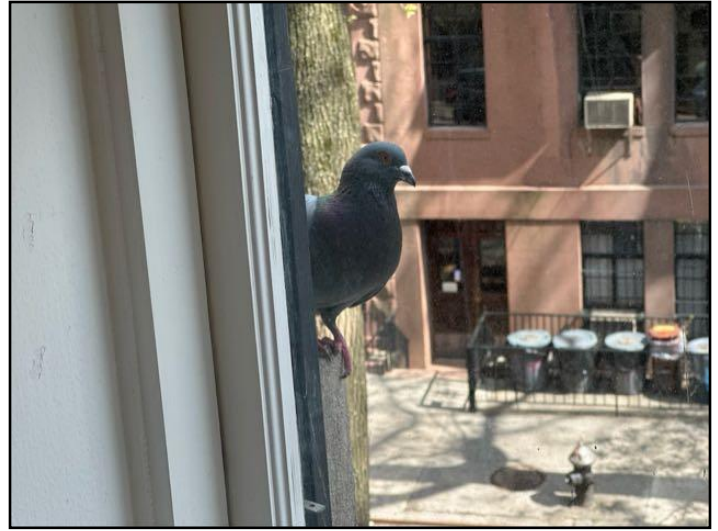
**RECOMMENDATIONS \ General****9. Condition:** • Birds nesting**Location:** Front**Task:** Improve

*Birds nesting***RECOMMENDATIONS \ Overview**

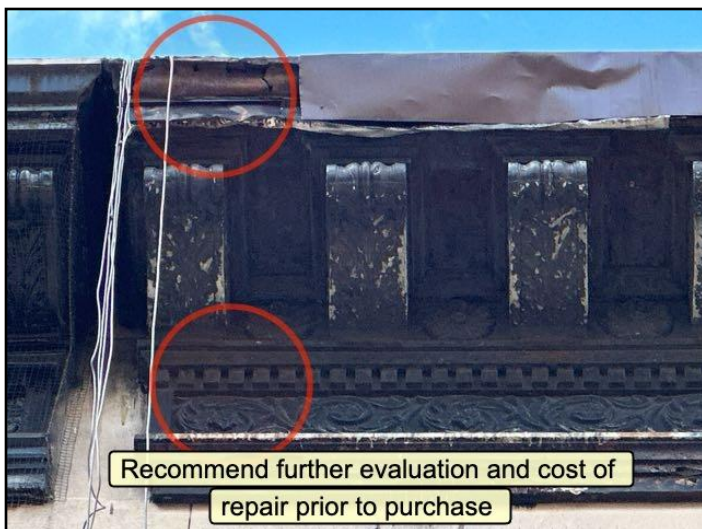
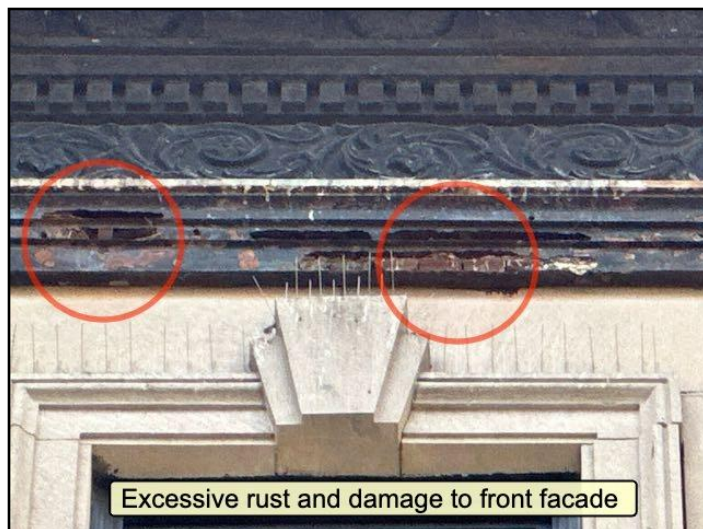
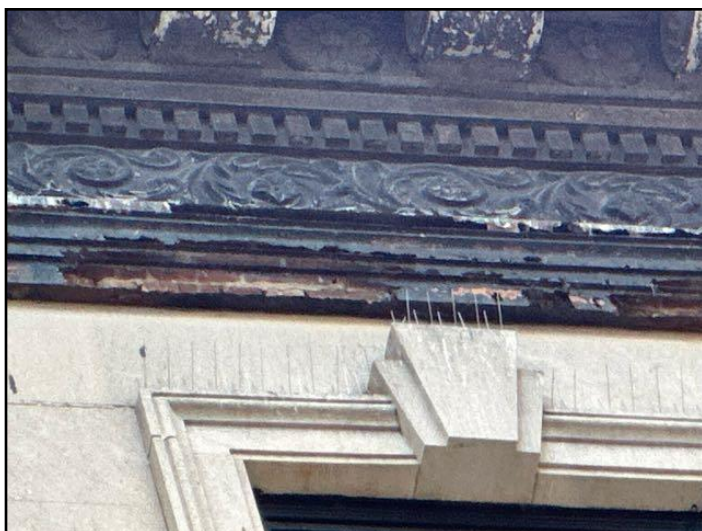
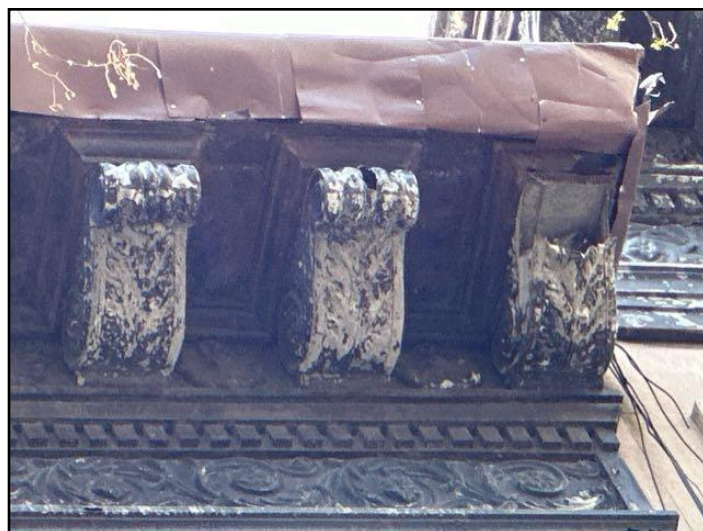
**12. Condition:** • [Damage](#)

**Implication(s):** Chance of water damage to structure, finishes and contents

Damage

**Task:** Recommend further evaluation by a qualified professional to determine next best course of action

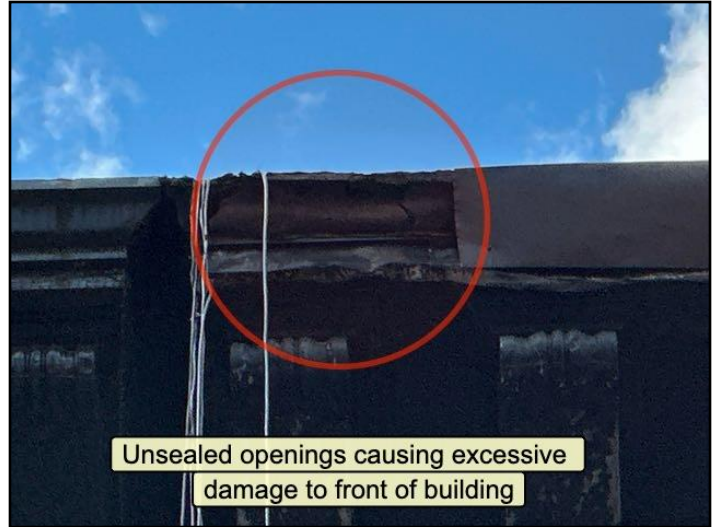
**WALLS \ -Flashings****13. Condition:** • [Flashings missing](#)**Implication(s):** Chance of water damage to structure, finishes and contents

Unsealed openings causing excessive damage to front of building

Flashings missing

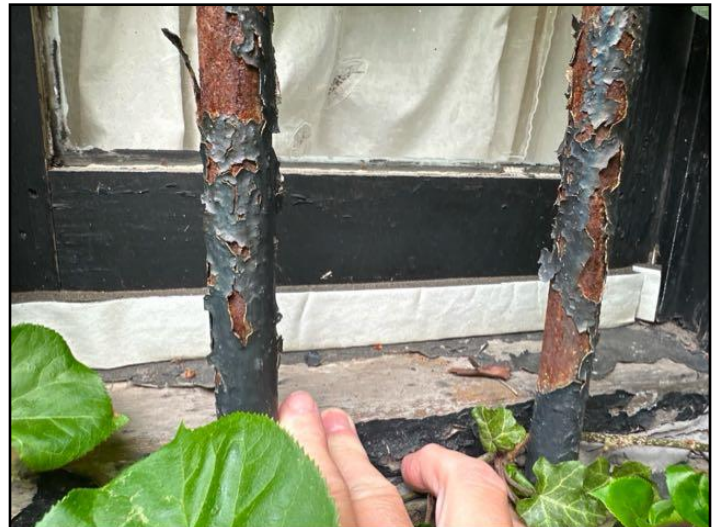
14. Condition: • Old budget for replacement

Old budget for replacement

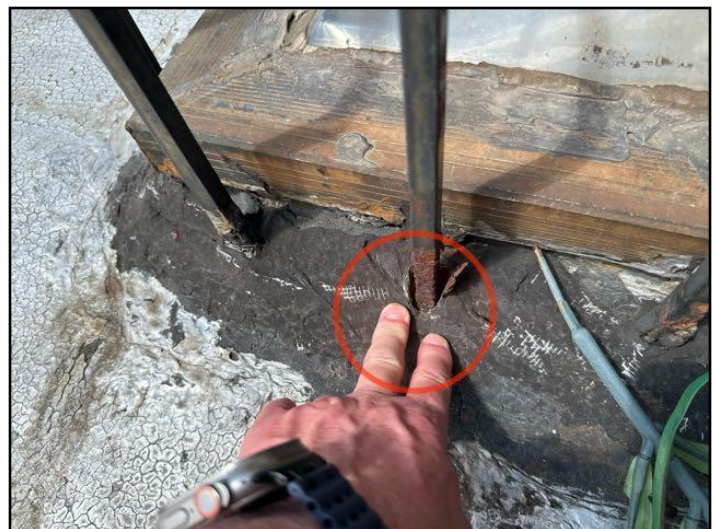
15. Condition: • Old

Old

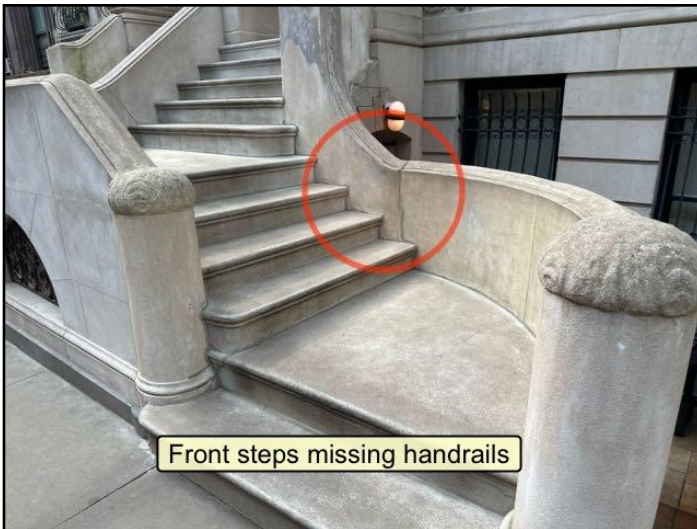
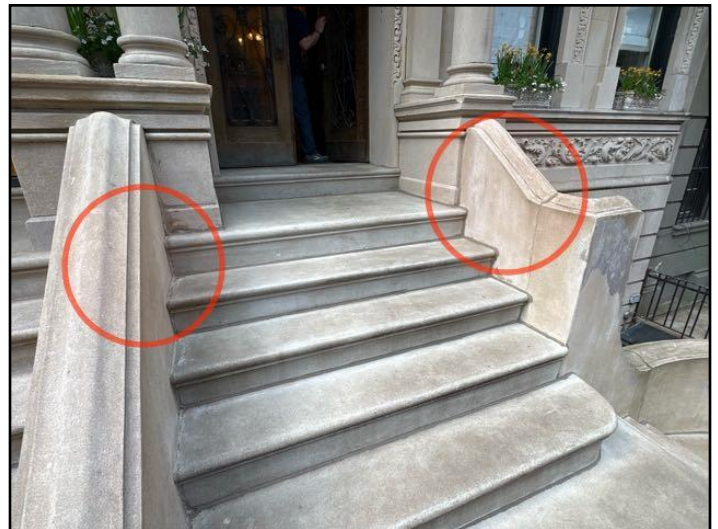
**PORCHES, DECKS, STAIRS, PATIOS \ \*Handrails and guards\*****16. Condition:** • [Missing](#)**Implication(s):** Fall hazard**Location:** Front**Task:** Provide

Missing

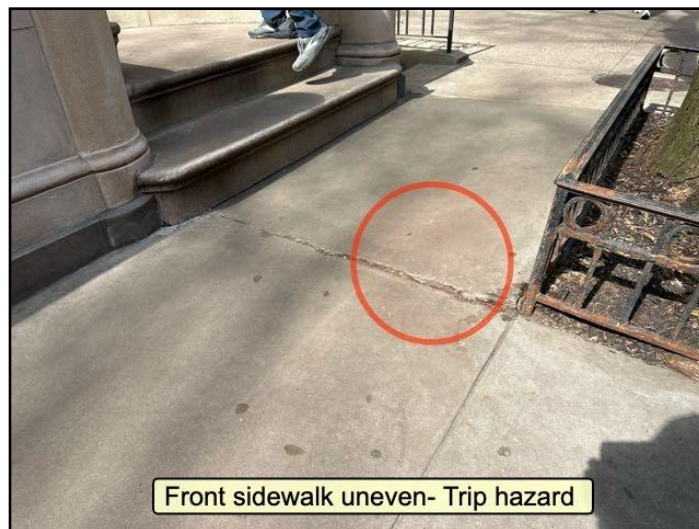
**18. Condition:** • Uneven (trip hazard)

*Uneven (trip hazard)*

**Task:** Improve

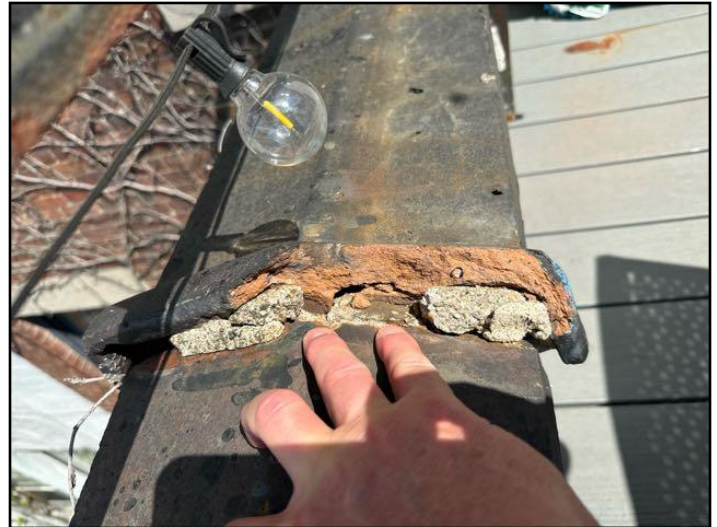
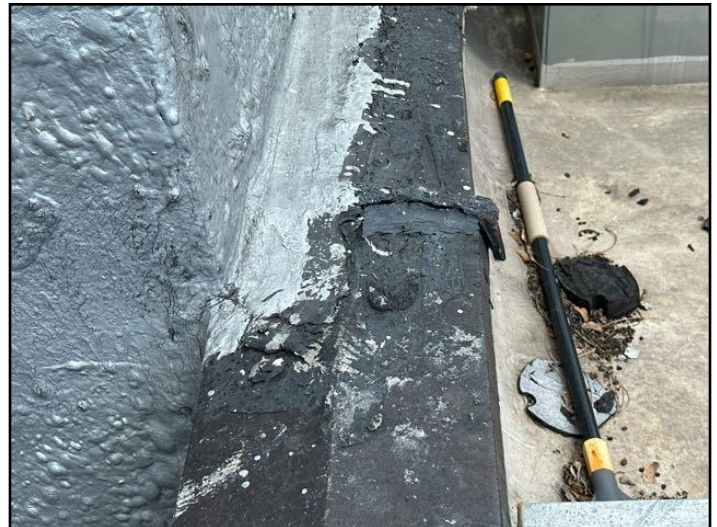
**20. Condition:** • Parapet wall coping damaged

Parapet wall coping damaged

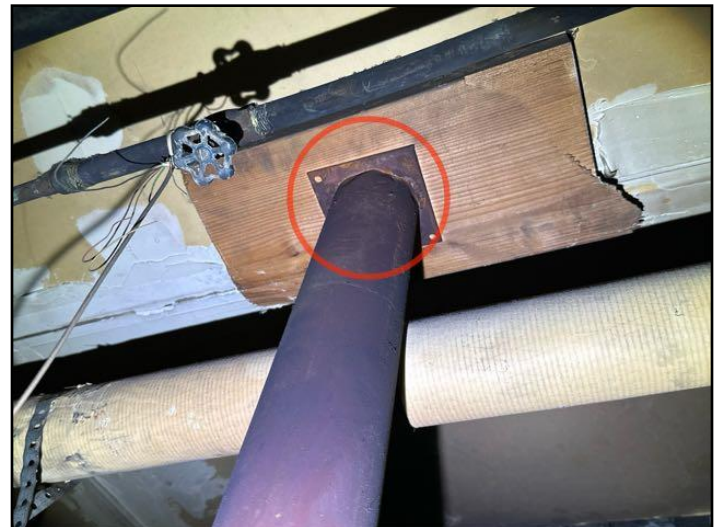
**21. Condition:** • [Poorly secured at top or bottom](#)

Poorly secured at top or bottom

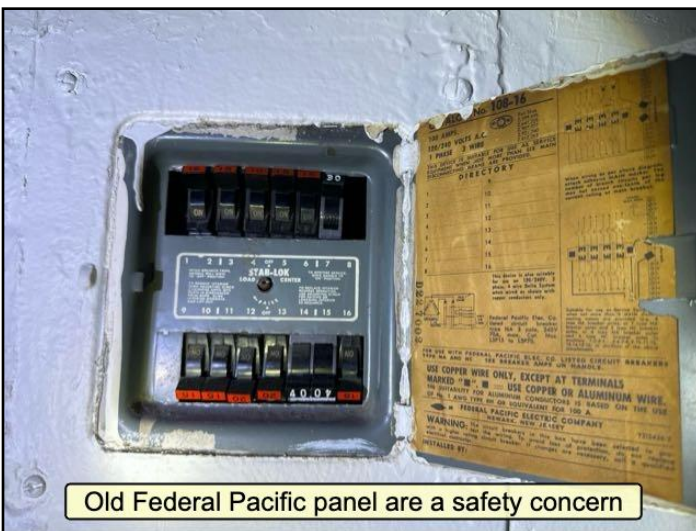
#### 23. Condition: • Old Stab-Lock panel and breakers

Stab-Lok circuit breakers - particularly those manufactured by Federal Pacific Electric - have been noted as a serious safety hazard in homes. Stab-Lok circuit breakers are dangerous because they do not function properly as circuit breakers. The circuit "breaker," which is the switch that is supposed to flip and interrupt current flow when an issue is detected, does not function properly in these panels.. The circuit breakers are not effective for addressing issues like overloaded circuits and short circuits. Because the breakers may not trip when an issue is detected, this can damage home electrical systems, and even increase the risk of an electrical fire.

Old Stab-Lock panel and breakers

**Task:** Replace

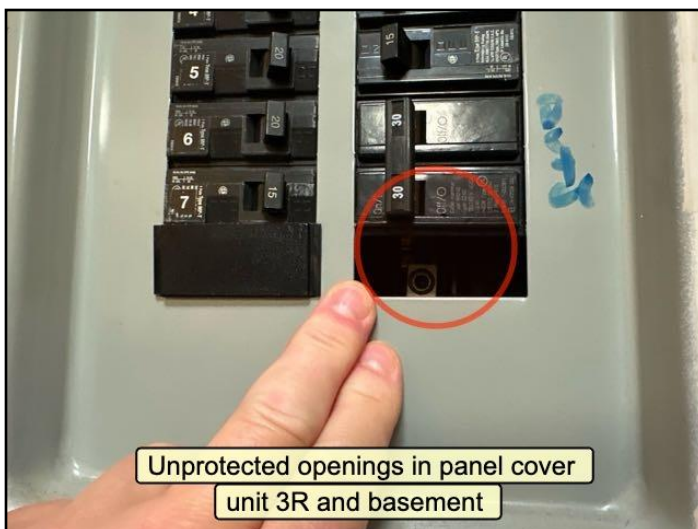
**MAIN PANEL \ Distribution panel****25. Condition:** • [Openings in panel](#)**Implication(s):** Electric shock | Fire hazard**Location:** Unit 3R and basement**Task:** Improve**Time:** As soon as practical

Openings in panel

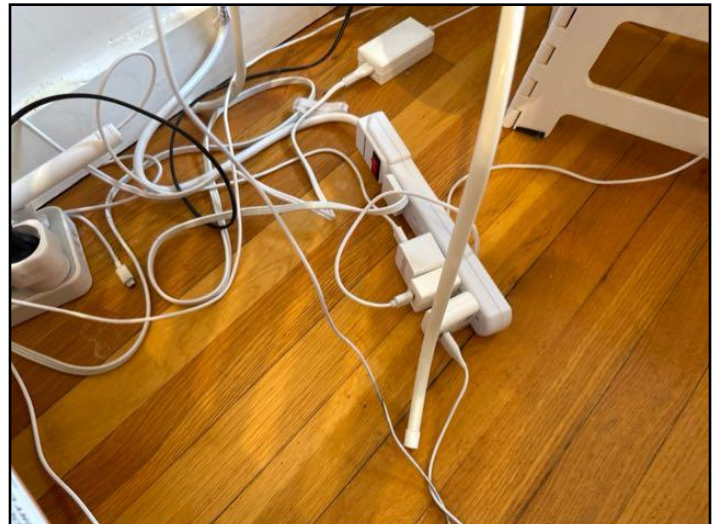
*Excessive use of extension cord***27. Condition:** • Excessive use of extension cord**Location:** Second Floor**Task:** Improve**Time:** As soon as practical

*Excessive use of extension cord***DISTRIBUTION \ Wiring (wires) - damaged or exposed****28. Condition:** • Exposed**Location:** Boiler room

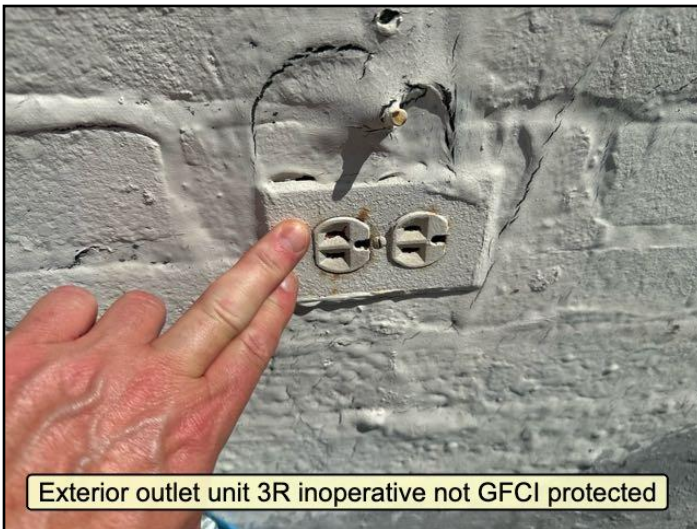
*Exposed***DISTRIBUTION \ Outlets****29. Condition:** • [Inoperative](#)**Implication(s):** Equipment inoperative**Location:** 3R rear deck /Owner suite basement bathroom

*Inoperative*

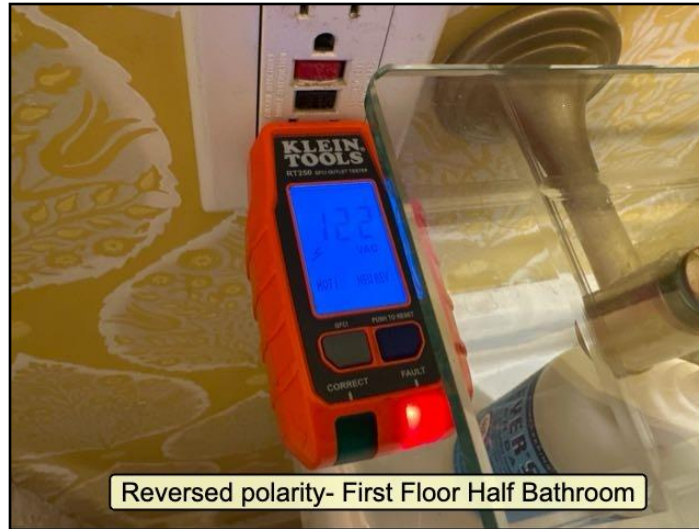
Reversed polarity- First Floor Half Bathroom

*Reversed polarity***31. Condition:** • [Ungrounded](#)

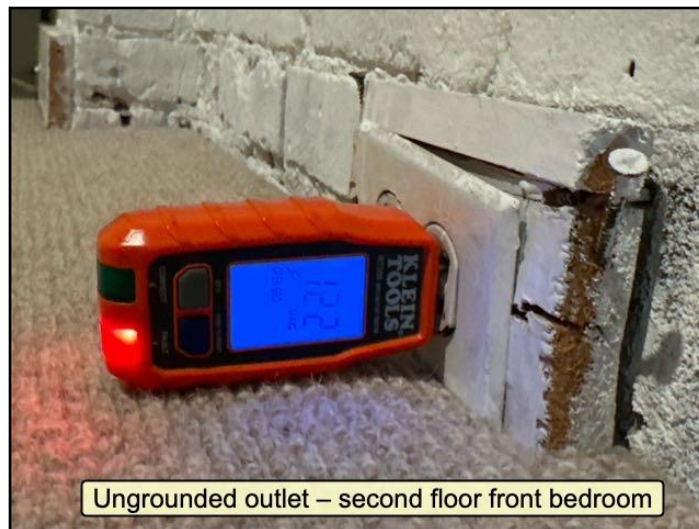
Ungrounded outlet – second floor front bedroom

*Ungrounded***32. Condition:** • [No GFCI/GFI \(Ground Fault Circuit Interrupter\)](#)

**Task:** Improve

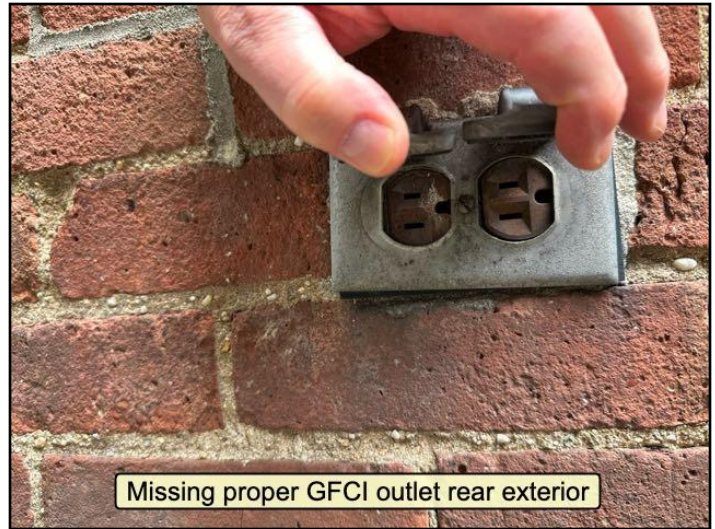
Missing proper GFCI outlet rear exterior

No GFCI/GFI (Ground Fault Circuit...

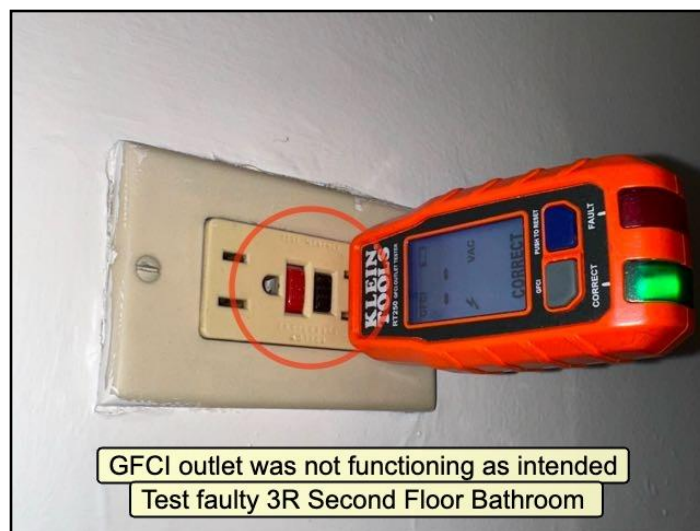
**33. Condition:** • [Test faulty on GFCI/GFI \(Ground Fault Circuit Interrupter\)](#)

GFCI outlet was not functioning as intended

Test faulty 3R Second Floor Bathroom

Have licensed electrician repair all electrical concerns.

**Task:** Improve or replace

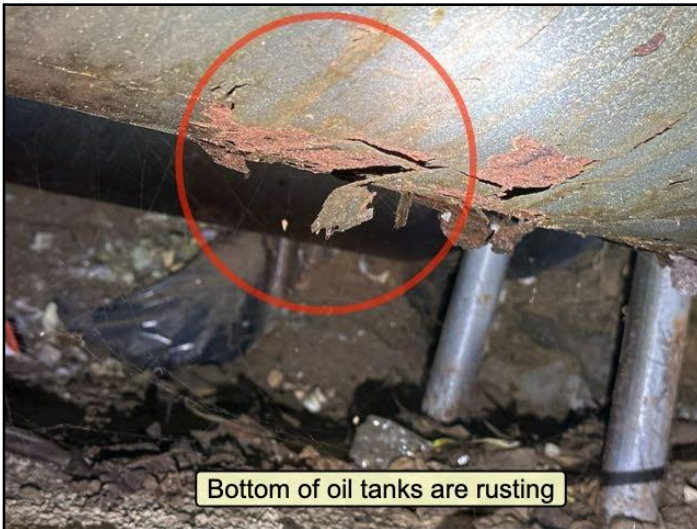
**38. Condition:** • [Rust](#)

Bottom of oil tanks are rusting

*Rust*

**Task:** Replace

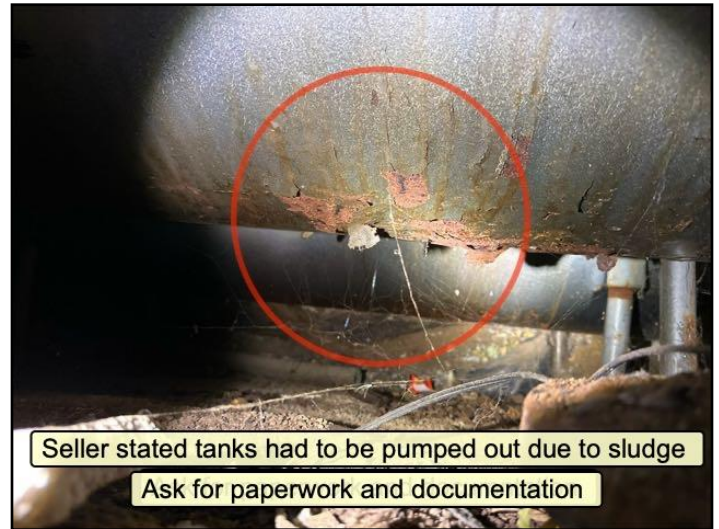
Seller stated tanks had to be pumped out due to sludge

*Rust*

Ask for paperwork and documentation

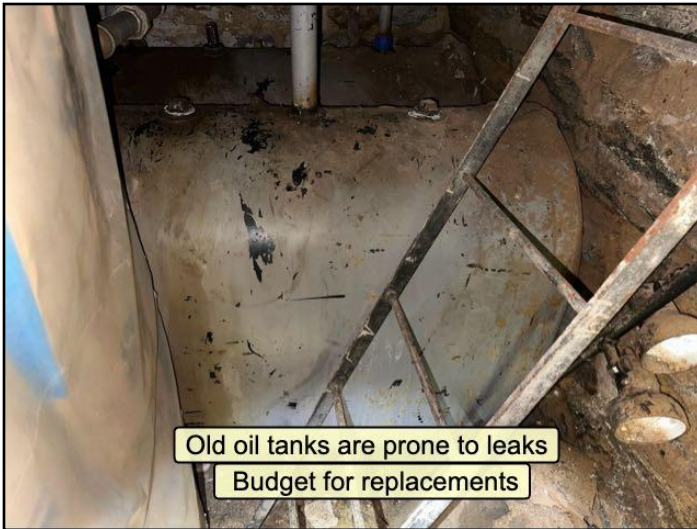
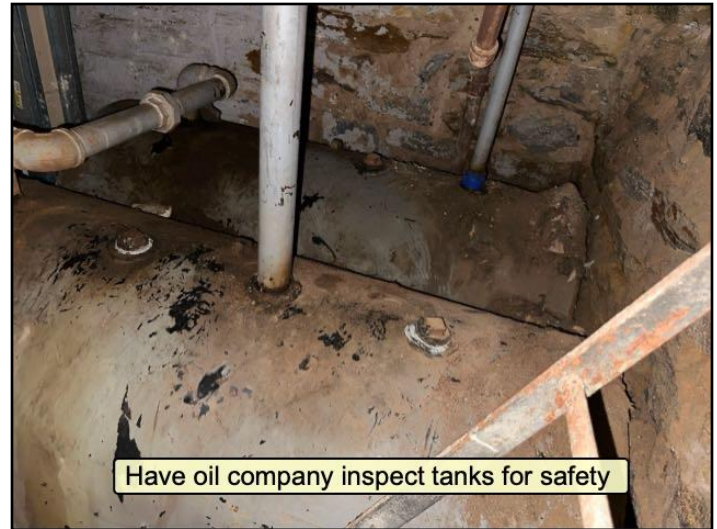
**39. Condition:** • Old oil tanks are prone to leaks

Old oil tanks are prone to leaks  
Budget for replacements

*Old oil tanks are prone to leaks*

**Task:** Replace

Have oil company inspect tanks for safety

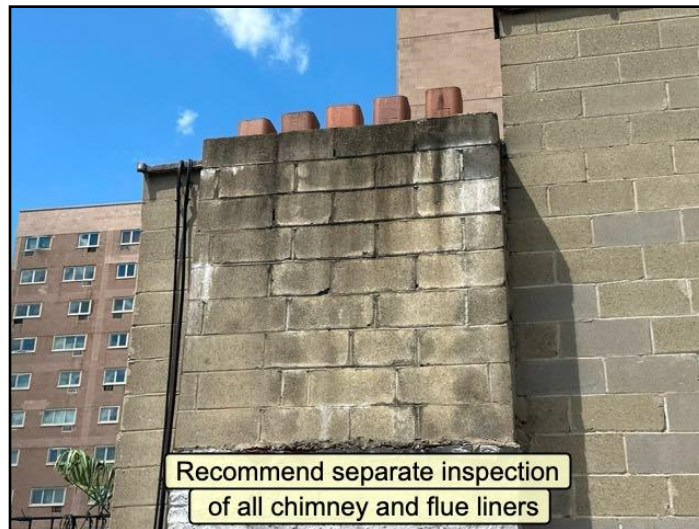
**40. Condition:** • Needs to be inspected

*Needs to be inspected*

Recommend separate inspection  
of all chimney and flue liners

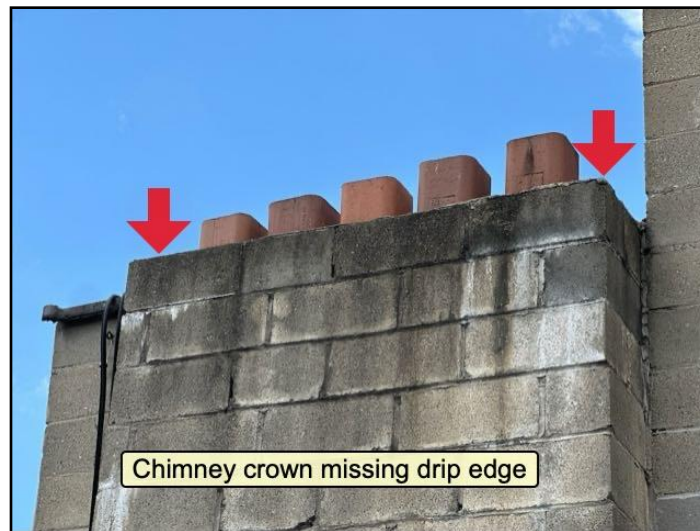
**41. Condition:** • [No drip edge on cap \(crown\)](#)

**Implication(s):** Chance of water damage to structure, finishes and contents | Shortened life expectancy of material | Material deterioration

*No drip edge on cap (crown)*

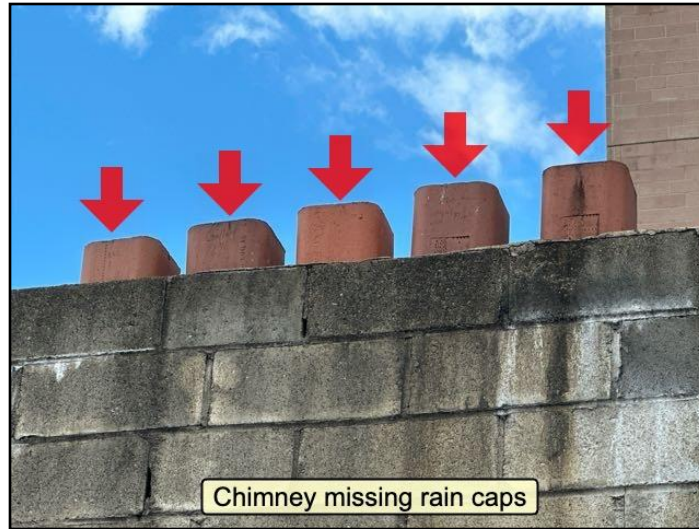
**42. Condition:** • [Rain cap missing or damaged](#)

*Rain cap missing or damaged*

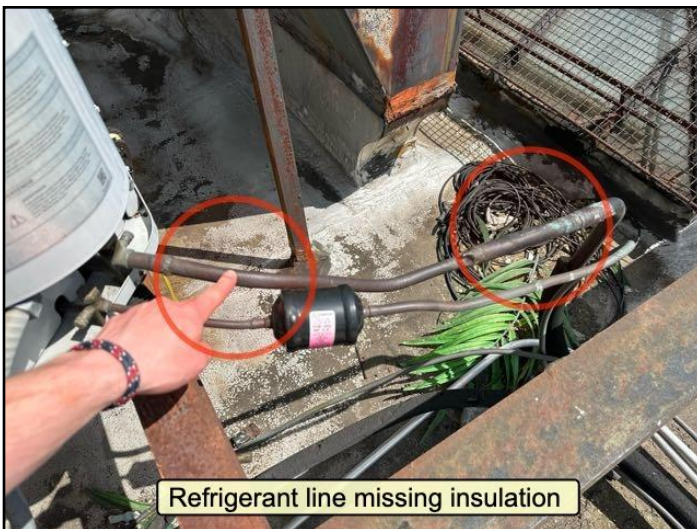
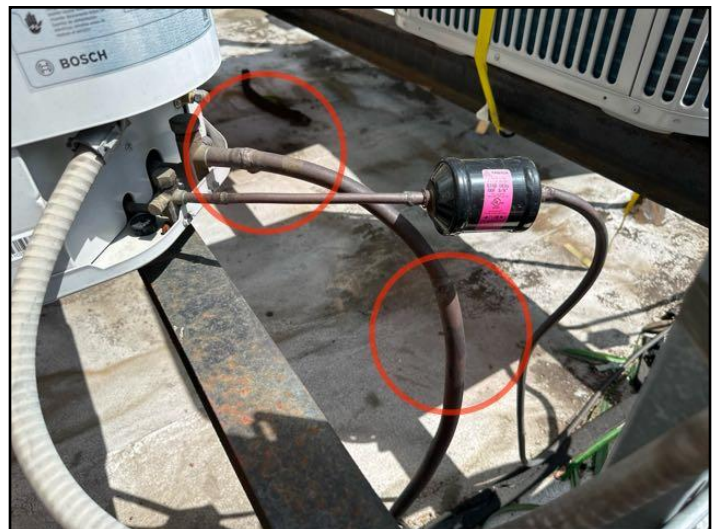
#### 43. Condition: • Insulation - missing

The larger low pressure suction line requires insulation to protect it from condensation. Without insulation around this line, thermal energy is lost and condensation forms, which can both lower efficiency and cause moisture damage to the unit.

Insulation - missing

**Task:** Improve

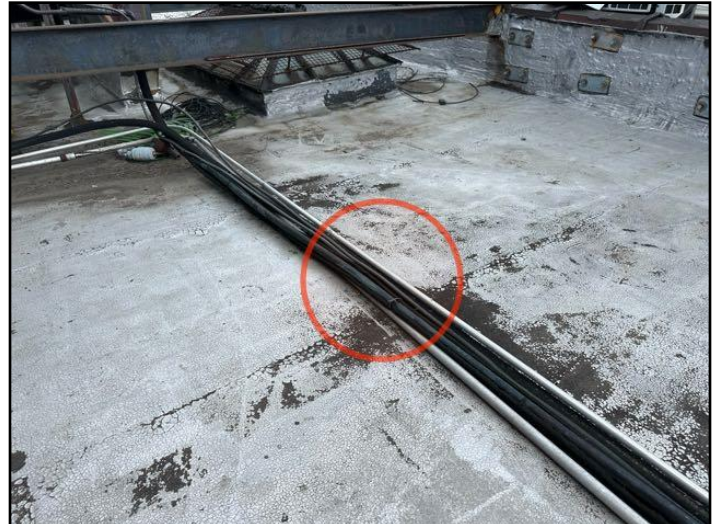
#### 44. Condition: • Refrigerant lines on roof are missing support pads

Missing support

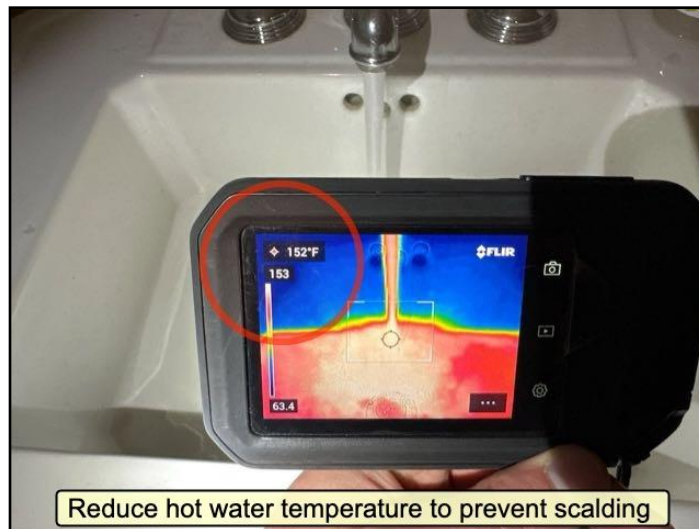
**48. Condition:** • Hot water temperature (Generally accepted safe temp. is 120° F)

The severity of tap water scalds depends on the temperature of the water and the length of time the skin is exposed. Most adults will suffer third-degree burns if exposed to 150 degree water for two seconds. Burns will also occur with a six-second exposure to 140 degree water or with a thirty second exposure to 130 degree water. Even if the temperature is 120 degrees, a five minute exposure could result in third-degree burns. Extra precaution is advised in homes with children and elderly residents.

*Hot water temperature (Generally accepted...*

**Task:** Improve

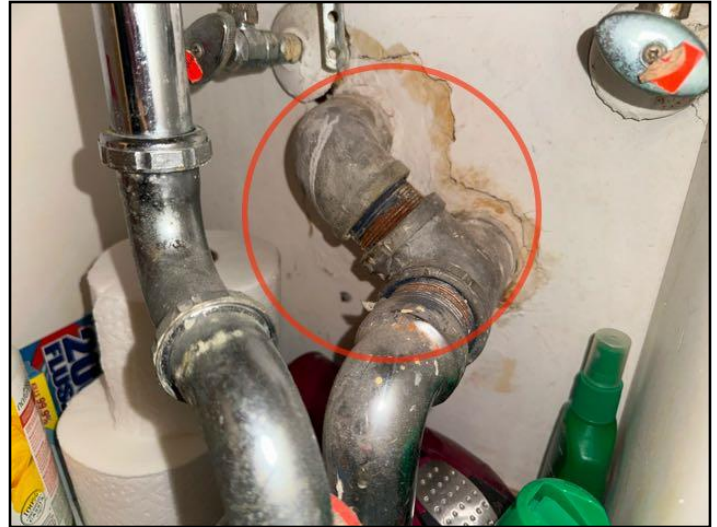
**49. Condition:** • Old galvanized drains

Various old galvanized drains still in use replace as needed

Old galvanized drains

**Task:** Replace

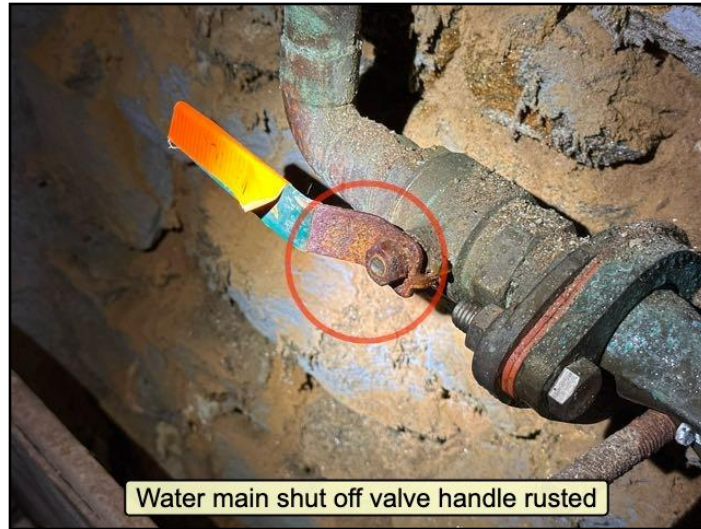
50. Condition: • [Rust](#)

Implication(s): Chance of water damage to structure, finishes and contents | Difficult to service

Water main shut off valve handle rusted

*Rust*

Task: Replace

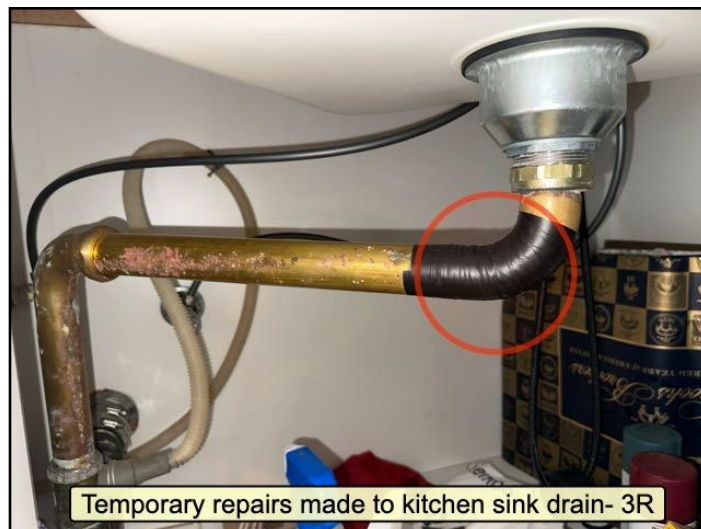
**51. Condition:** • Temporary repairs

**Location:** 3R Kitchen

Temporary repairs made to kitchen sink drain- 3R

*Temporary repairs*

**Task:** Repair or replace

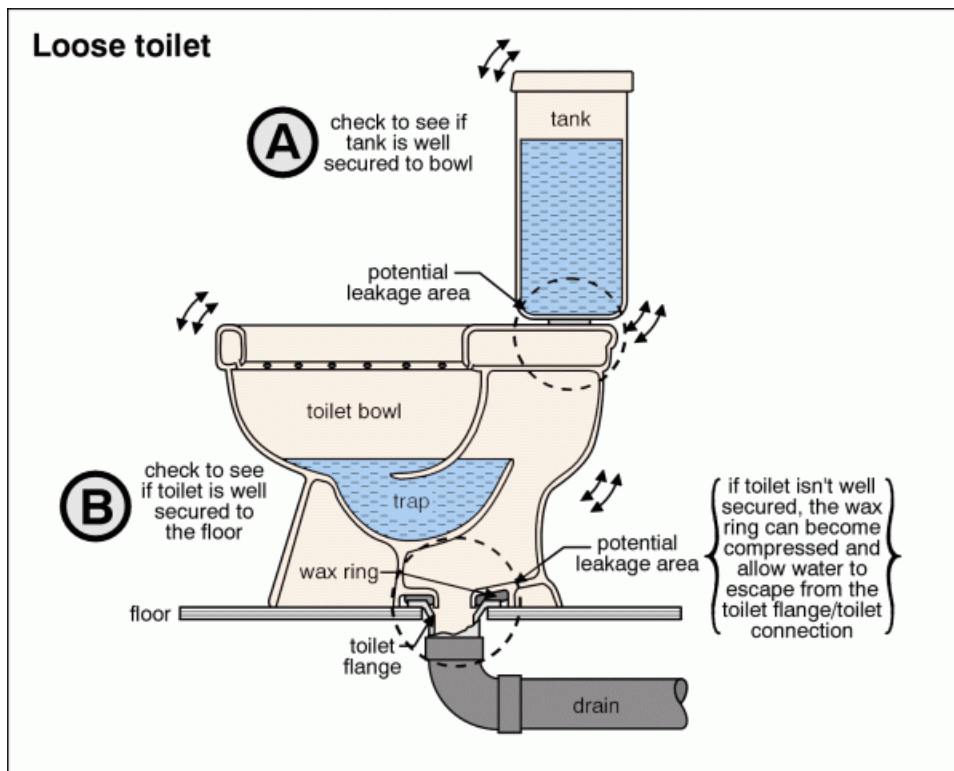
**54. Condition:** • [Loose](#)

Toilet loose- Apartment 2 bathroom

**Implication(s):** Chance of water damage to structure, finishes and contents | Sewage entering the building | Possible hidden damage

**Task:** Improve

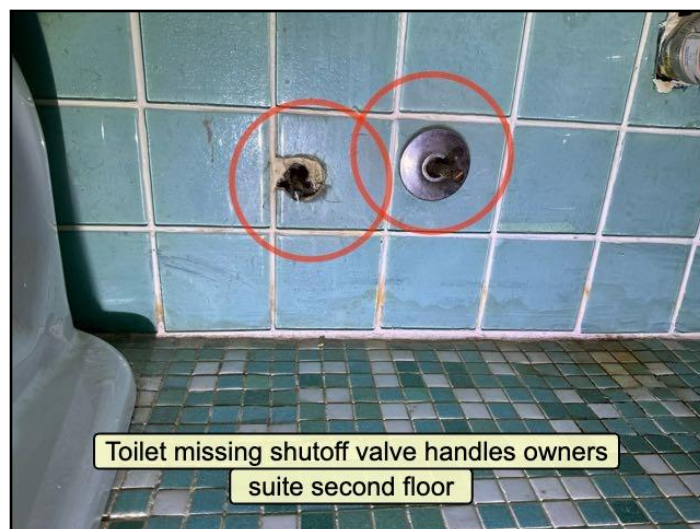
**55. Condition:** • Missing handle

Missing handle

**Task:** Provide

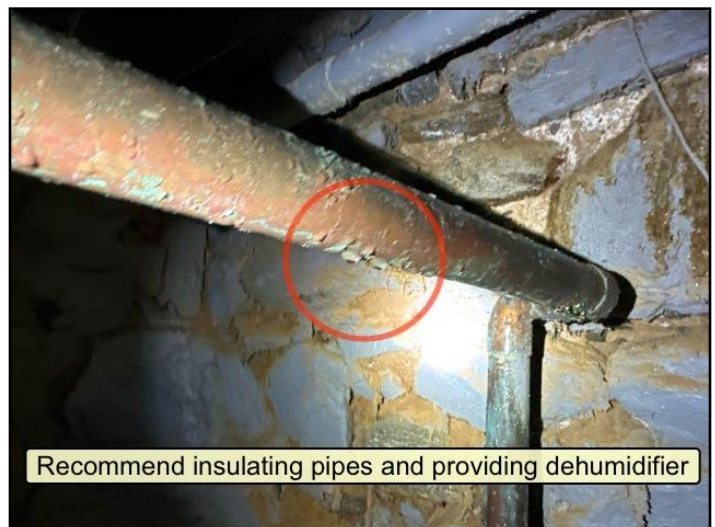
Condensation on water supply pipes in electrical room

Recommend insulating pipes and providing dehumidifier

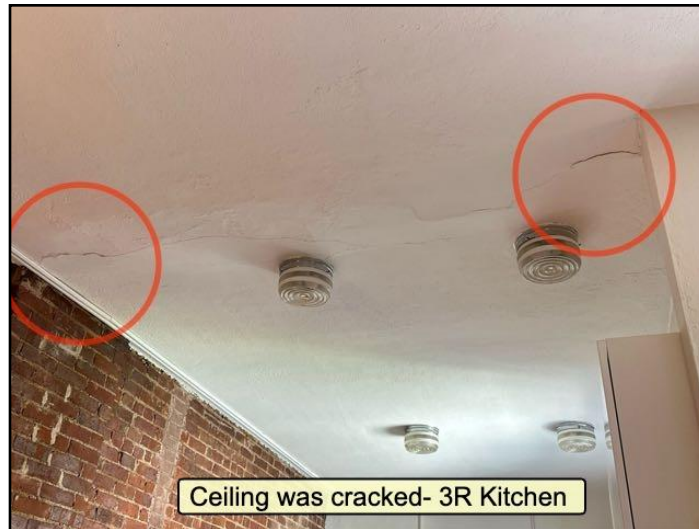
**57. Condition:** • Cracked

**Location:** 3R Kitchen

*Cracked*

**Task:** Repair

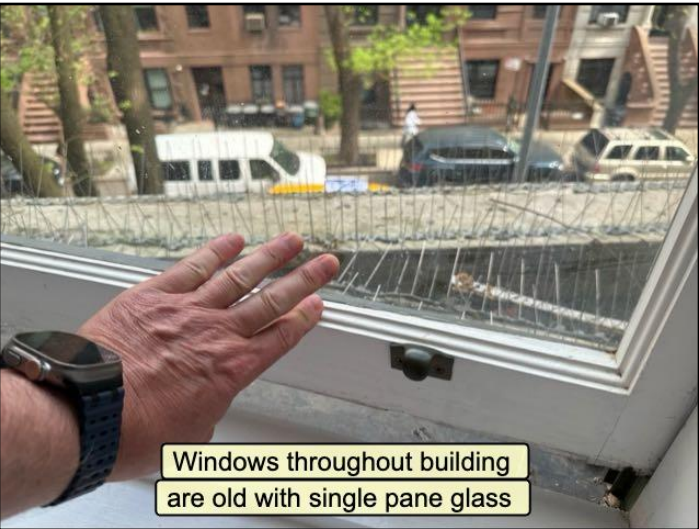
**60. Condition:** • Old single pane glass

Old single pane glass

**Task:** Upgrade/ replace

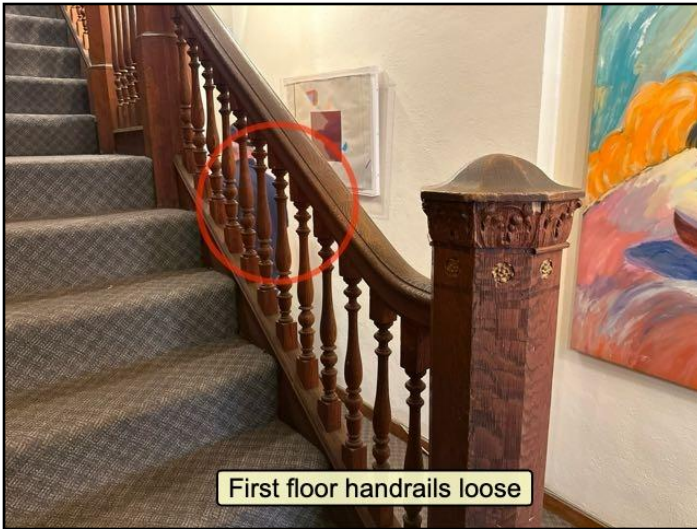
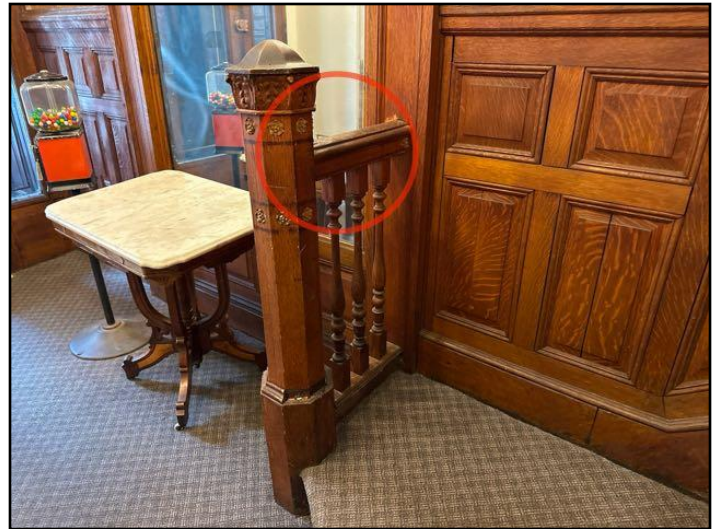
62. Condition: • [Loose](#)

Implication(s): Fall hazard

Loose

Task: Repair
