# INSPECTION REPORT

***New York City Brownstone Apartments  
145 Heritage Place  
New York, NY 10024***

**Prepared by:** East Coast Commercial Inspections  
**Prepared for:** Julian Perez  
**Inspection:** April 20, 2026  
**Date of Report:** April 22, 2026

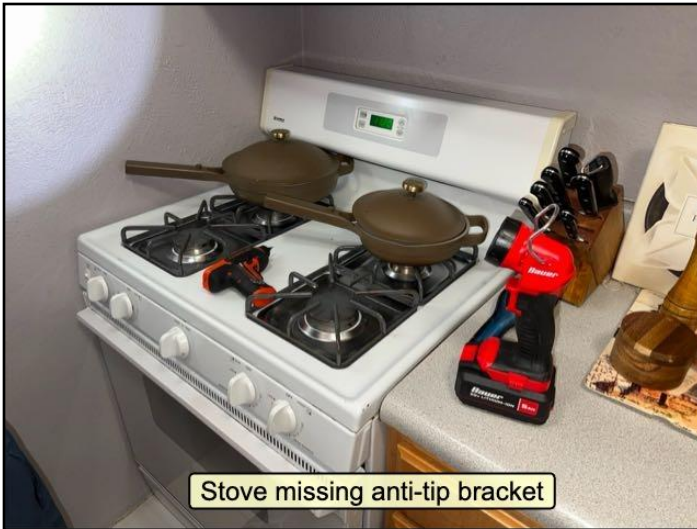
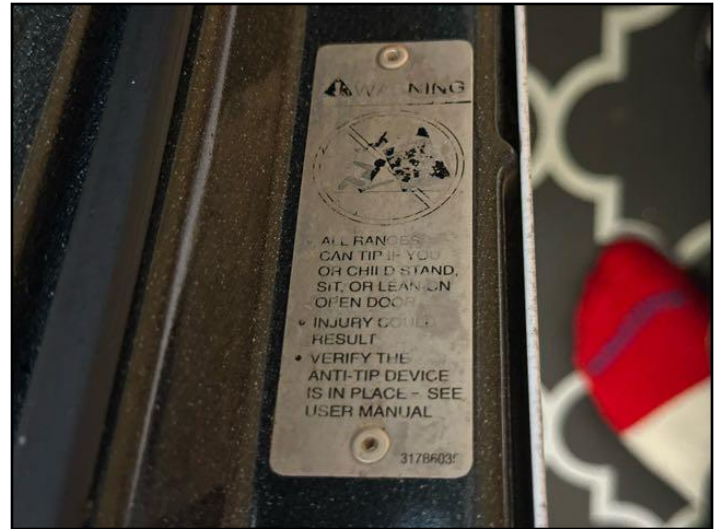
**64. Condition:** • Anti-tip device missing

Anti-tip device missing

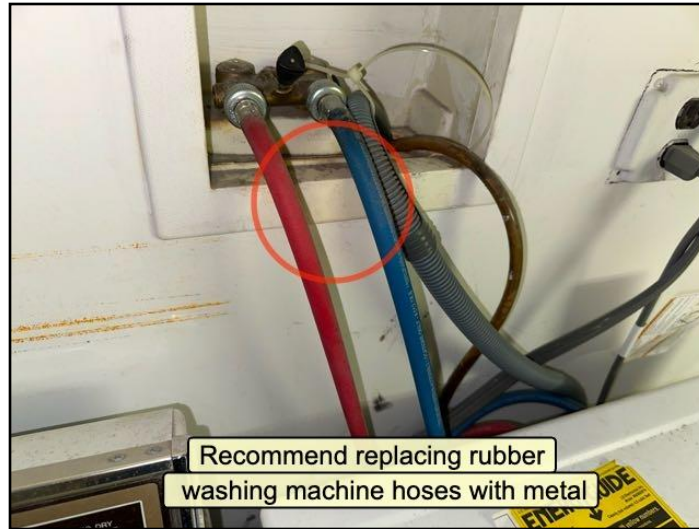
**66. Condition:** • Replace with braided hoses

The washing machine has standard rubber supply hoses, which are more prone to deterioration and sudden failure. Upgrading to braided stainless steel hoses is advised to reduce the risk of leaks or water damage.

*Replace with braided hoses*

**Task:** Replace

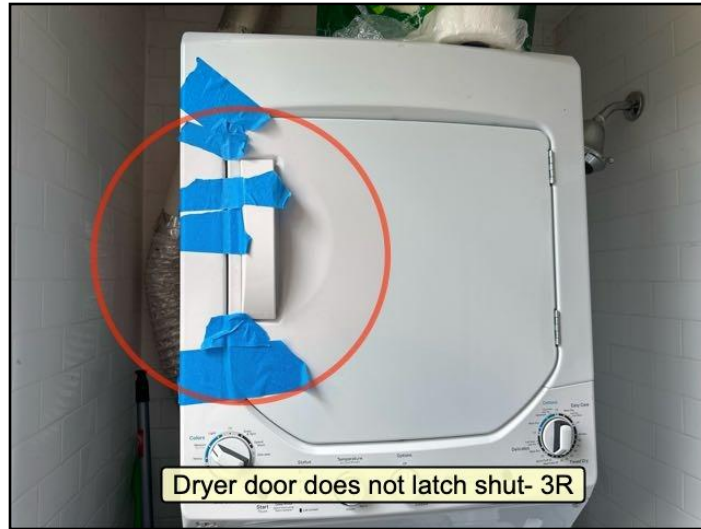
**68. Condition:** • Damage

Damage
