# INSPECTION REPORT

For the Property at:  
**FARMINGDALE, NY 11735**

Inspection Date: Wednesday, December 28, 2022

Prepared by:  
**East Coast Commercial Property Inspections, LLC**

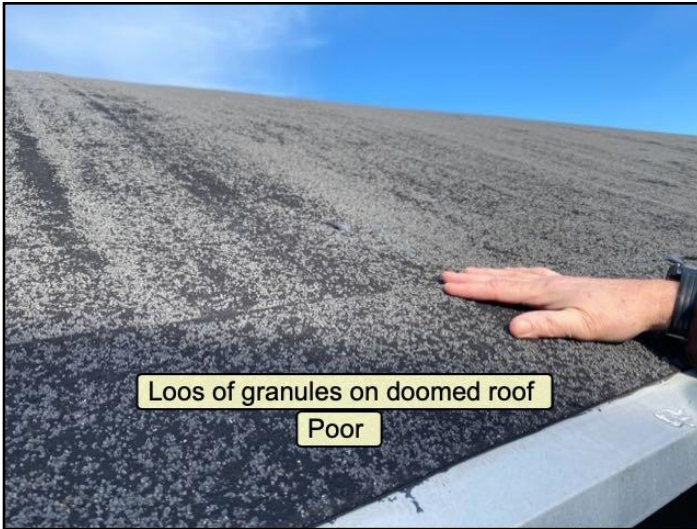
\*\*\*\*LEAKS ARE NOT ALWAYS DETECTABLE\*\*\*\*

**Implication(s):** Chance of water damage to structure, finishes and contents

Loss of granules - Poor

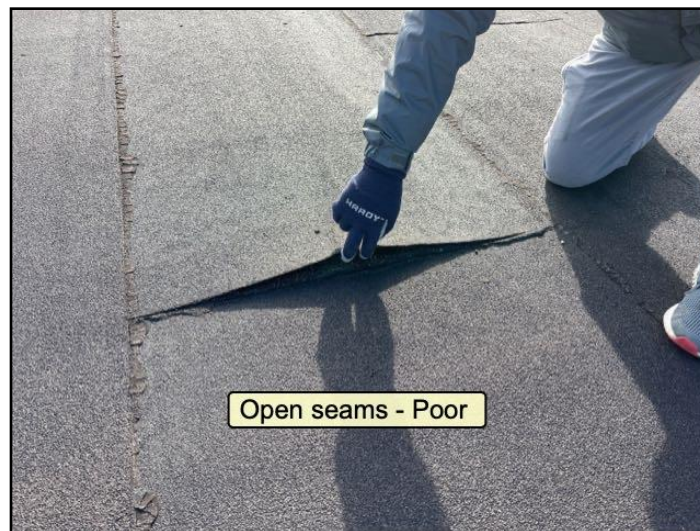
**Implication(s):** Chance of water damage to structure, finishes and contents

Openings at seams or flashings

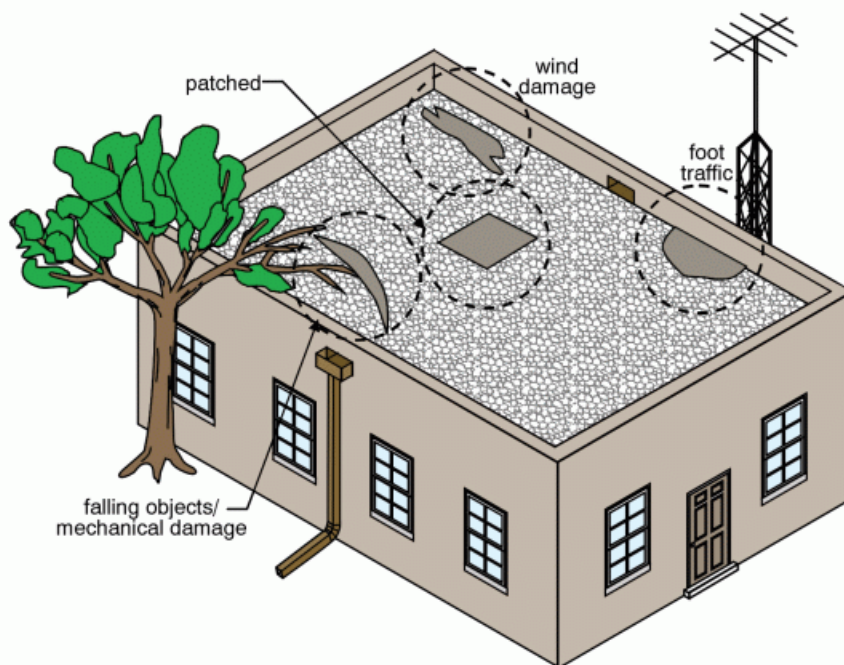
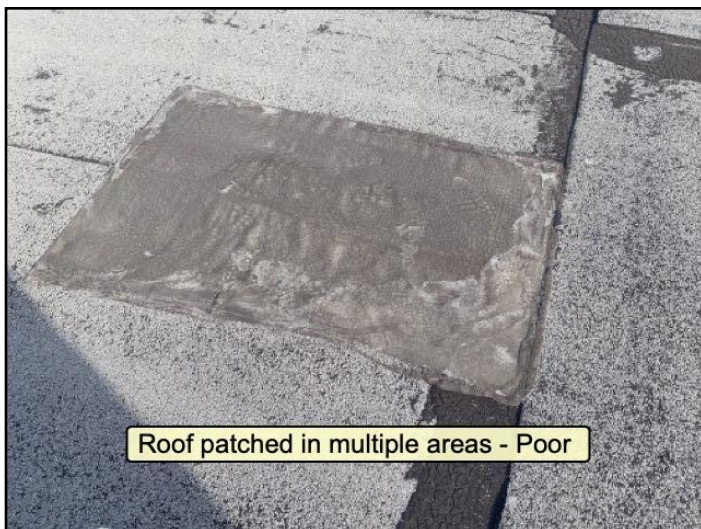
Roof patched in multiple areas - Poor

Patched

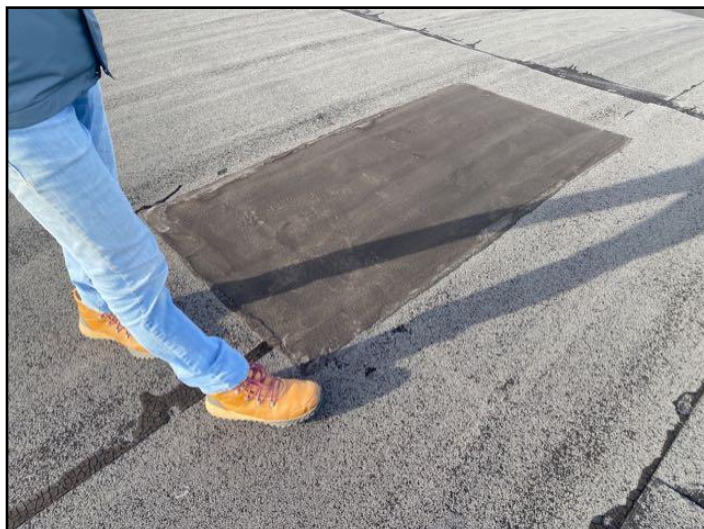
Patched

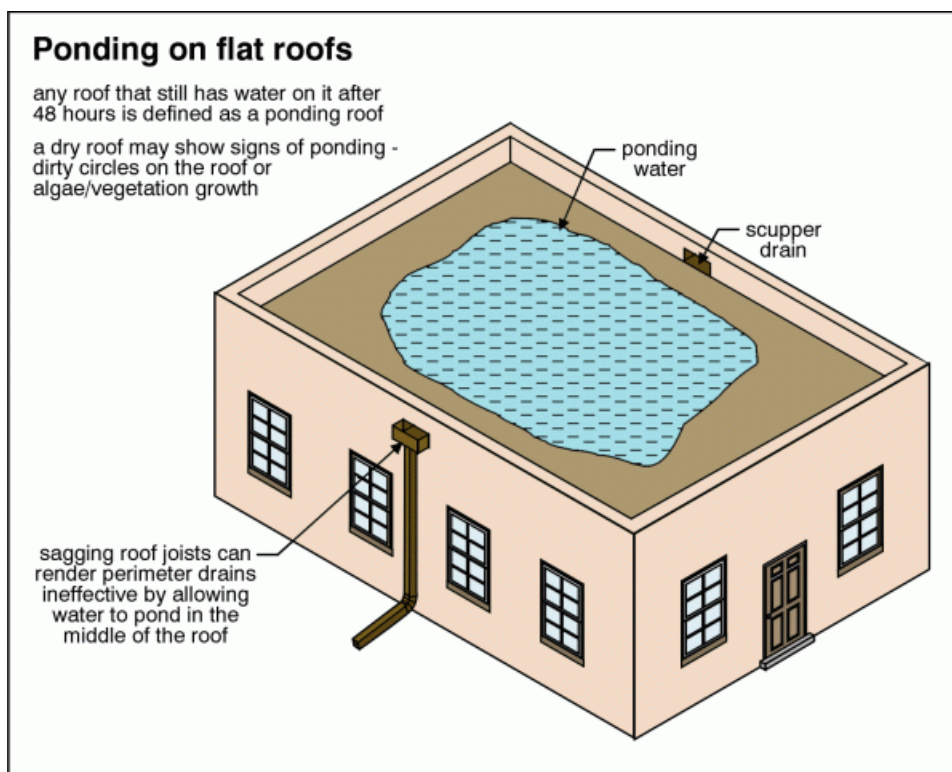
## 4. Condition: • [Ponding](#)

**Implication(s):** Chance of water damage to structure, finishes and contents

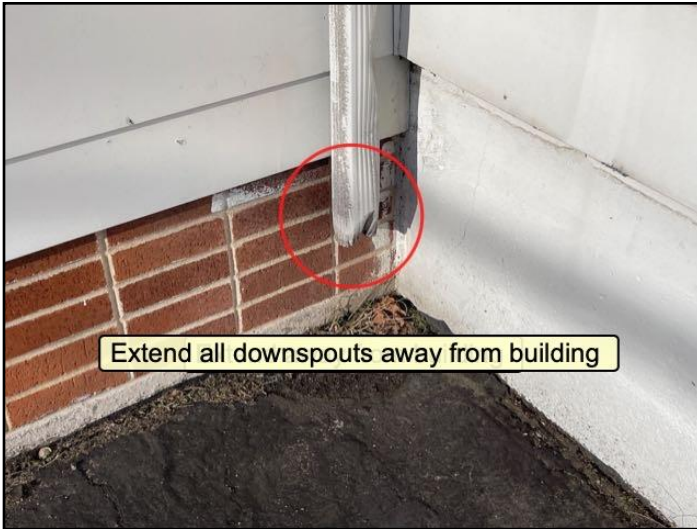
5. Condition: • [Should discharge 6 feet from building](#)

Should discharge 6 feet from building

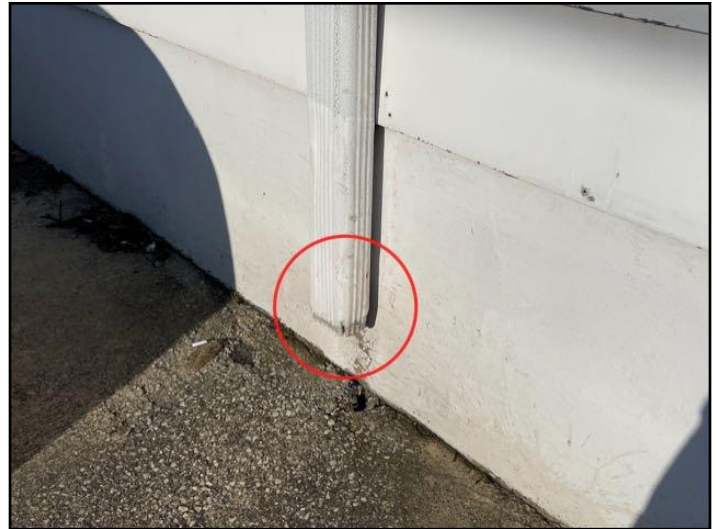
Should discharge 6 feet from building

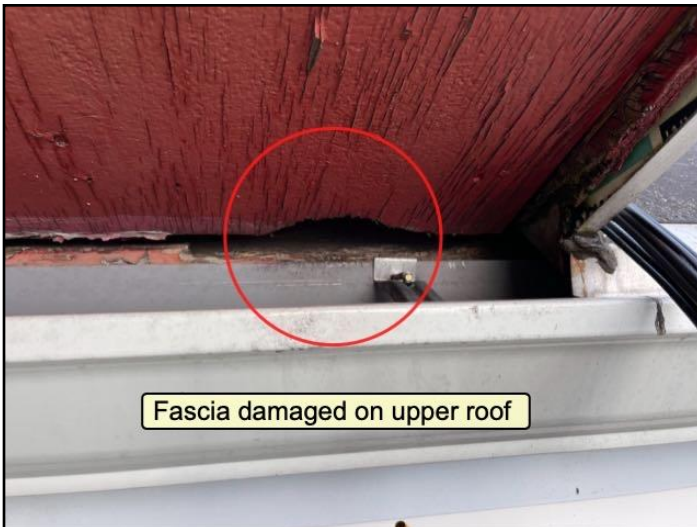
6. Condition: • [Damage](#)

Damage

Repair to prevent further damage

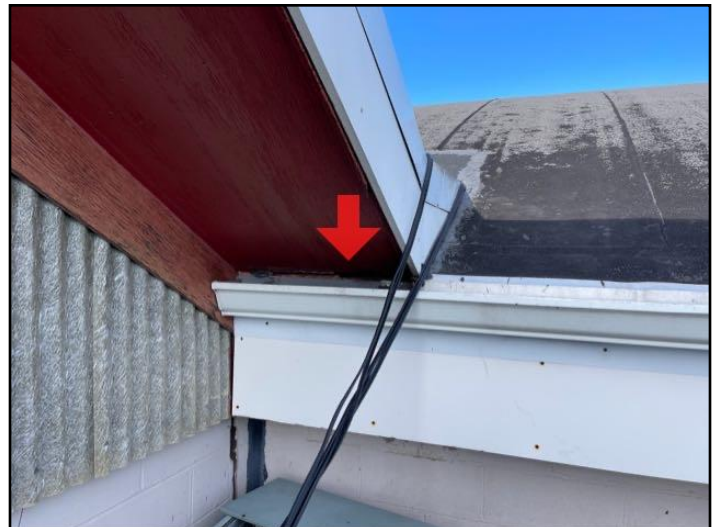
Damage

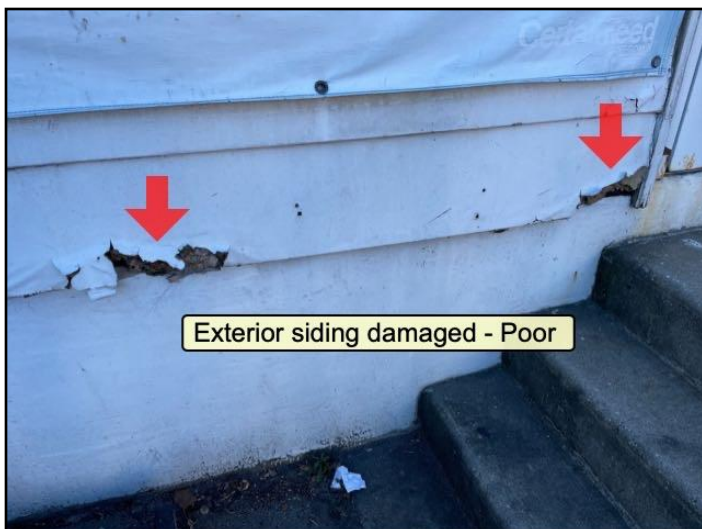
7. Condition: • [Rot](#)

Rot

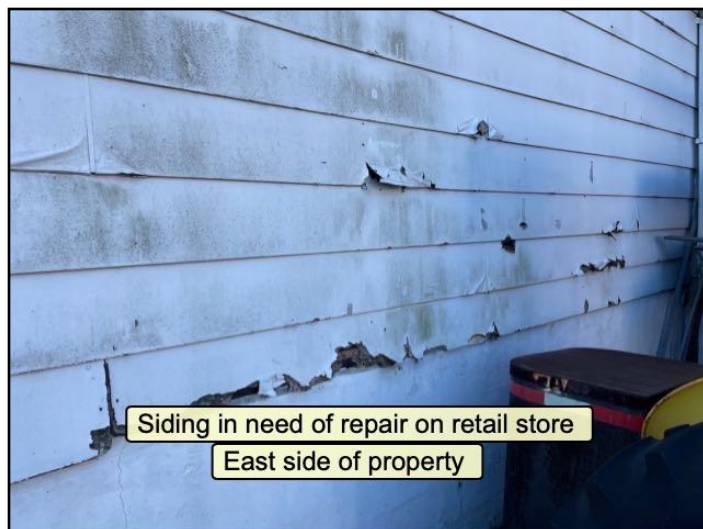
Rot

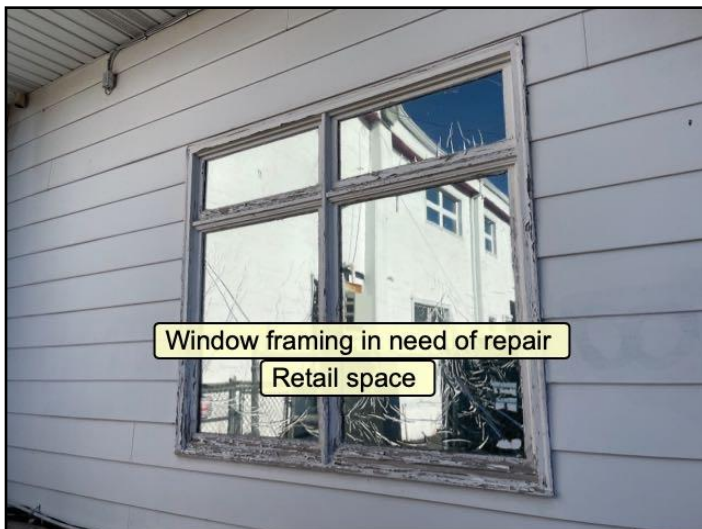
8. Condition: • [Paint or stain needed](#)

Paint or stain needed

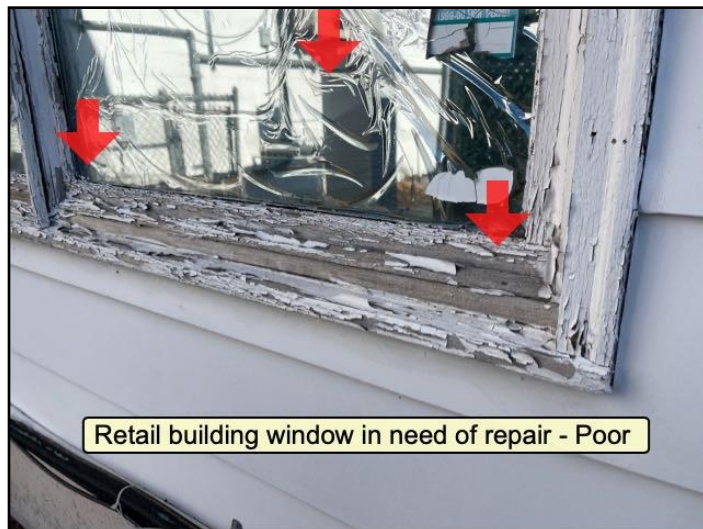
Paint or stain needed

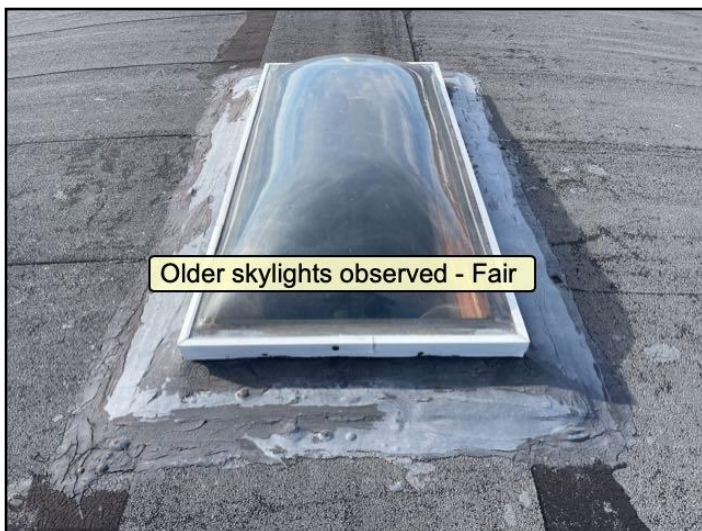
9. Condition: • Old

Old

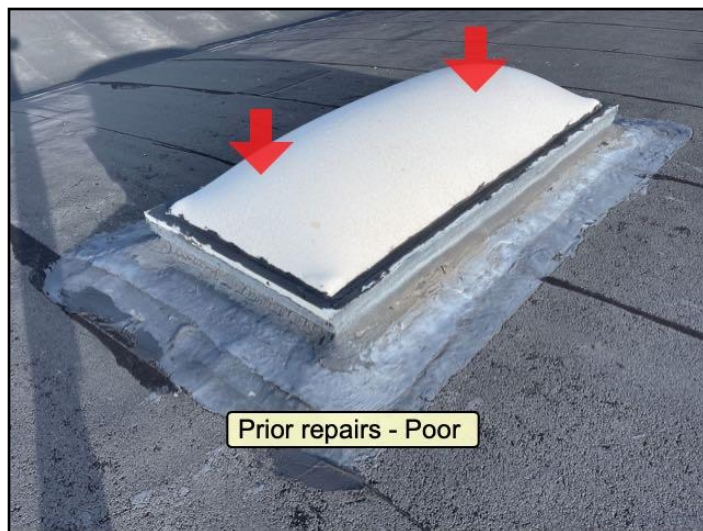
Old

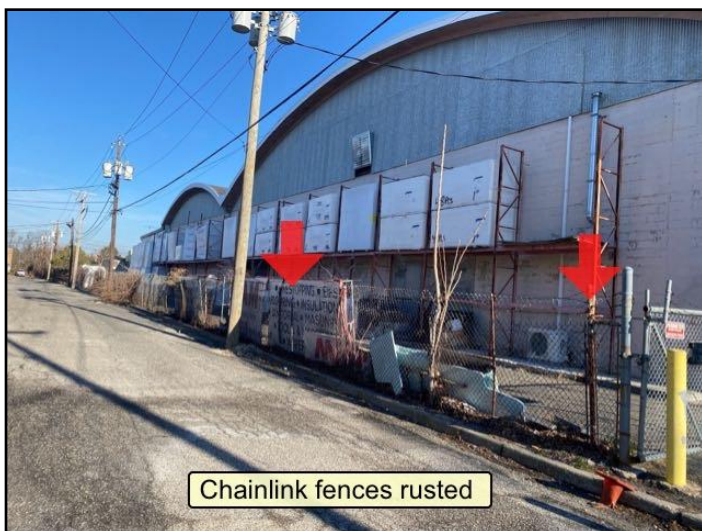
Chainlink fences rusted

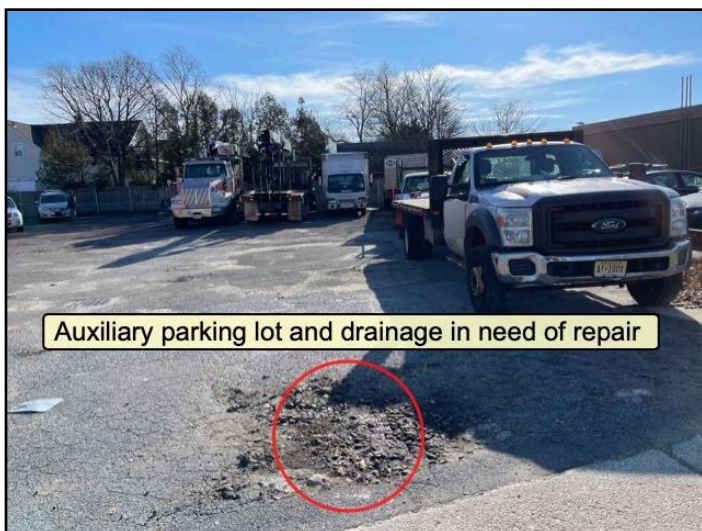
Auxiliary parking lot and drainage in need of repair - Poor Condition

Auxiliary parking lot and drainage in need of repair

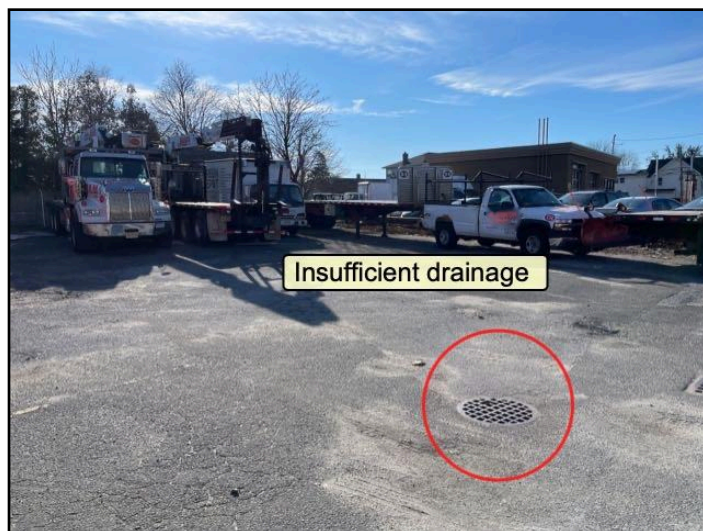
Insufficient drainage

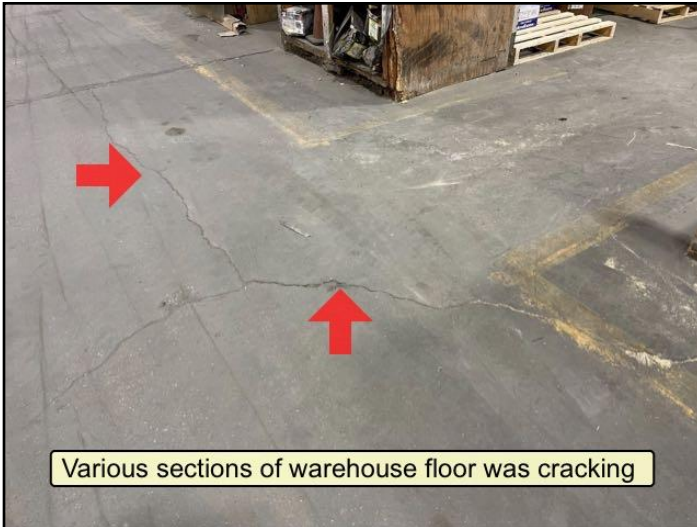
10. Condition: • [Cracked](#)

Cracked

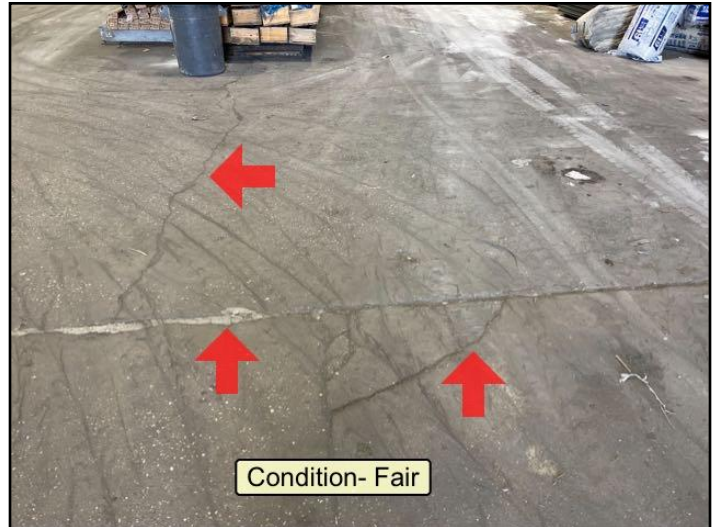
Cracked

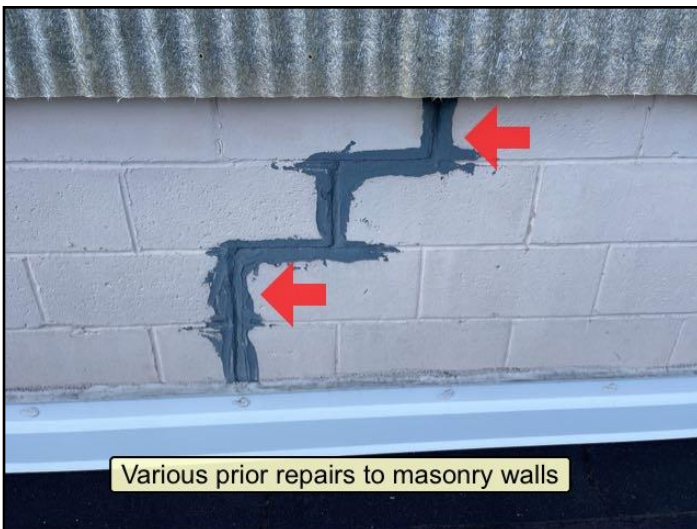
11. Condition: • [Prior repairs](#)

Prior repairs

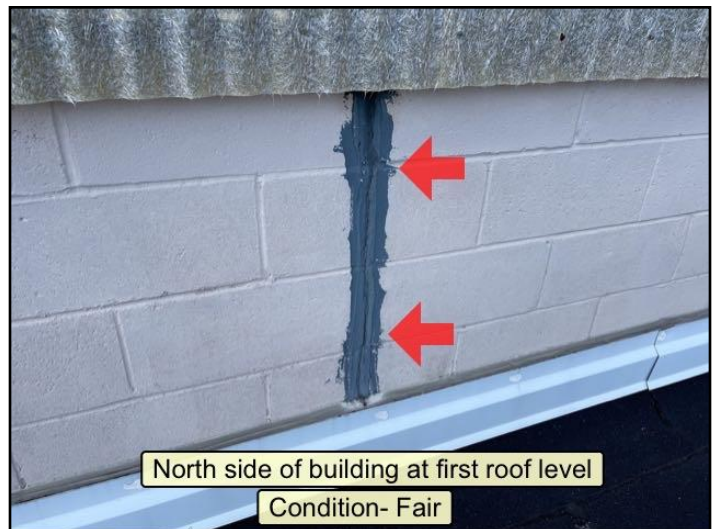
Prior repairs

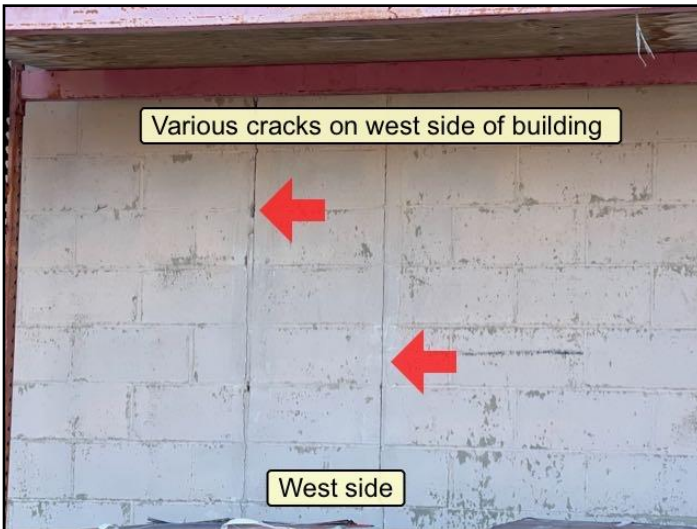
12. Condition: • [Cracked](#)

Cracked

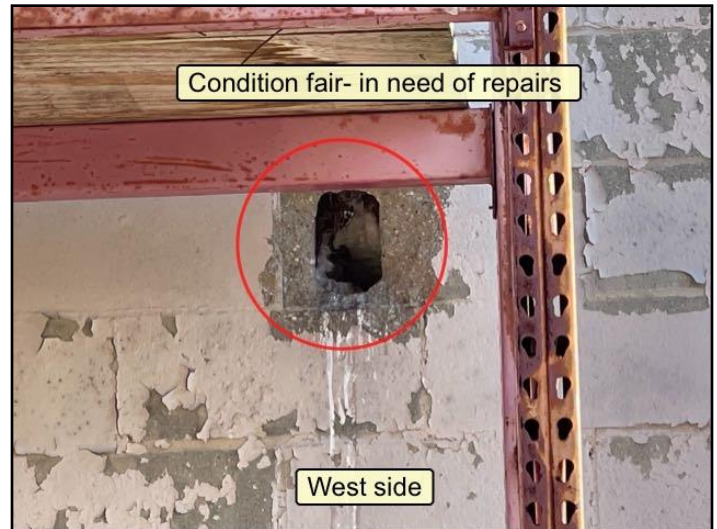
Cracked

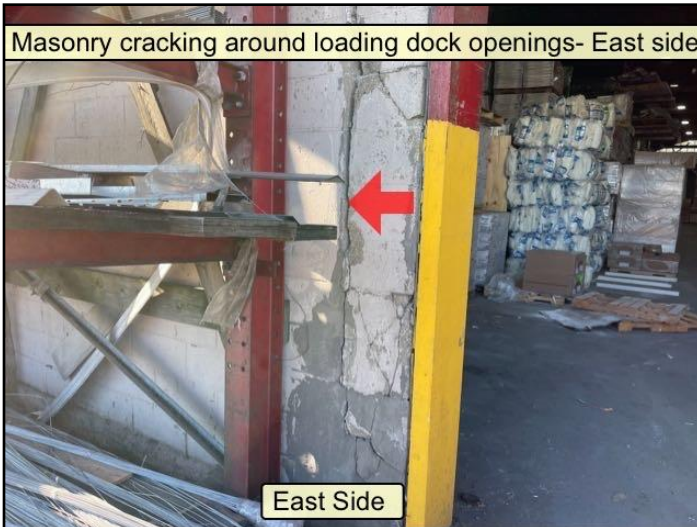
Cracked

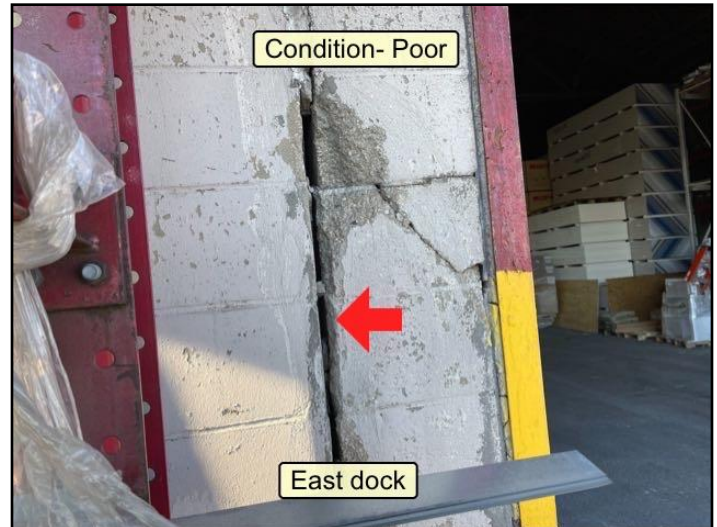
Cracked

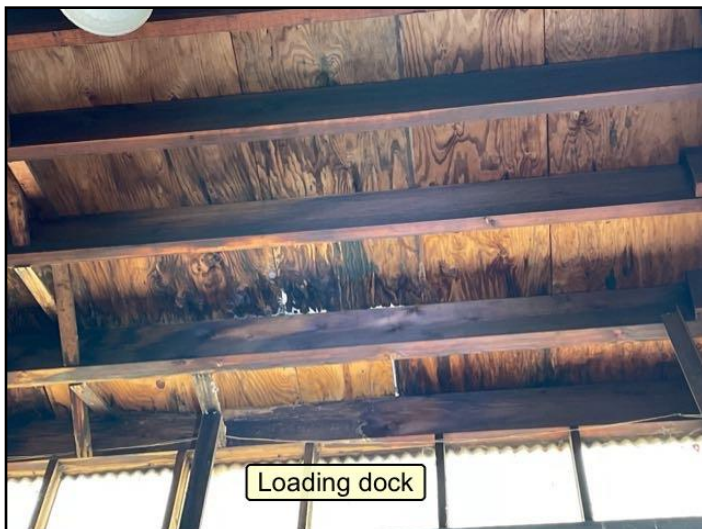
**13. Condition:** • Water damage

Water damage

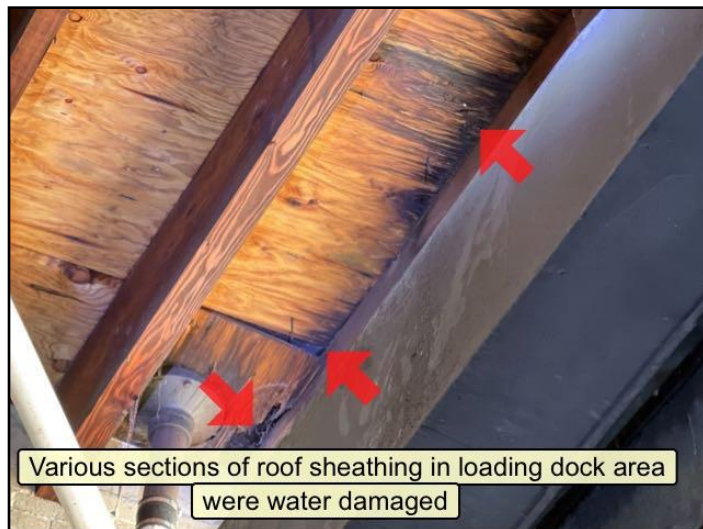
Water damage

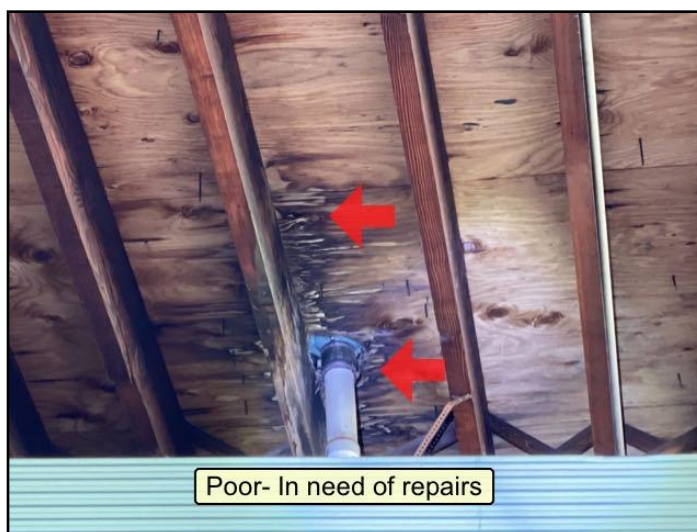
Water damage

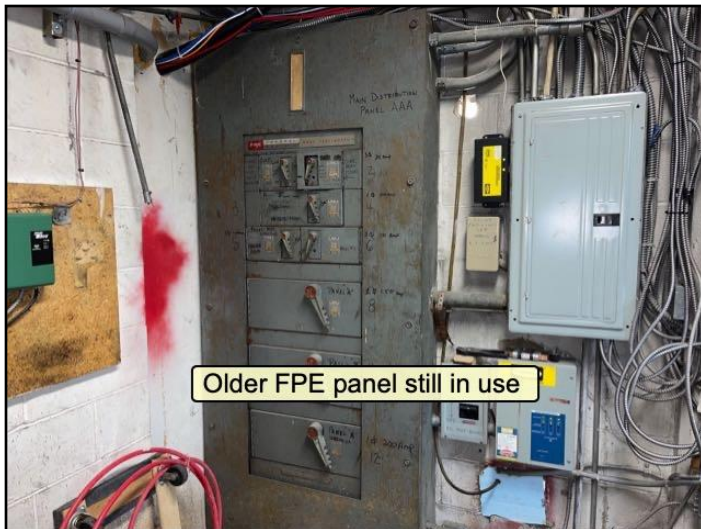
Older Federal Pacific Panel still in use. Consult with licensed electrician for possible upgrading.

Older FPE panel still in use

Have licensed electrician further evaluate FPE panel

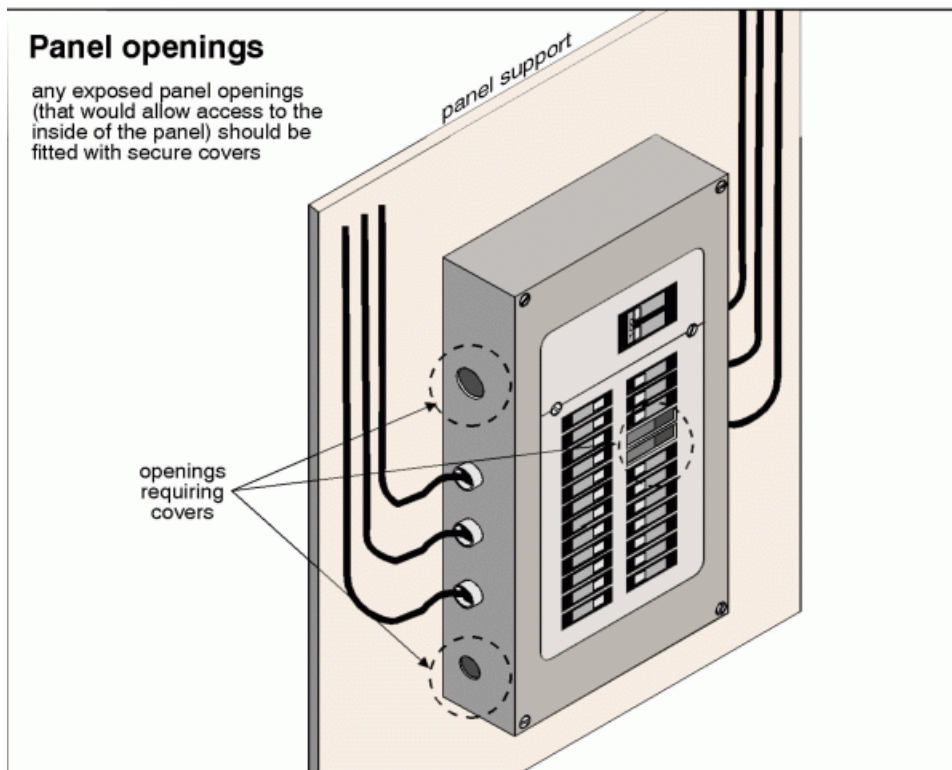
**15. Condition:** • Federal Pacific panel**16. Condition:** • [Openings in panel](#)

Implication(s): Electric shock | Fire hazard

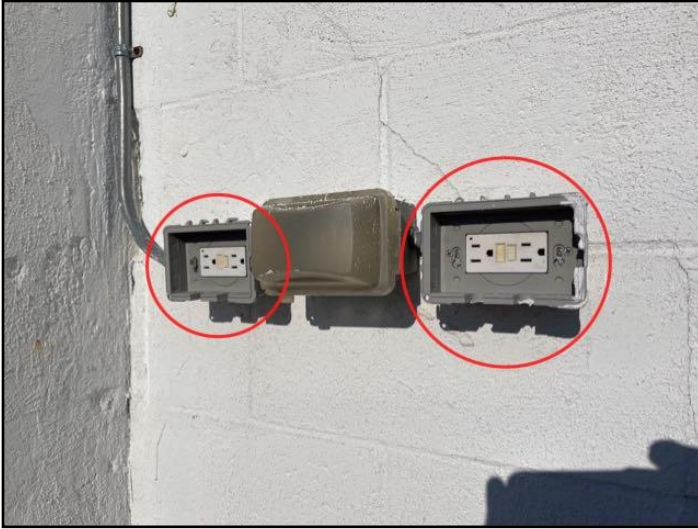
**DISTRIBUTION \ Outlets****17. Condition:** • Missing cover

Outlet inoperative

Missing cover

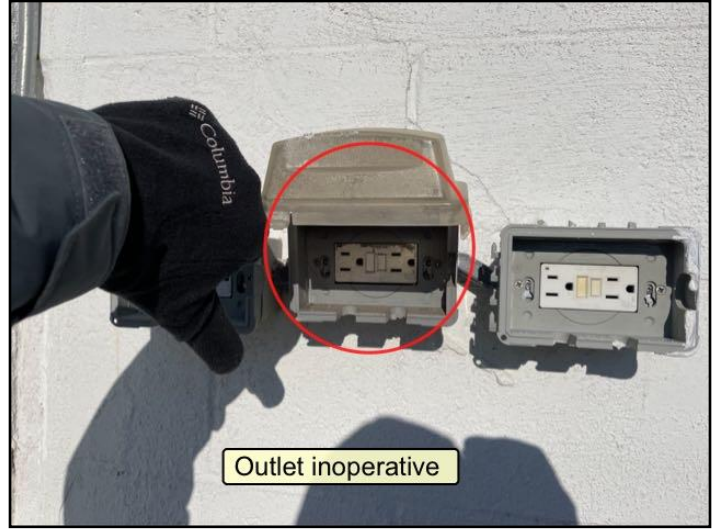
Missing cover

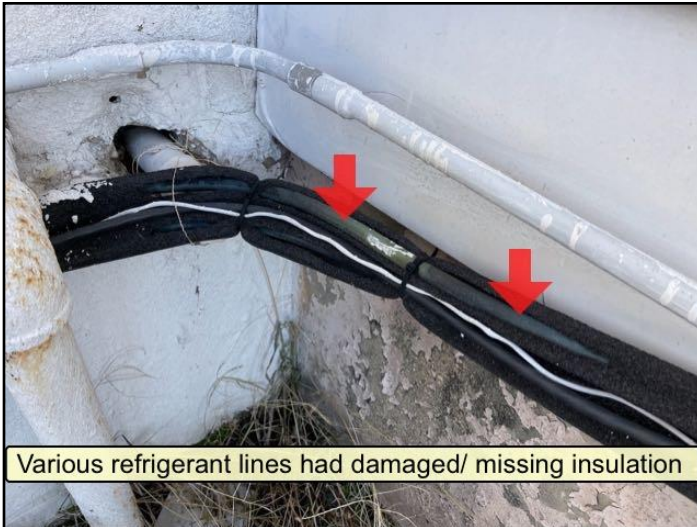
Multiple refrigerant lines had damaged or missing insulation- Fair/ Poor condition

Insulation - missing/ damaged

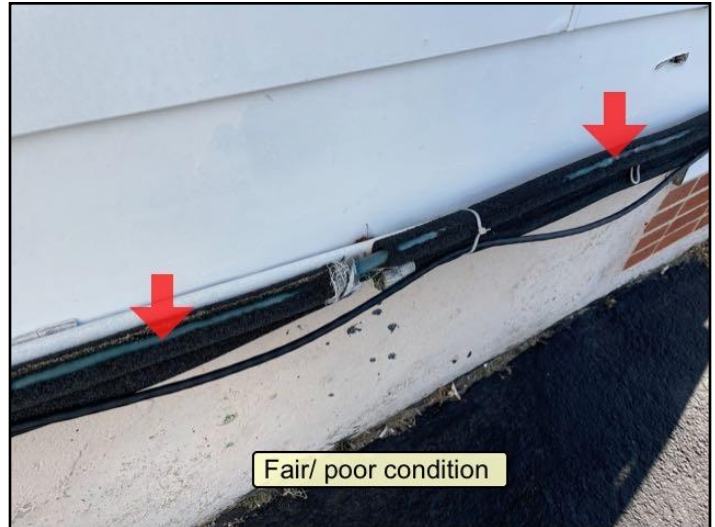
Insulation - missing/ damaged

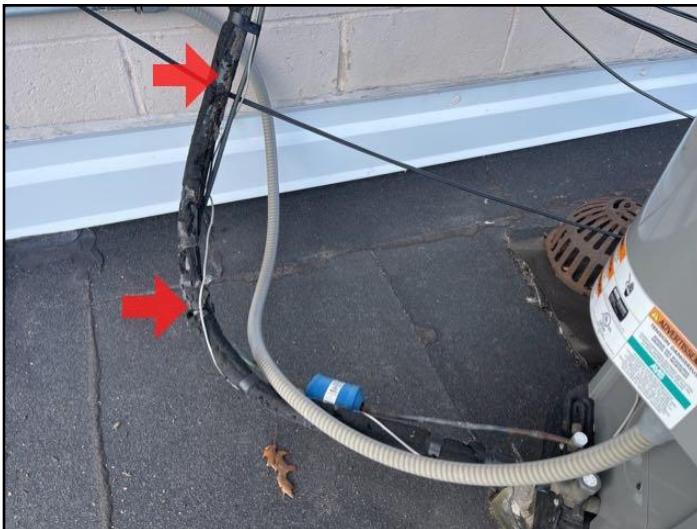
Insulation - missing

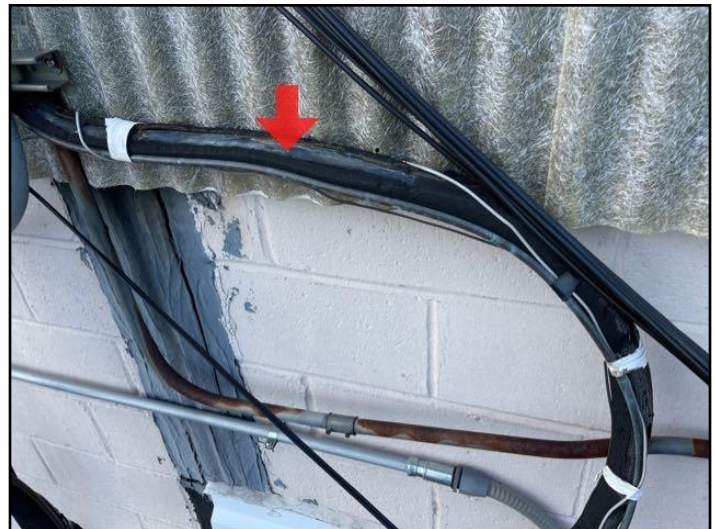
Insulation - missing

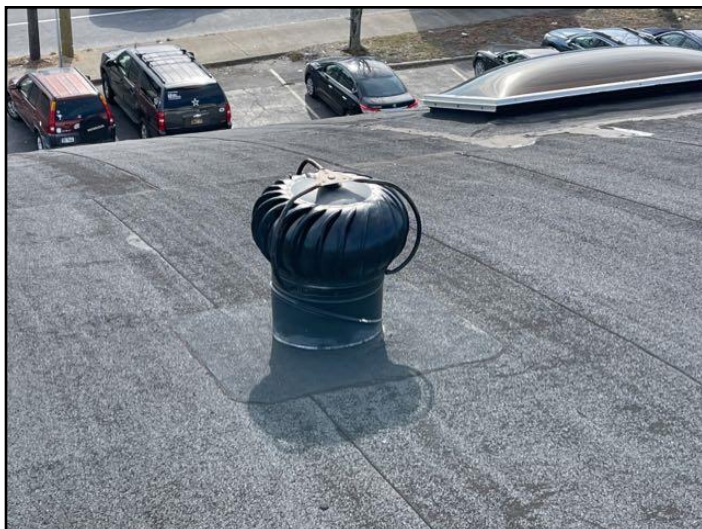
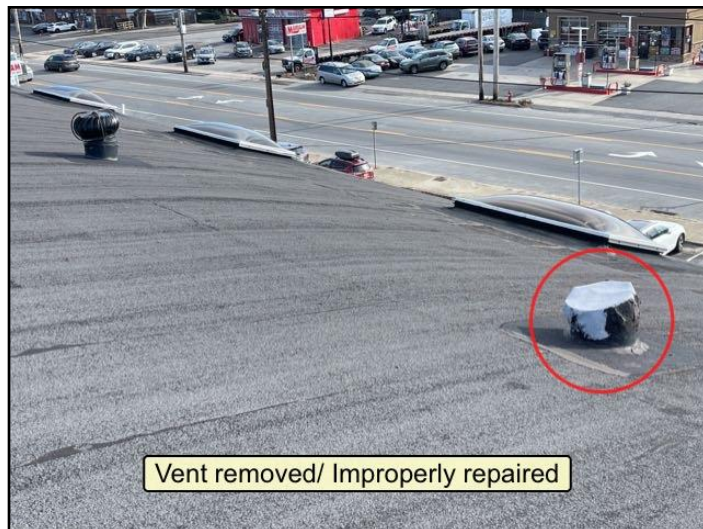
Vent removed/ Improperly repaired

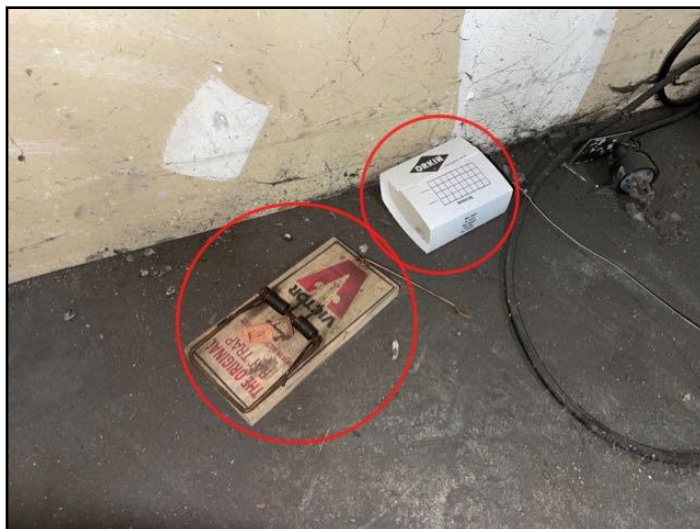
19. Condition: • Evidence of rodent activity

Evidence of rodent activity

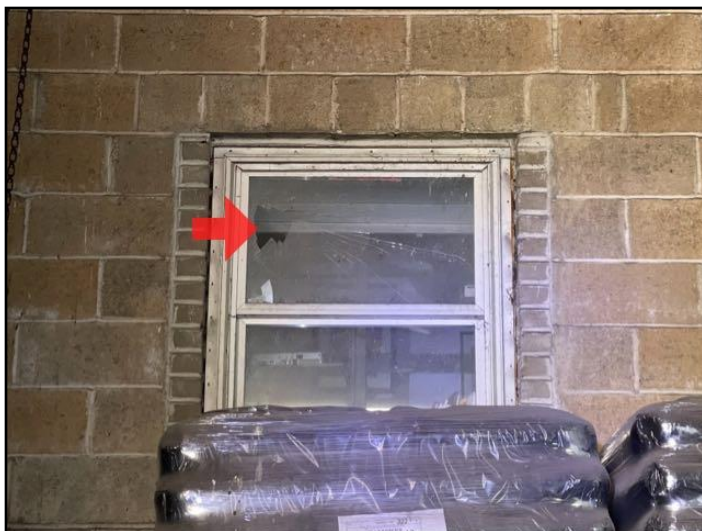
20. Condition: • [Broken](#)

Broken

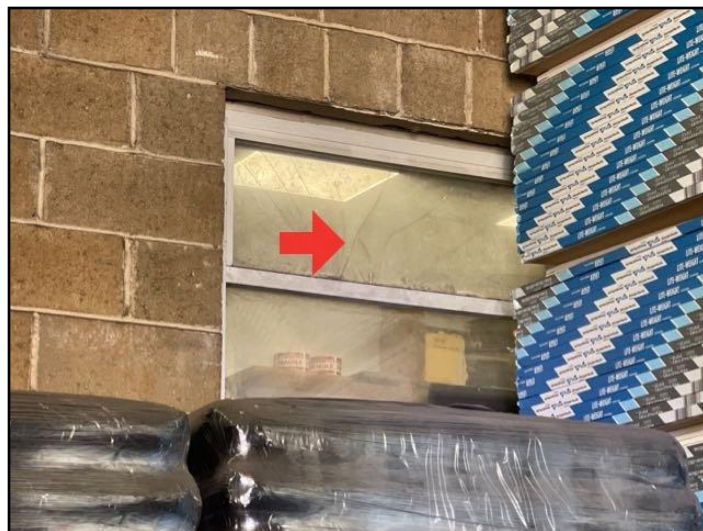
Broken
