# INSPECTION REPORT

For the Property at:  
**ISLANDIA, NY 11749**

Inspection Date: Tuesday, July 30, 2024

Report No. 1046

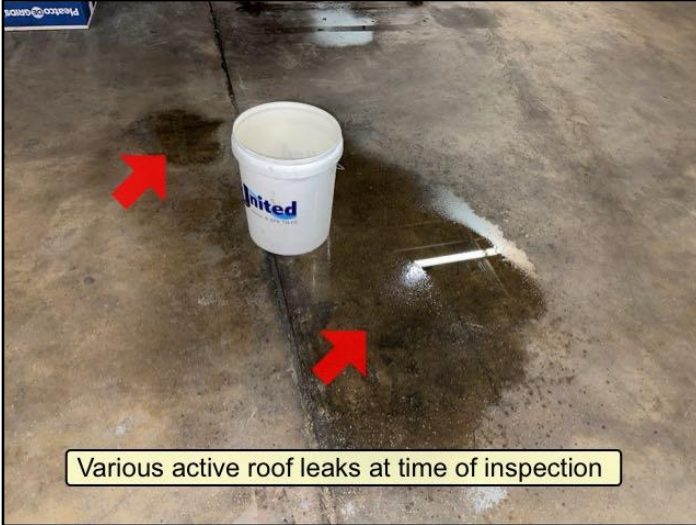
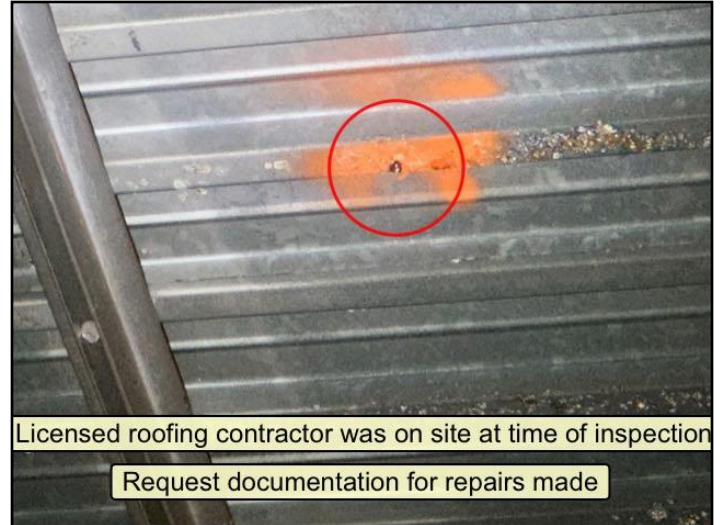
1. Condition: • Leak

Location: Various

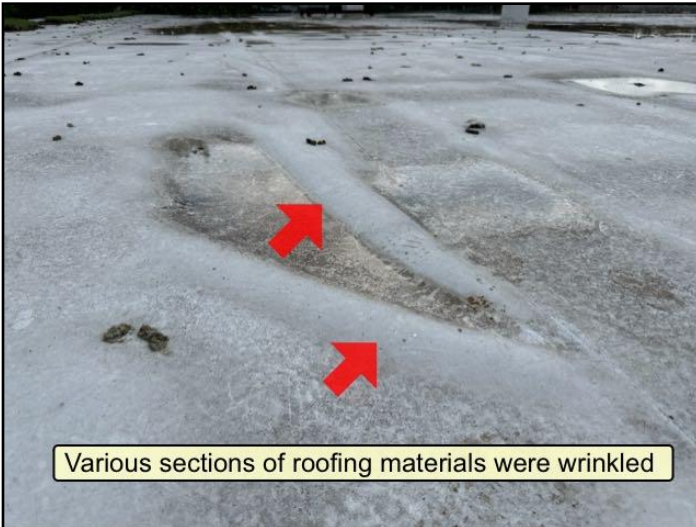
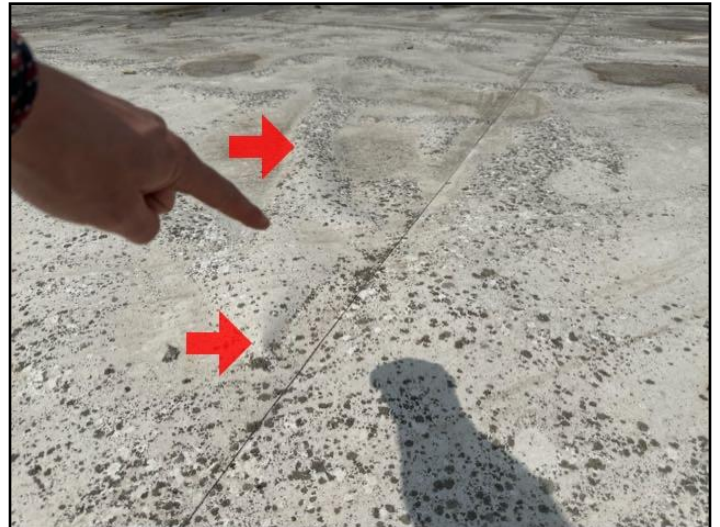
2. Condition: • [Wrinkles, ridges, fishmouths](#)

Implication(s): Chance of water damage to structure, finishes and contents

Wrinkles, ridges, fishmouths

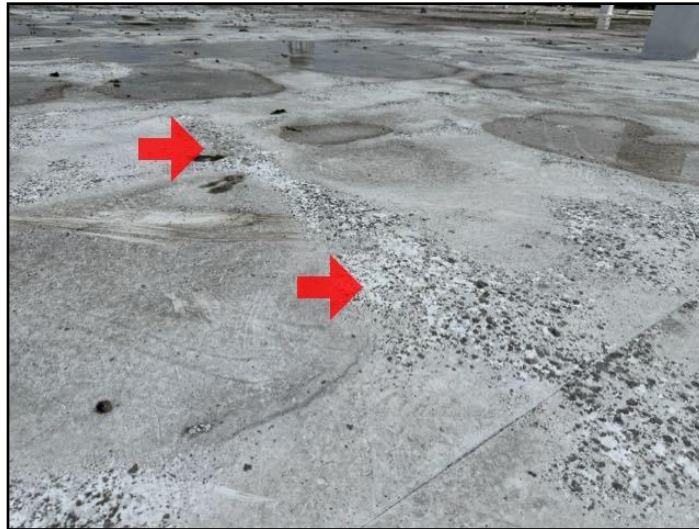
*Wrinkles, ridges, fishmouths*

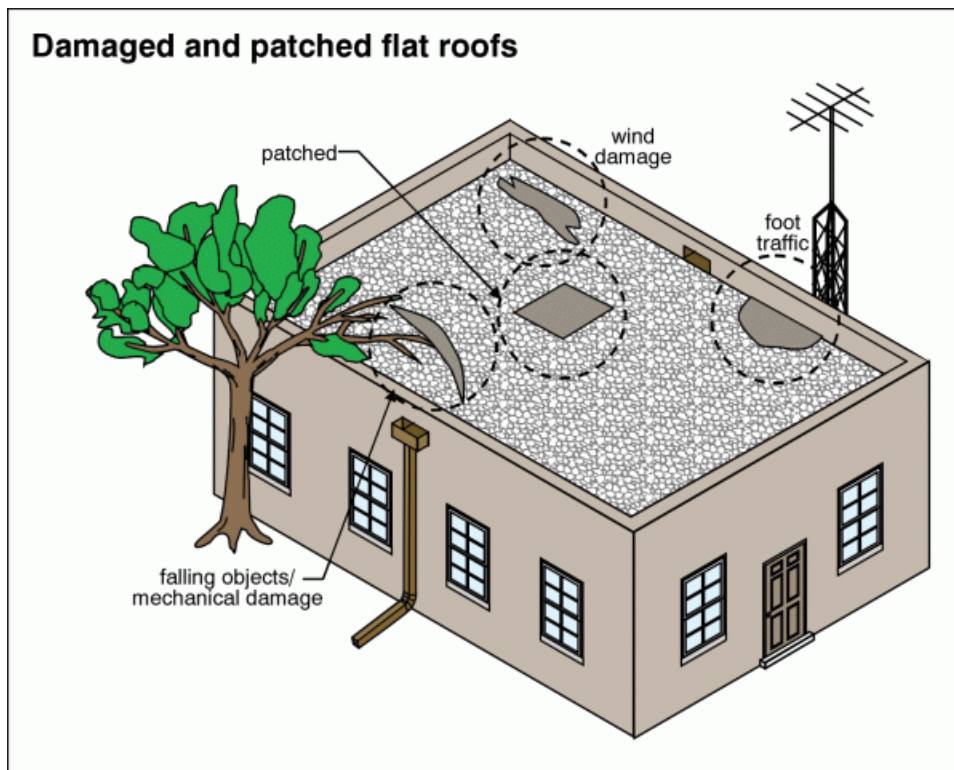
### 3. Condition: • [Tree branches touching roof](#)

Implication(s): Shortened life expectancy of material

Location: Left Side

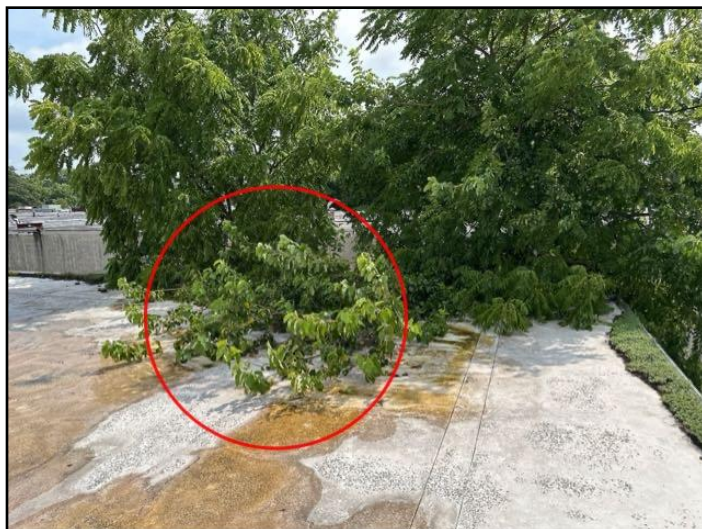
Tree branches touching roof

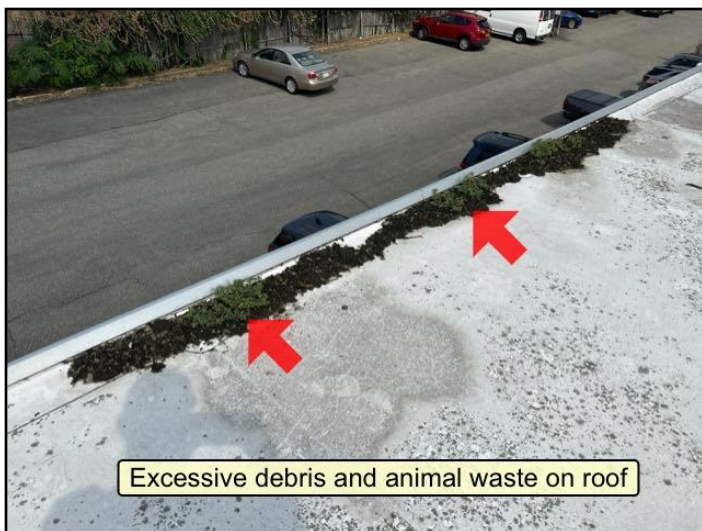
## 4. Condition: • [Debris/oil on roof](#)

Implication(s): Chance of water damage to structure, finishes and contents

Debris/oil on roof

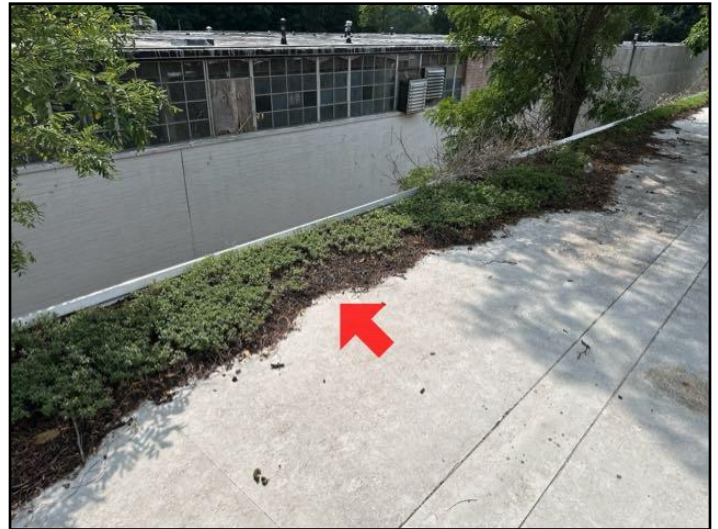
Debris/oil on roof

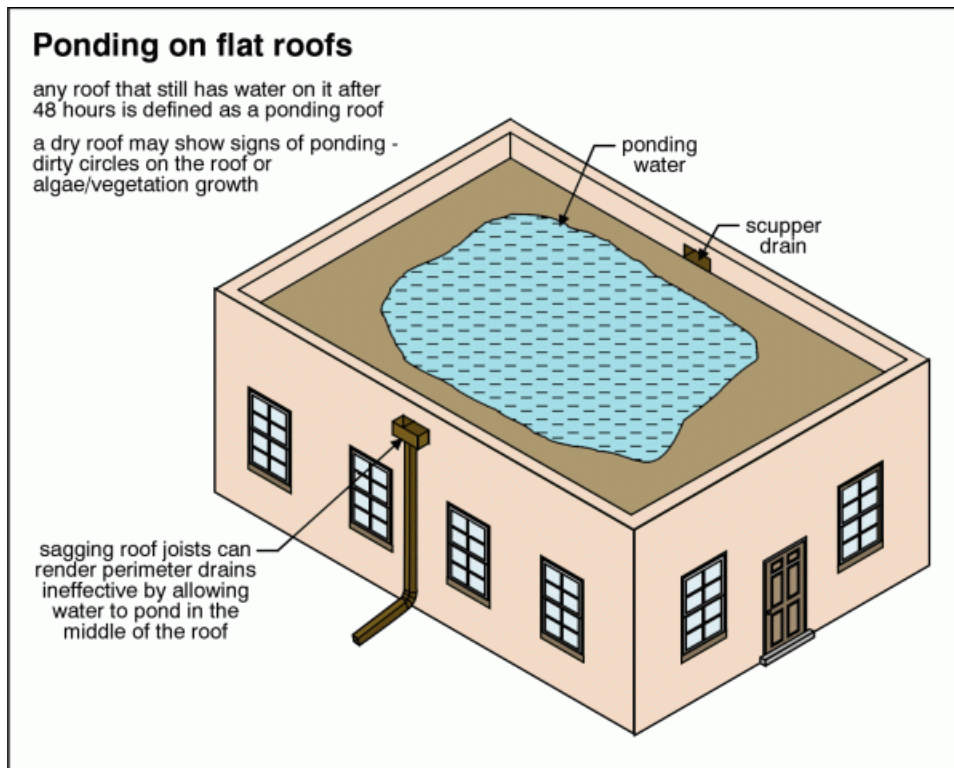
## 5. Condition: • [Ponding](#)

**Implication(s):** Chance of water damage to structure, finishes and contents

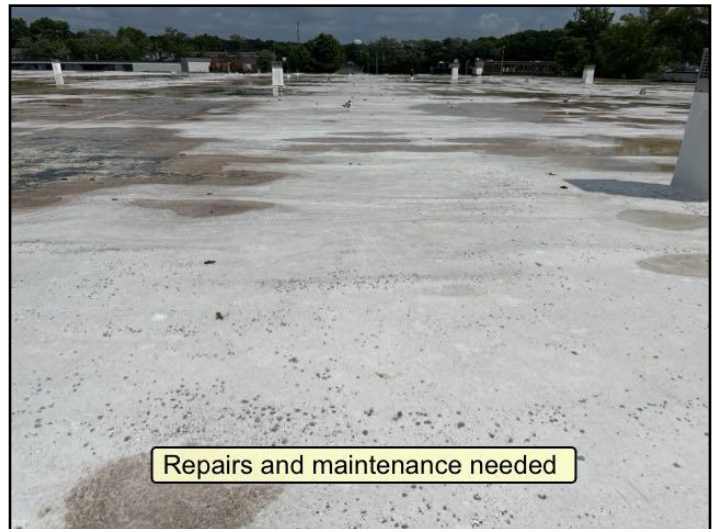
Metal flashing needs improvement

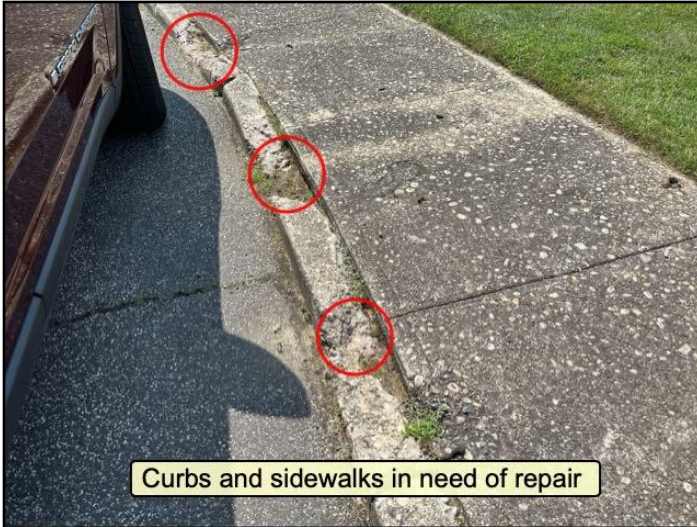
**6. Condition:** • Parking lot cracked/ damaged surfaces

*Parking lot cracked/ damaged surfaces*

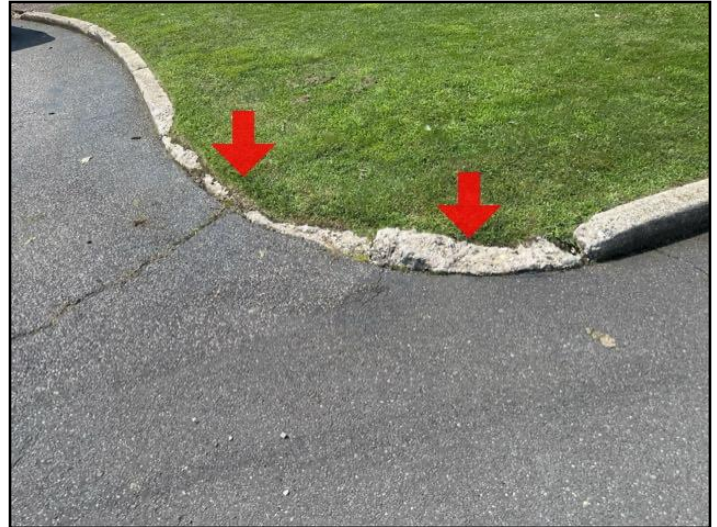
*Parking lot cracked/ damaged surfaces*

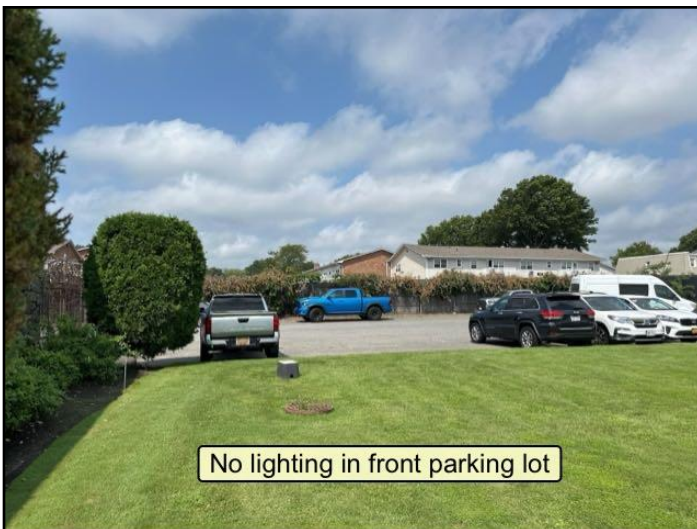
**7. Condition:** • Missing parking lot lights

*Missing parking lot lights*

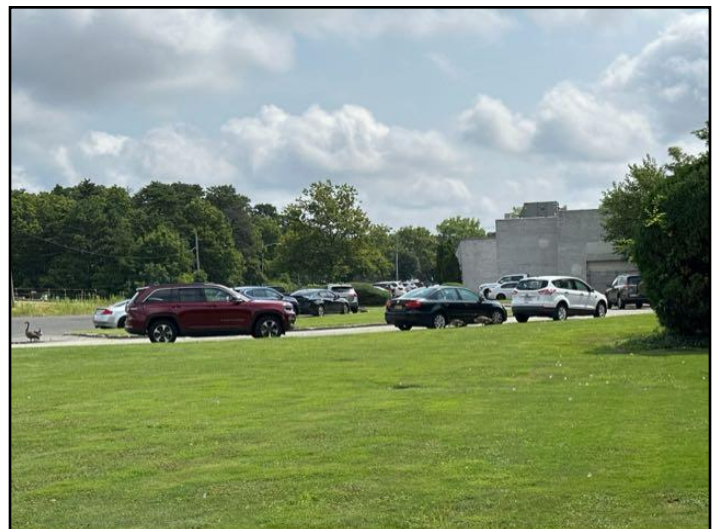
*Missing parking lot lights*

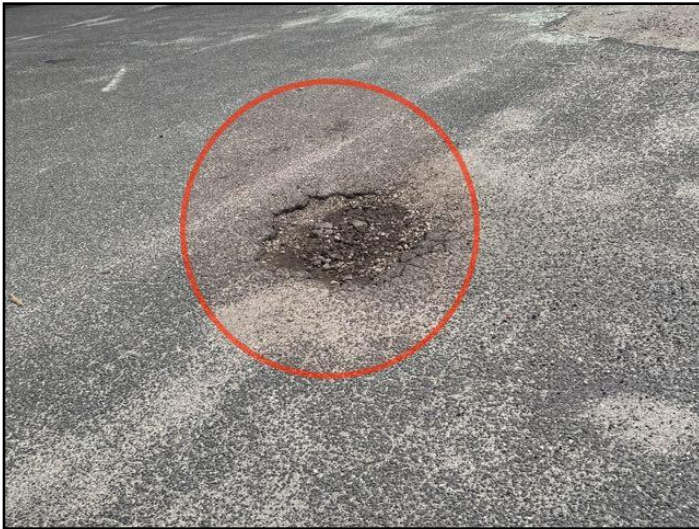
**8. Condition:** • Parking lot surface cracks/ damage

Parking lot surface cracks/ damage

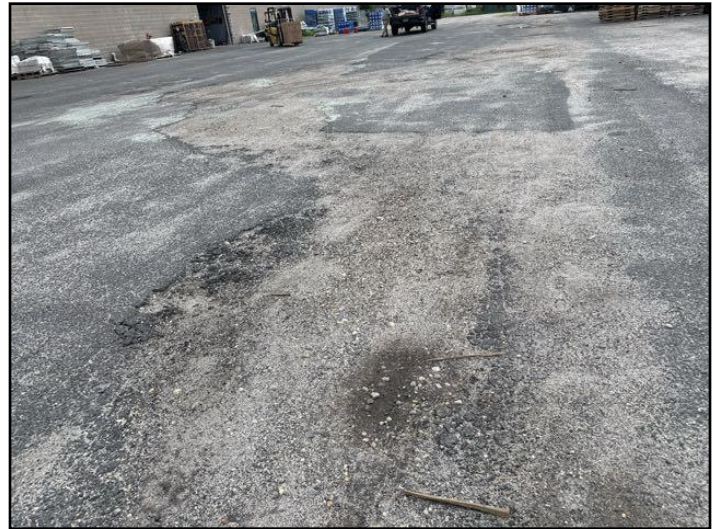
Parking lot surface cracks/ damage

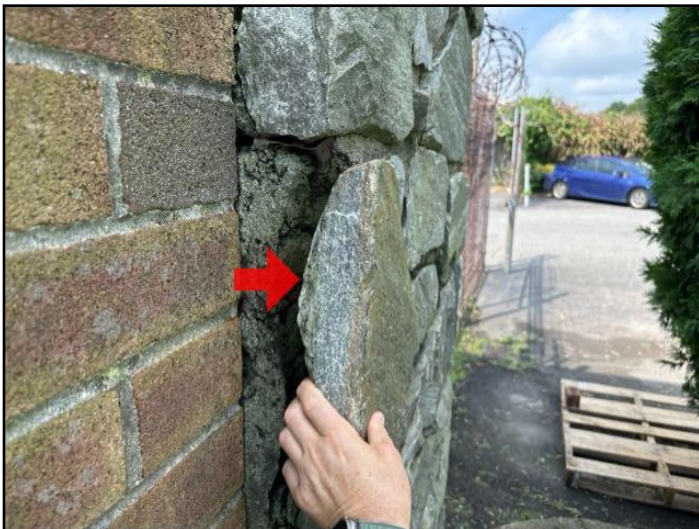
9. Condition: • Loose

Loose

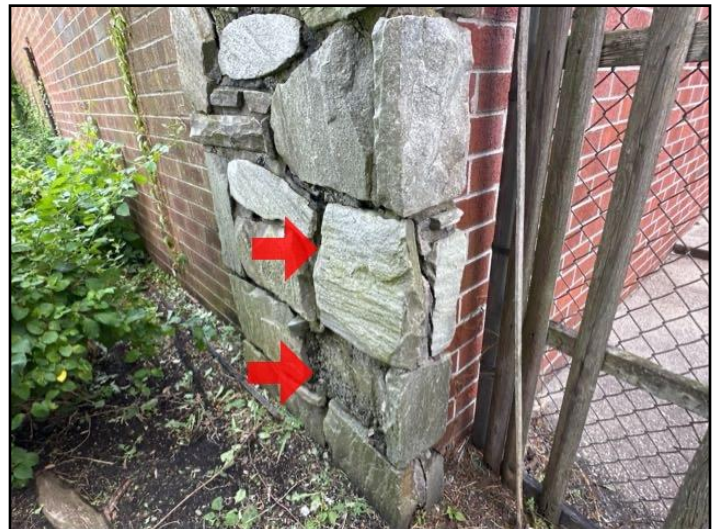
Loose

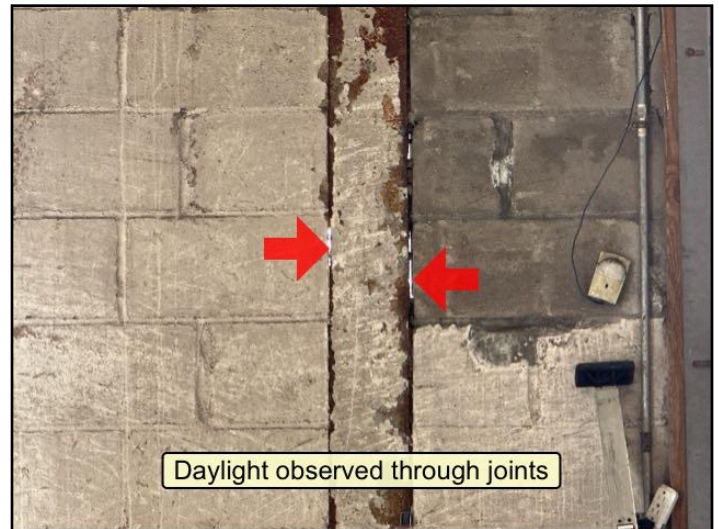
10. Condition: • Expansion joints

Expansion joints

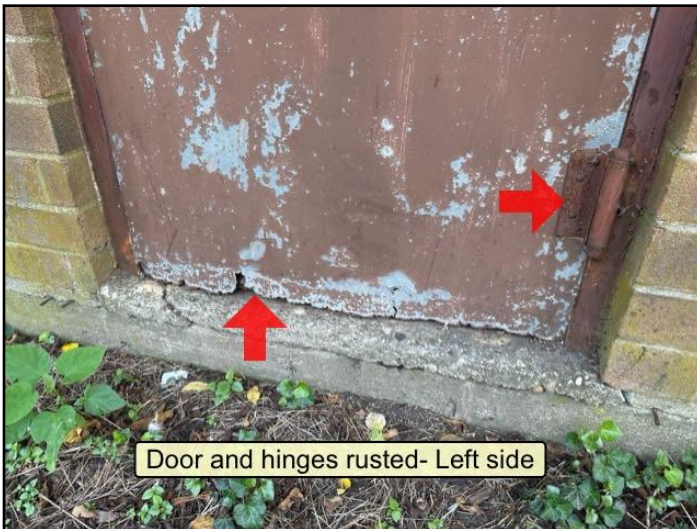
11. Condition: • [Rust](#)

Implication(s): Chance of damage to finishes and structure

Rust

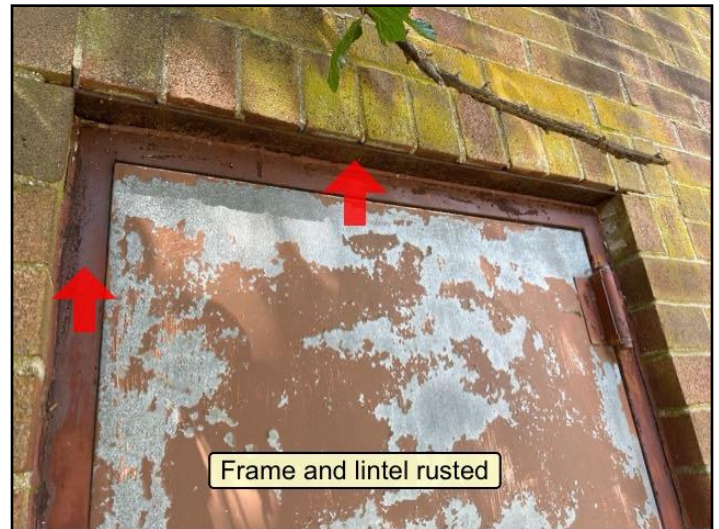
Rust

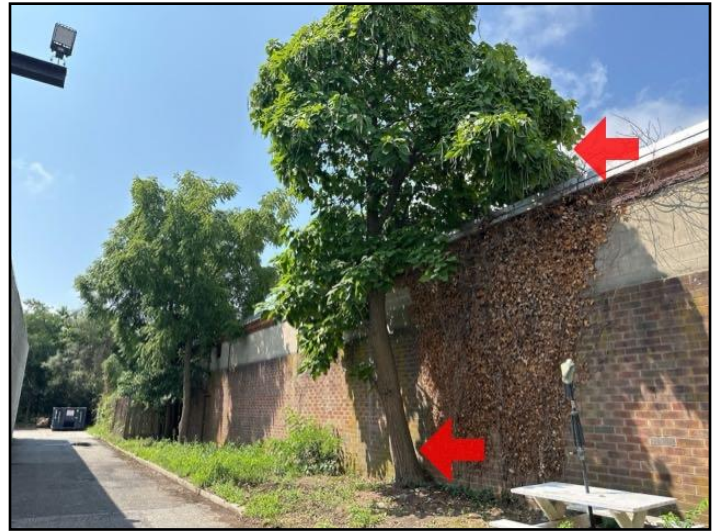
12. Condition: • [Trees or shrubs too close to building](#)

Implication(s): Chance of water damage to structure, finishes and contents | Chance of pests entering building | Material deterioration

*Trees or shrubs too close to building*

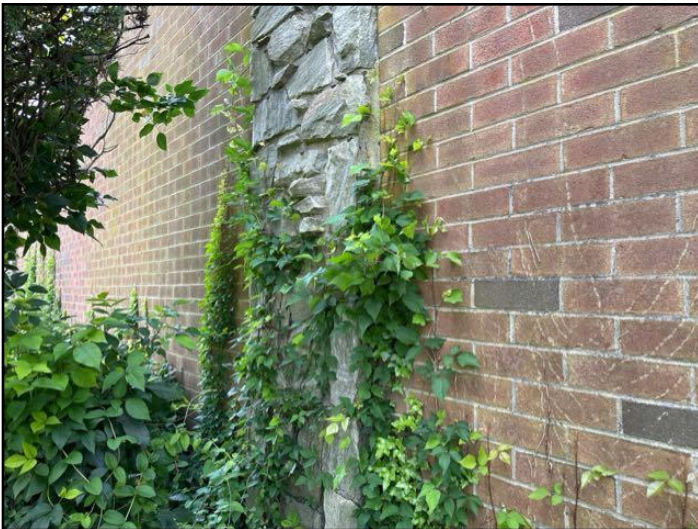
**13. Condition:** • Vines on building

**Implication(s):** Chance of damage to finishes | Chance of pests entering building

*Vines on building*

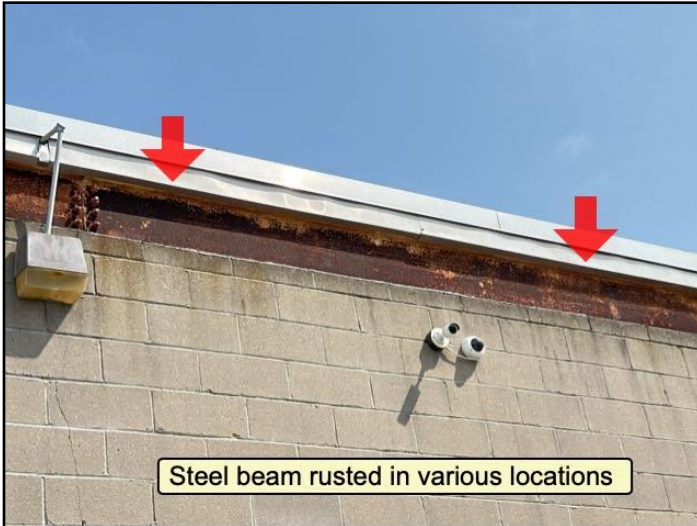
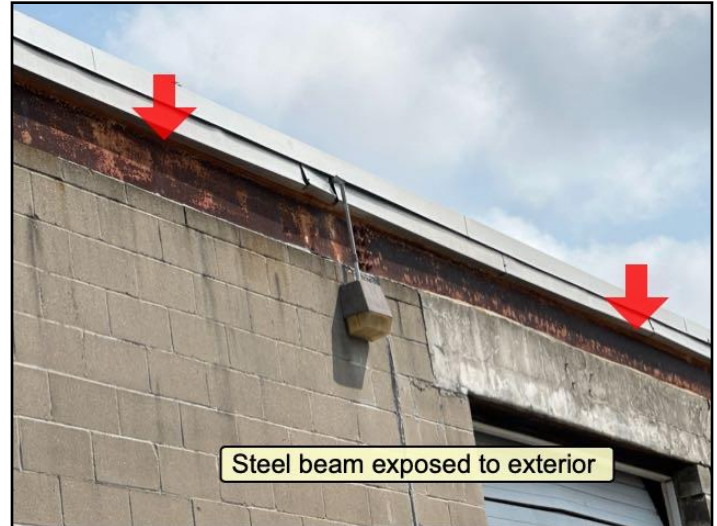
14. Condition: • Rust

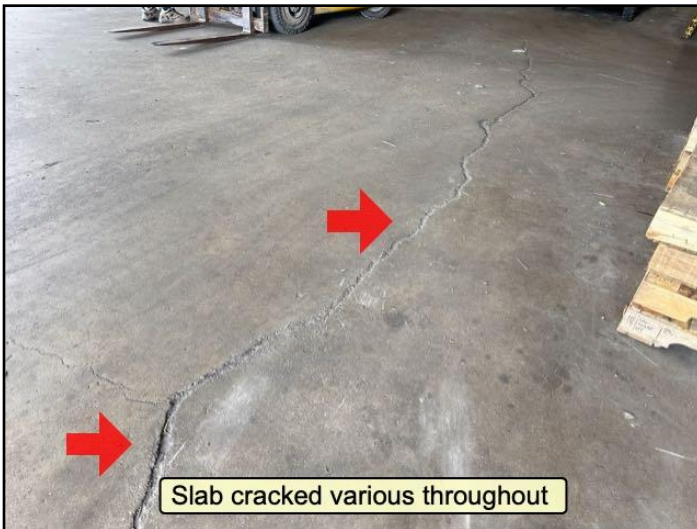
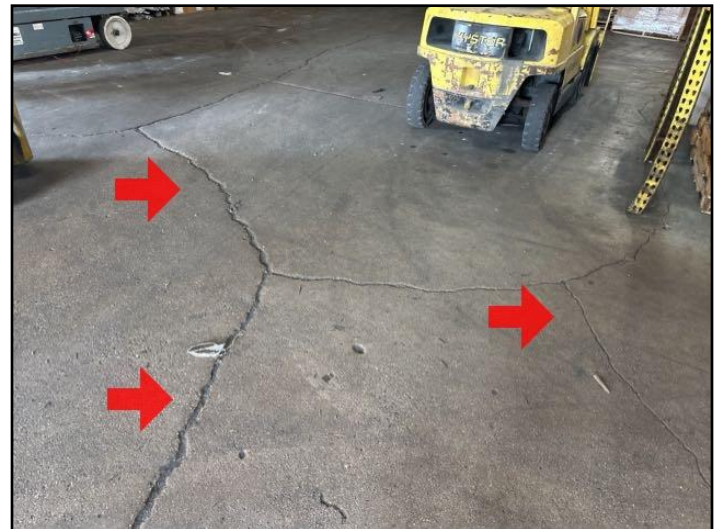
FLOORS \ Concrete slabs15. Condition: • [Cracked](#)

Implication(s): Chance of water damage to structure, finishes and contents | Trip or fall hazard

Cracked

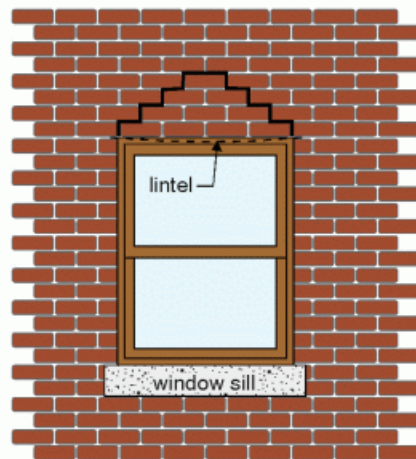
crack pattern commonly associated with sagging lintels due to undersizing or deterioration

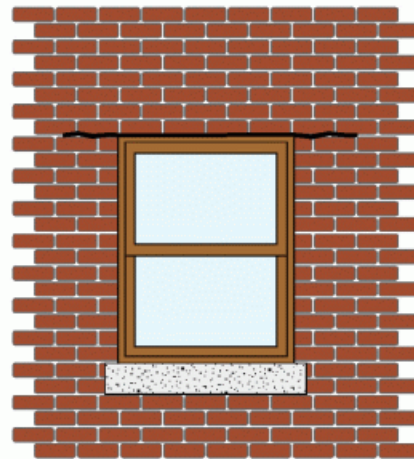
horizontal crack often caused by rusting steel lintels expanding

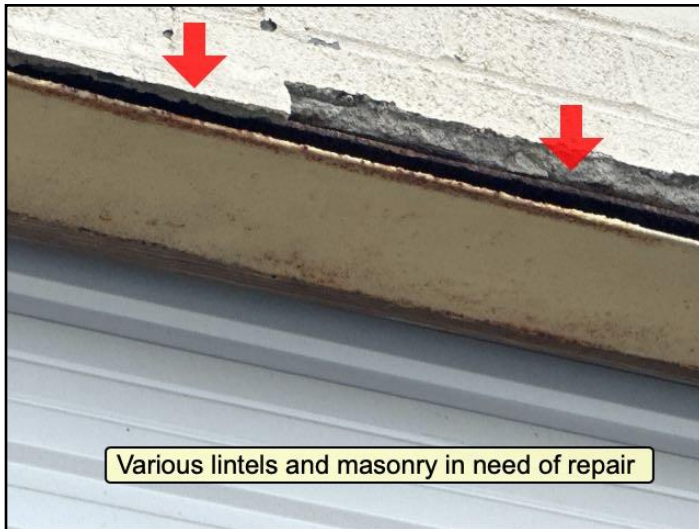
WALLS \ Headers or Lintels16. Condition: • [Rust](#)

Implication(s): Weakened structure | Chance of structural movement

Various lintels and masonry in need of repair

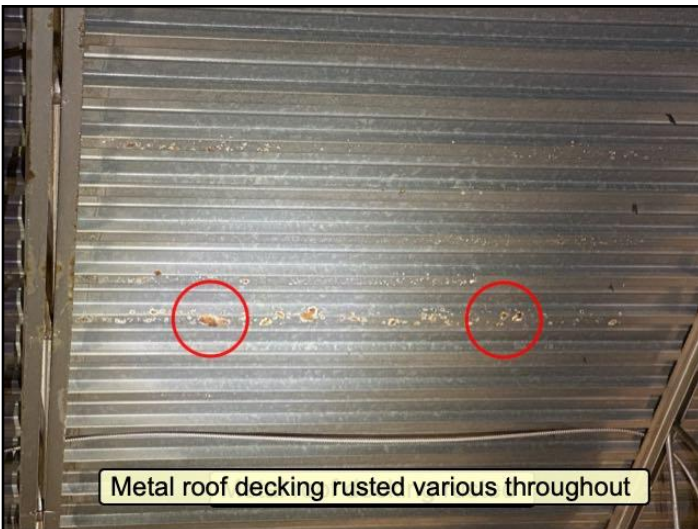
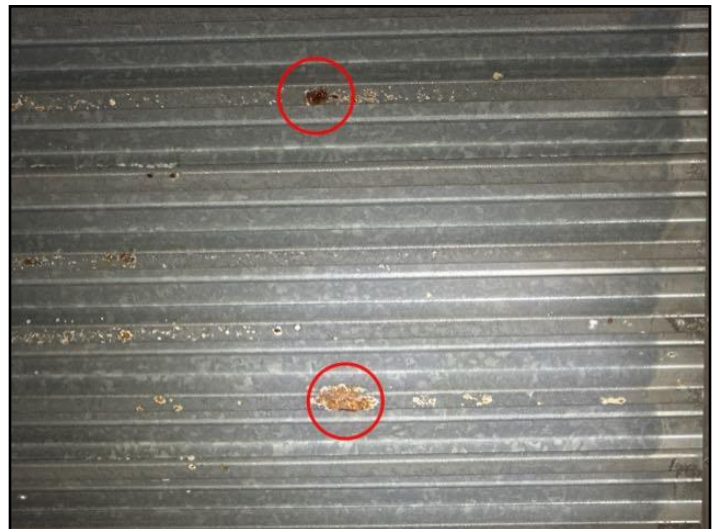
17. Condition: • Rust

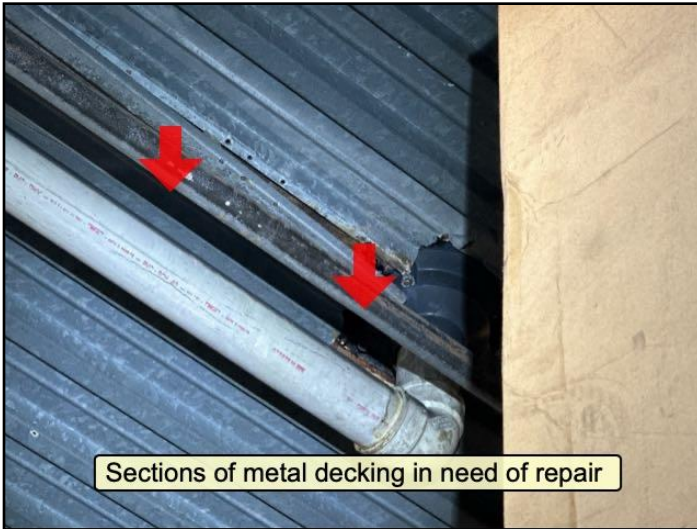
Sections of metal decking in need of repair

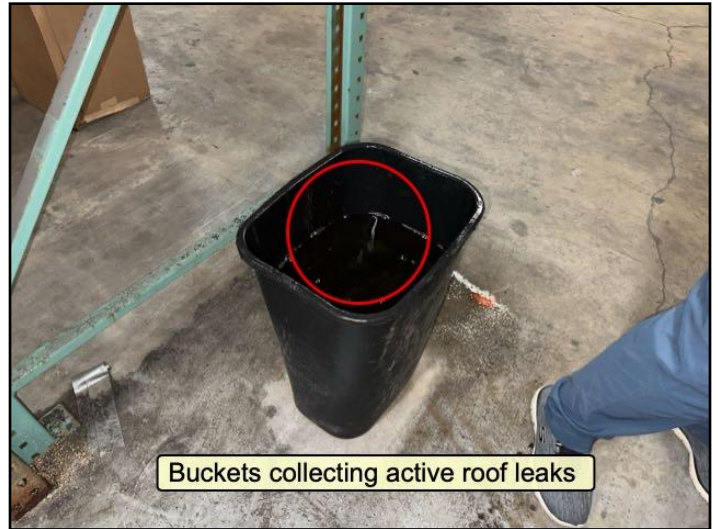
Buckets collecting active roof leaks

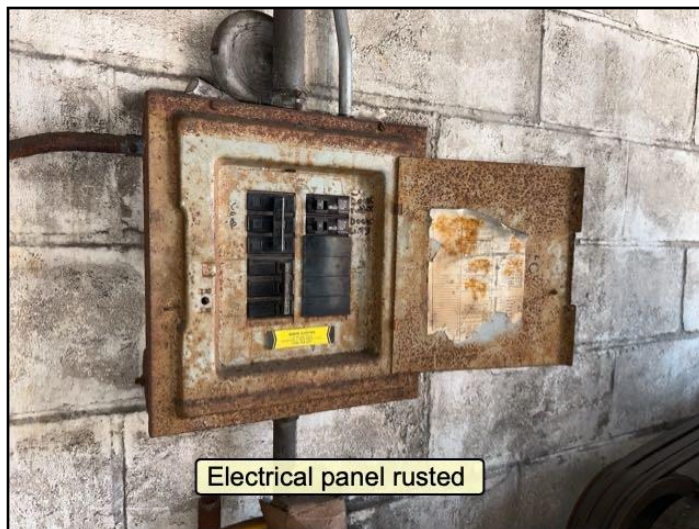
**18. Condition:** • Panel cover rusted

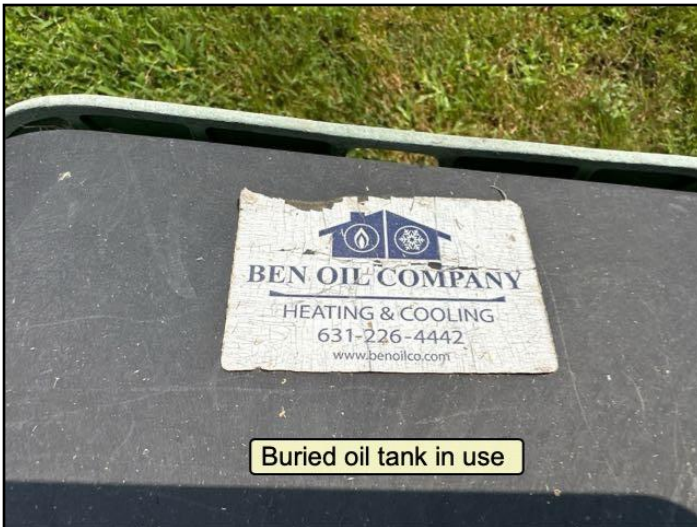
**19. Condition:** • Recommend asking seller if a buried oil tank exists on property. If so request proper abandonment paperwork and certificate.

Evidence of a buried oil tank front of property

Recommend asking seller if a buried oil tan...

**Task:** Recommend further evaluation

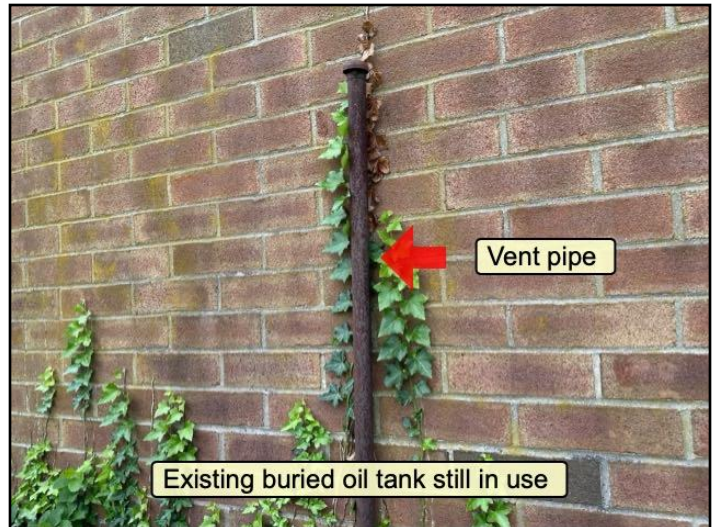
Recommend asking seller if a buried oil tan...

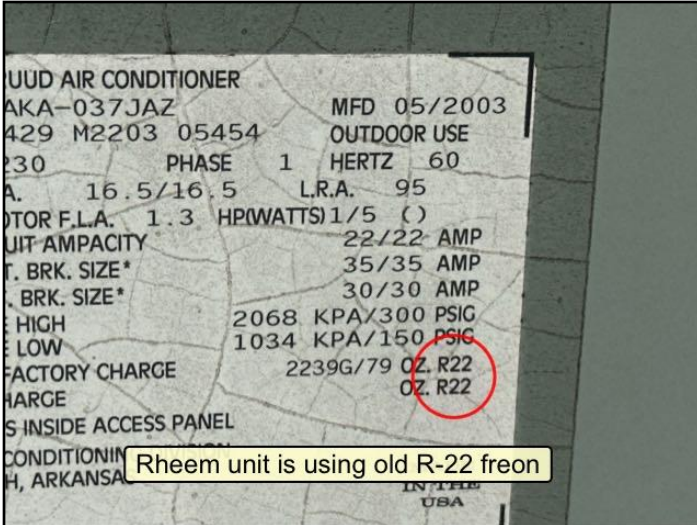
**20. Condition:** • AC is old using R-22 freon in system. This freon will not be available in the near future and is very expensive. Budget for replacement of AC unit when needed.

AC is old using R-22 freon in system. This...

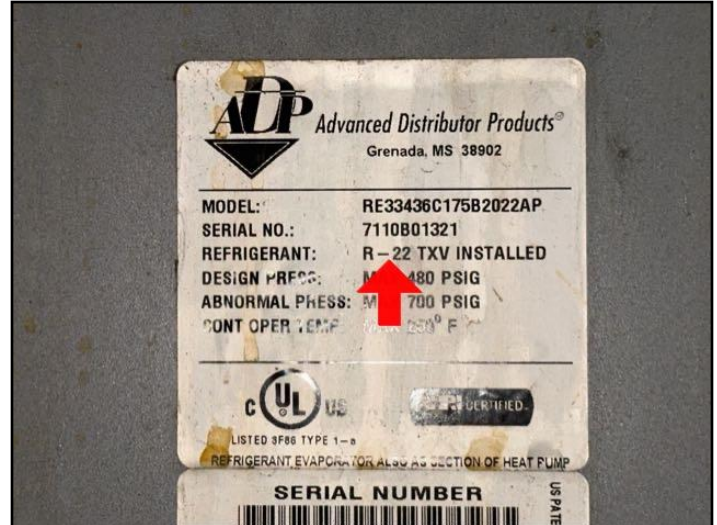
AC is old using R-22 freon in system. This...

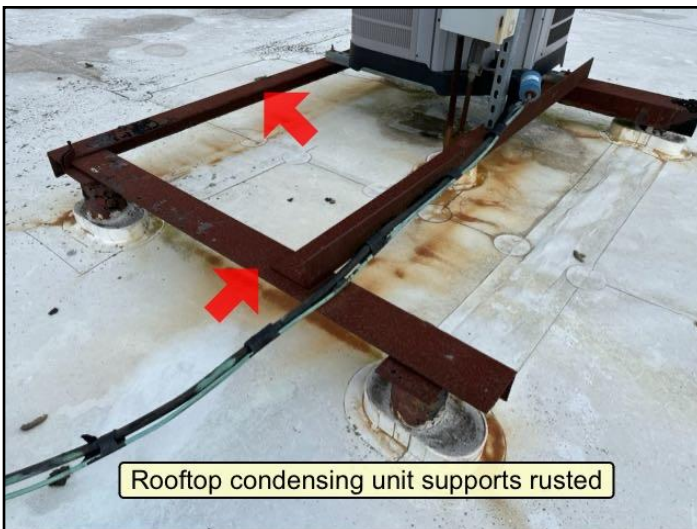
**21. Condition:** • Supports rusted

Supports rusted

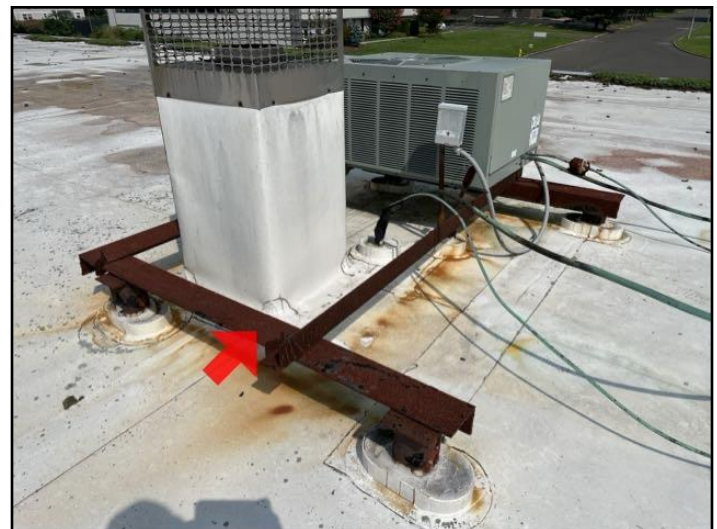
Supports rusted

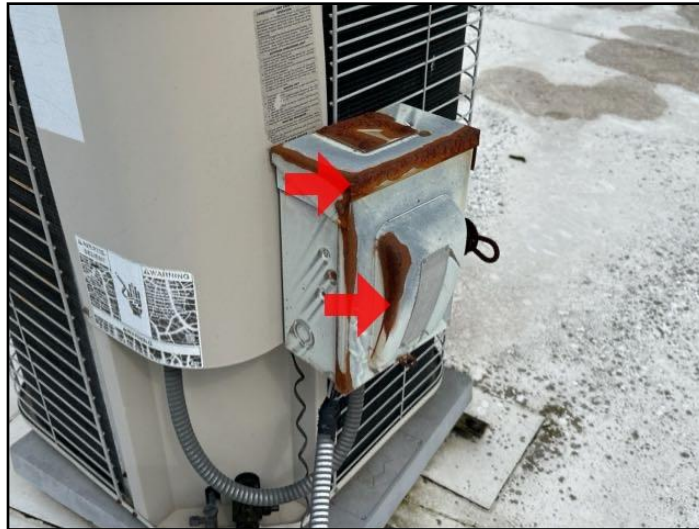
**22. Condition:** • Disconnect switch cover rusted

*Disconnect switch cover rusted*

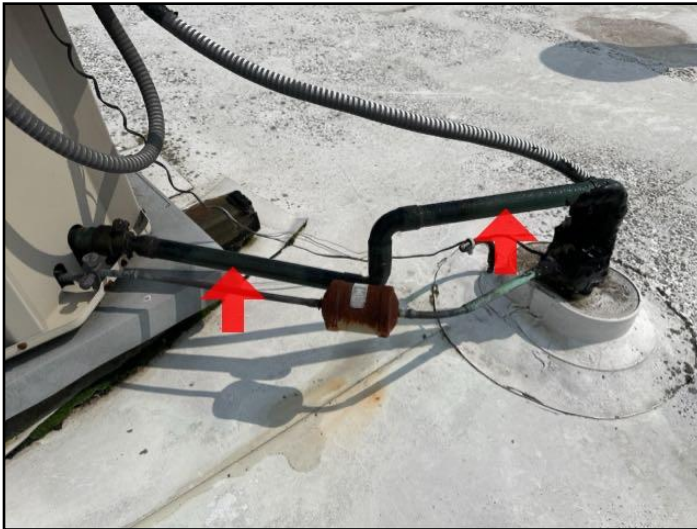
23. Condition: • [Insulation - missing](#)

Implication(s): Reduced system life expectancy | Increased cooling costs | Reduced comfort

*Insulation - missing*

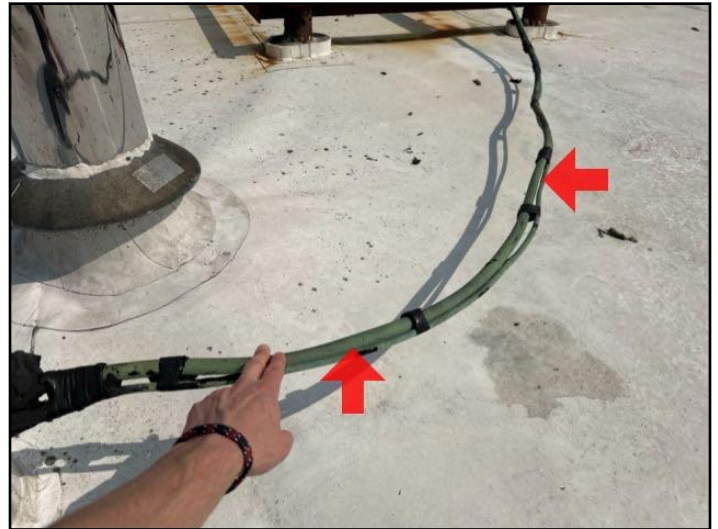
*Insulation - missing*

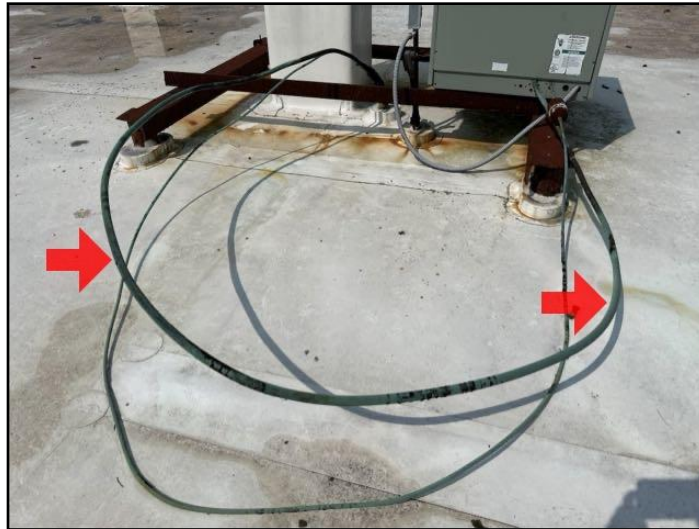
Insulation - missing

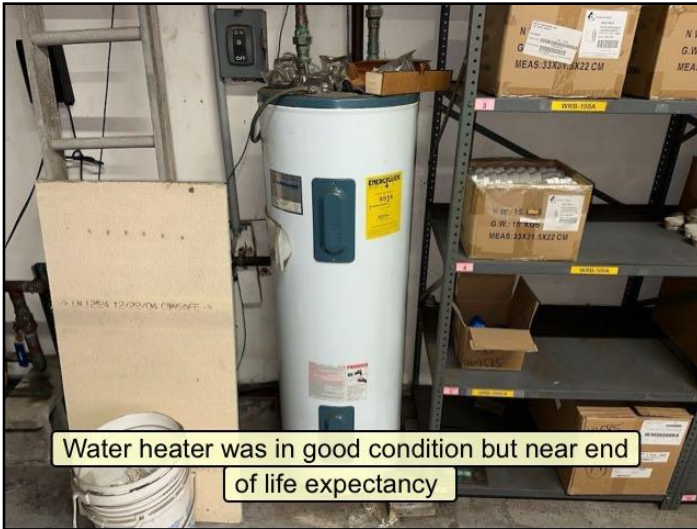
Water heater was in good condition but near end of life expectancy

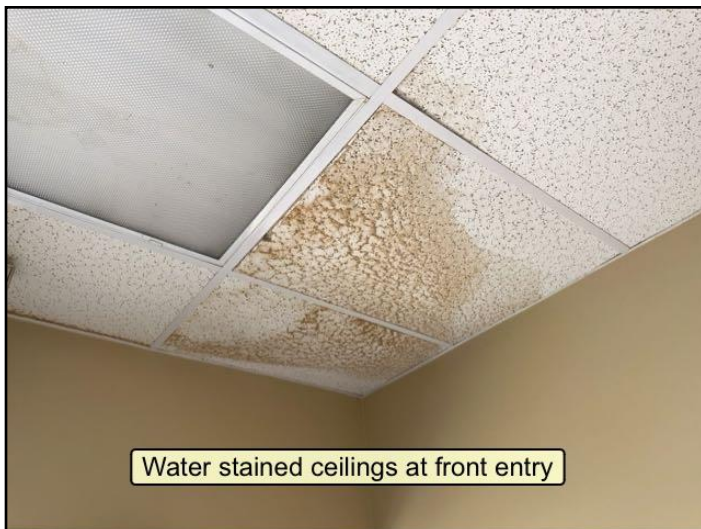
**24. Condition:** • Water stains

**Implication(s):** Chance of water damage to structure, finishes and contents

Water stains

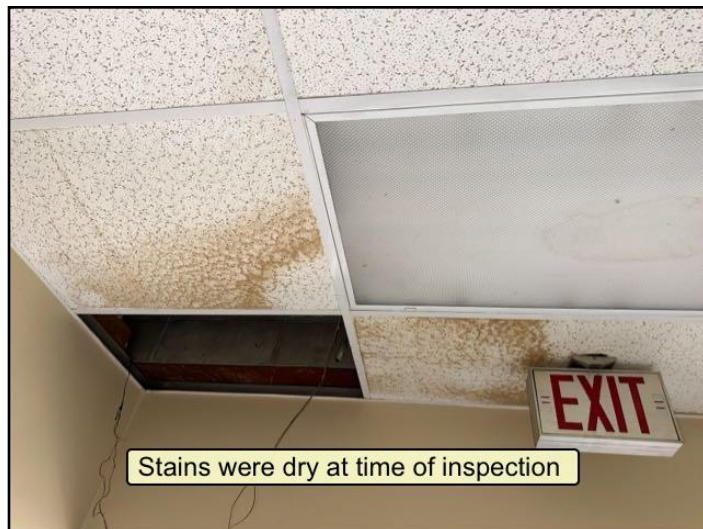
Water stains
