# INSPECTION REPORT

***For the Property at:  
1477 Middletown Road  
LAKE GROVE, NY 11755***

**Prepared by:** East Coast Commercial Inspections

**Date of Inspection:** January 28, 2026

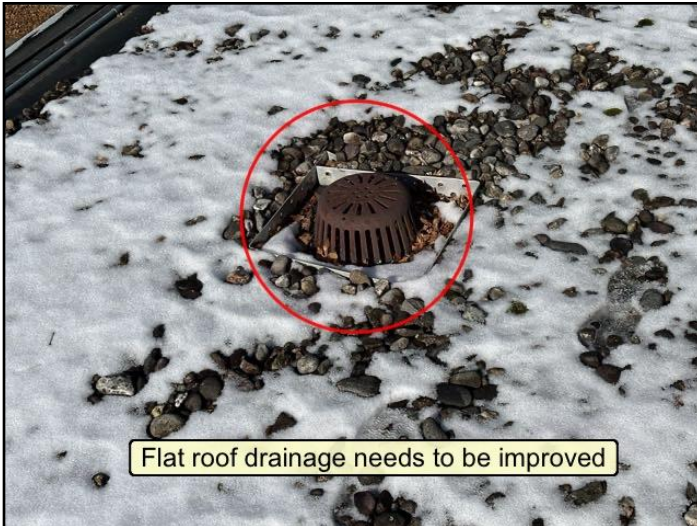
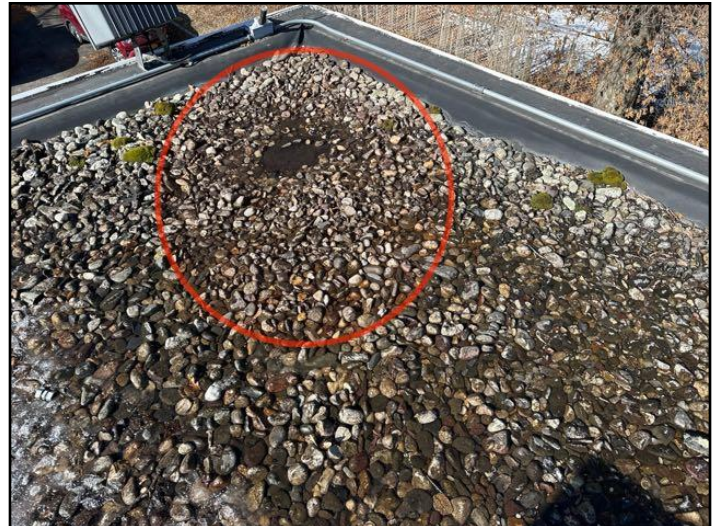
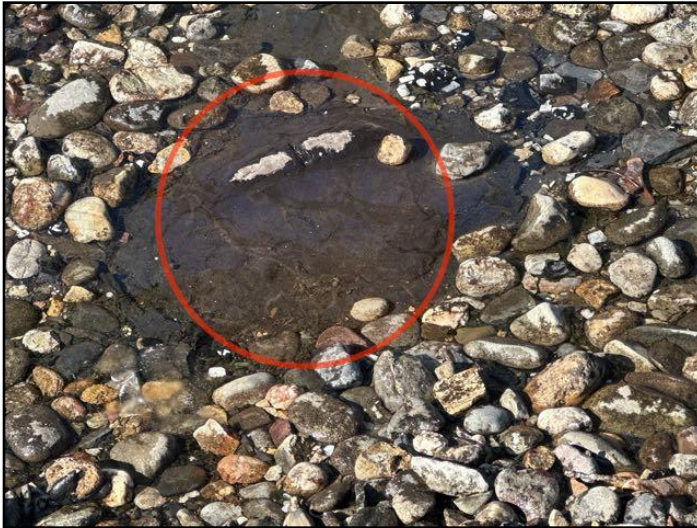
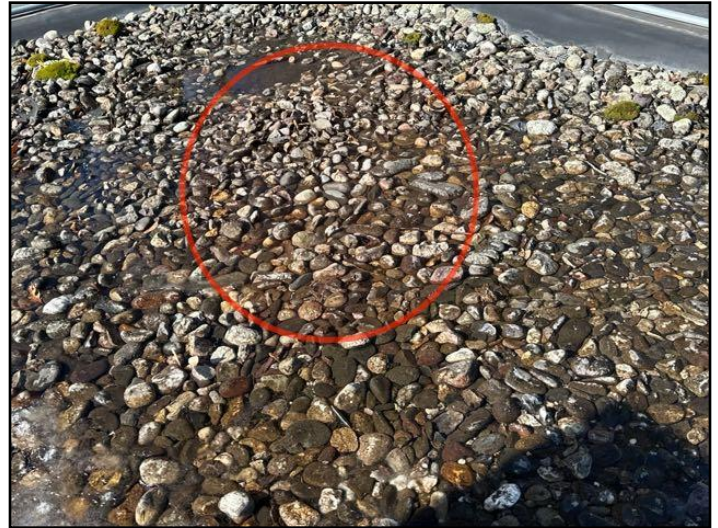
**2. Condition:** • Flat roof drainage needs to be improved

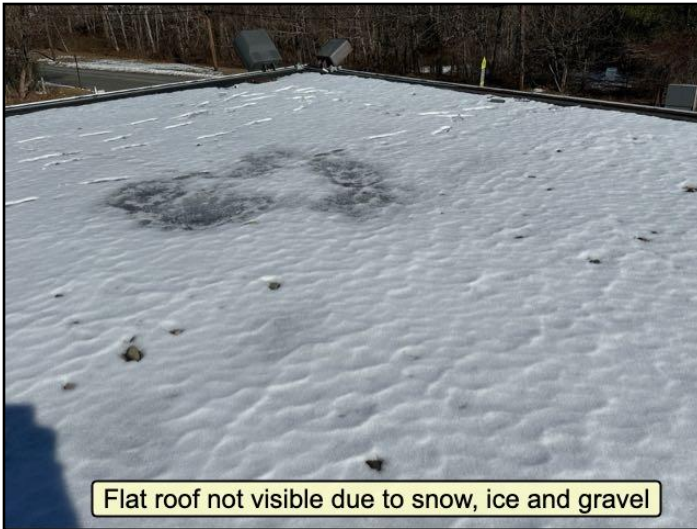
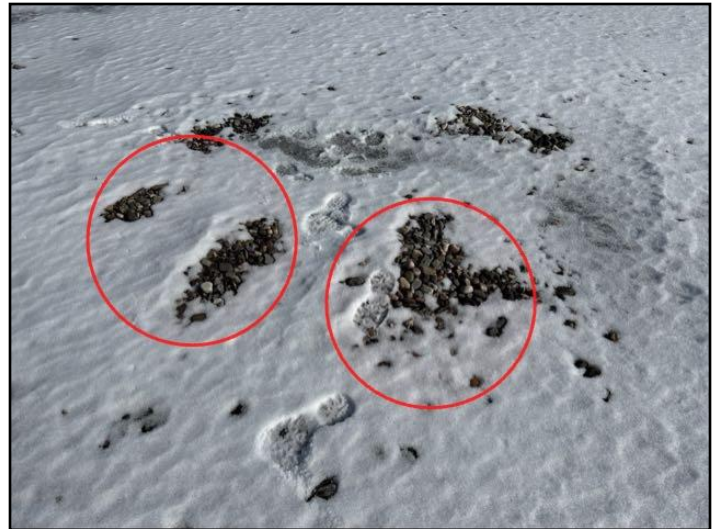
Flat roof not visible due to snow, ice and gravel

Not visible

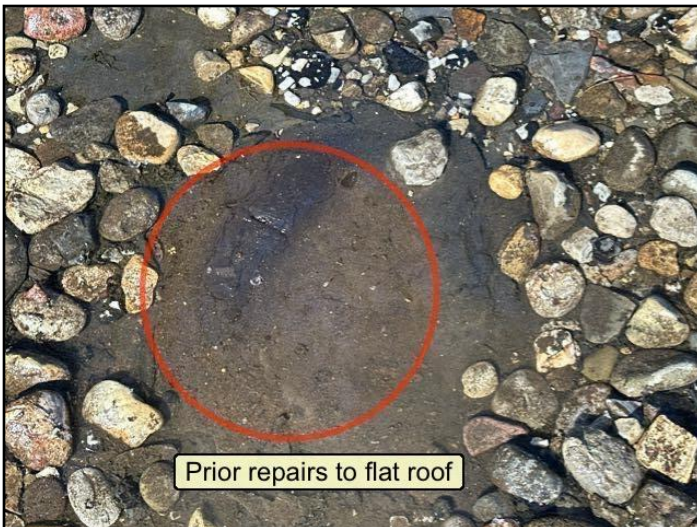
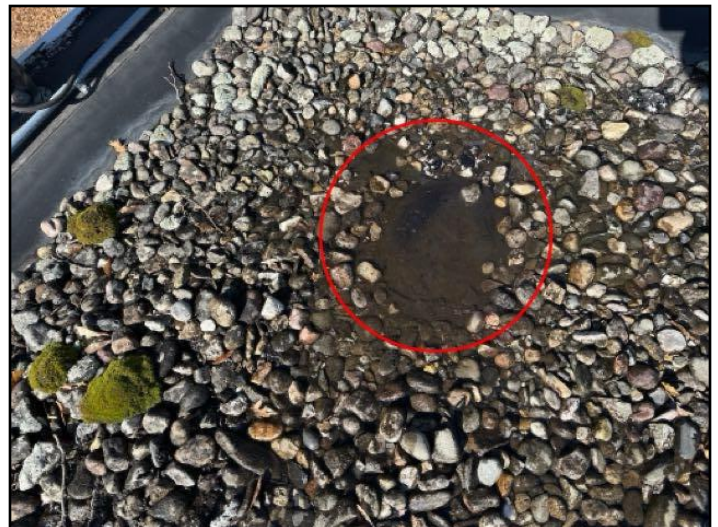
#### 4. Condition: • Prior repairs to flat roof

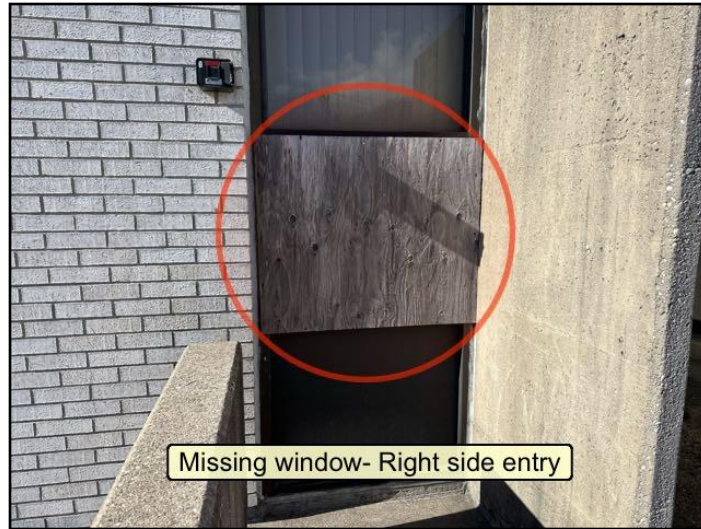
**8. Condition:** • [Missing](#)

*Missing*

**Task:** Repair

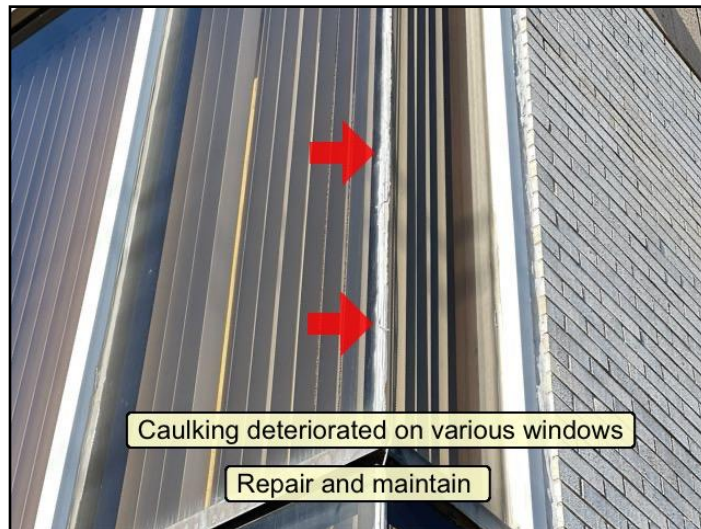
**9. Condition:** • Caulking deteriorated on various windows

Repair and maintain

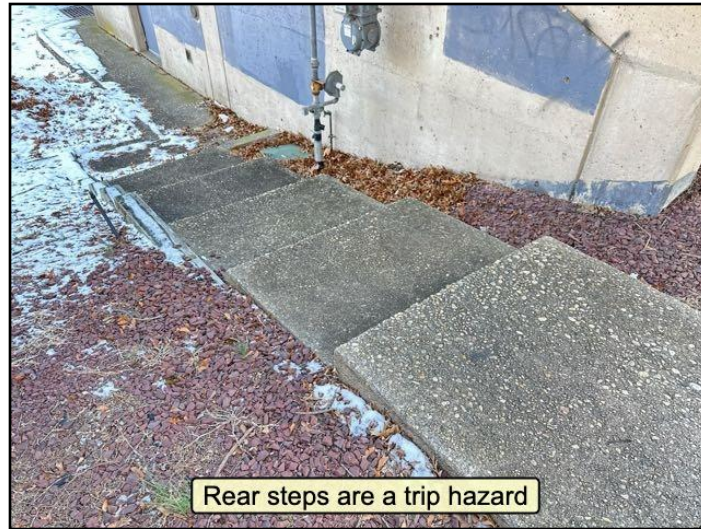
Rear steps are a trip hazard

*Trip hazard*

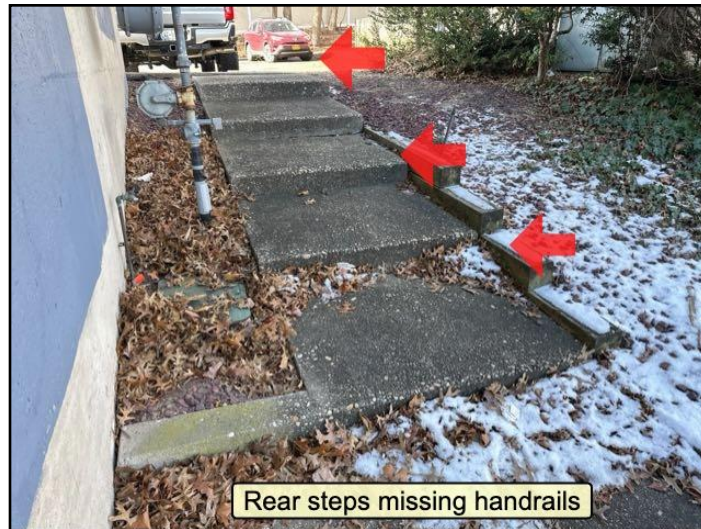
Rear steps missing handrails

*Missing*

**Task:** Provide

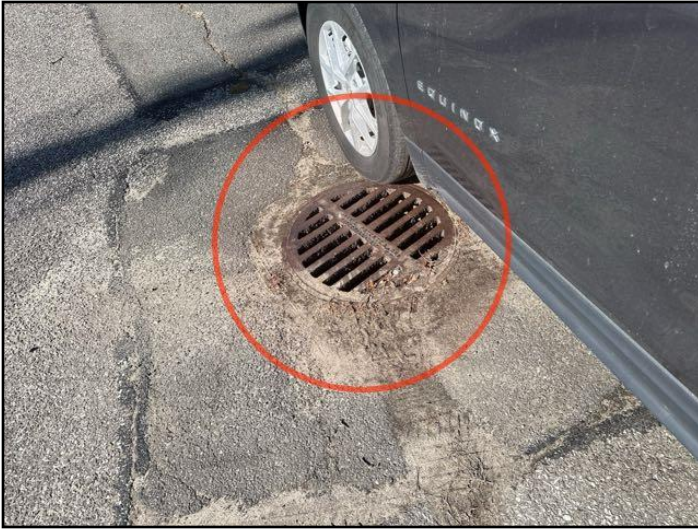
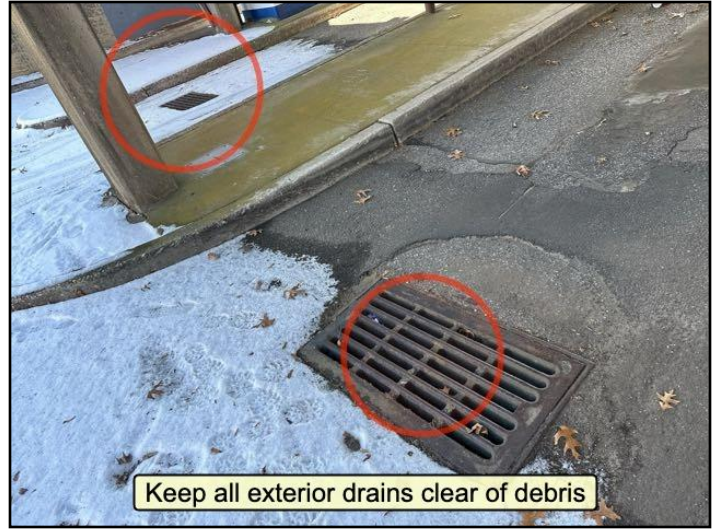
**14. Condition:** • Keep outside drains clear of debris to prevent water from entering house. Keep all exterior drains clear of debris

Keep outside drains clear of debris to...

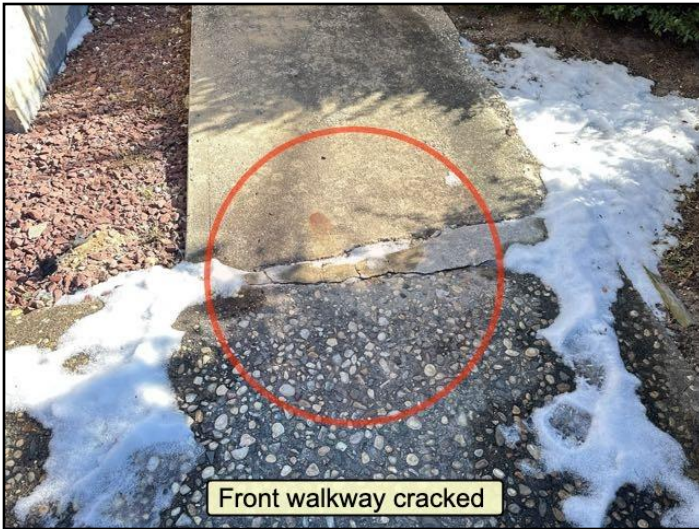
Front walkway cracked

Uneven (trip hazard)

**Task:** Repair

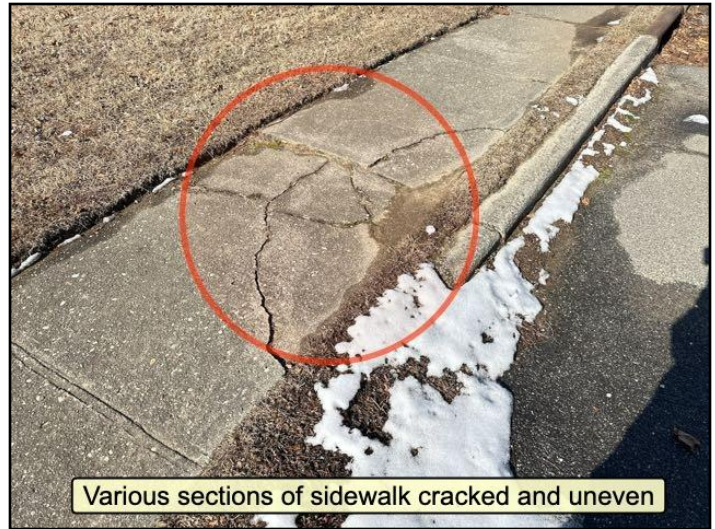
Various sections of sidewalk cracked and uneven

Uneven (trip hazard)

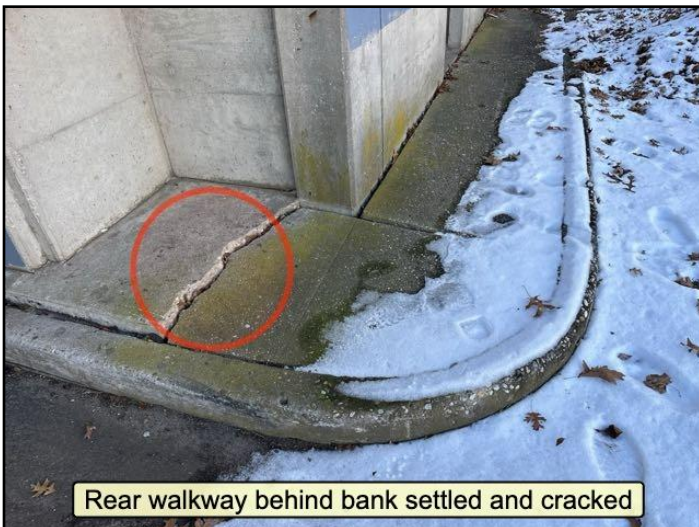
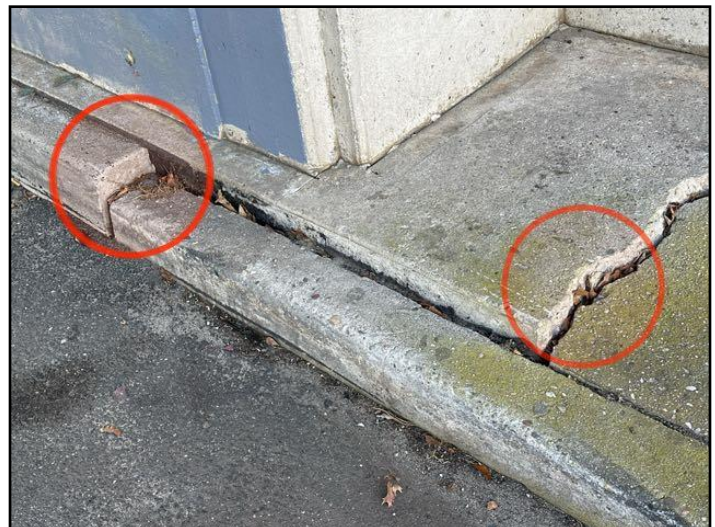
Rear walkway behind bank settled and cracked

Settlement

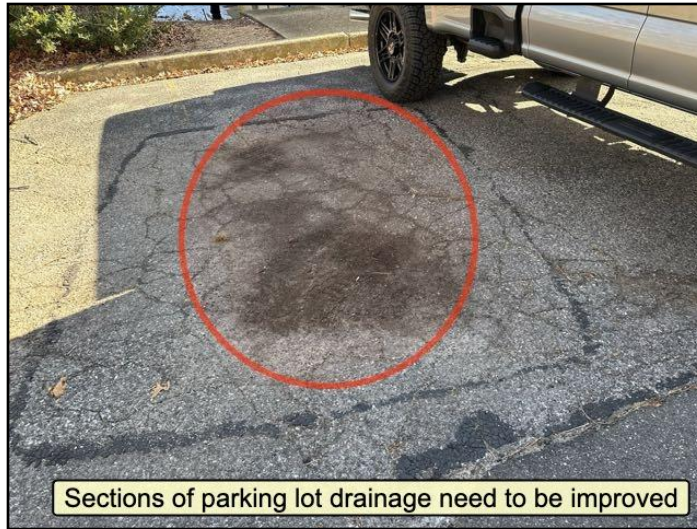
Sections of parking lot drainage need to be improved

*Improper slope or drainage*

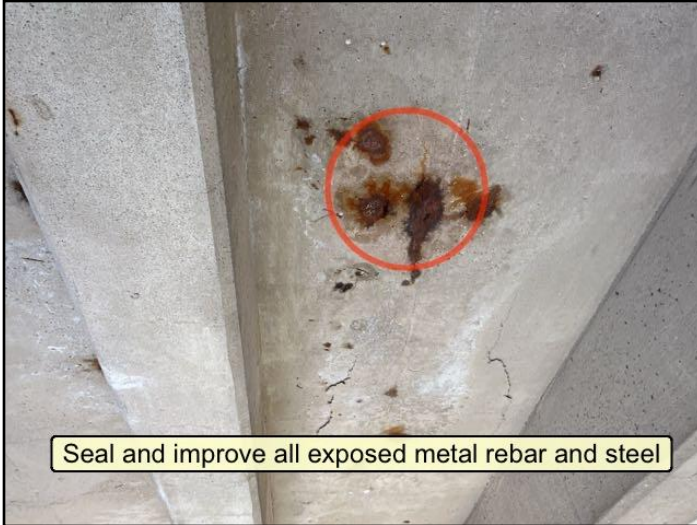
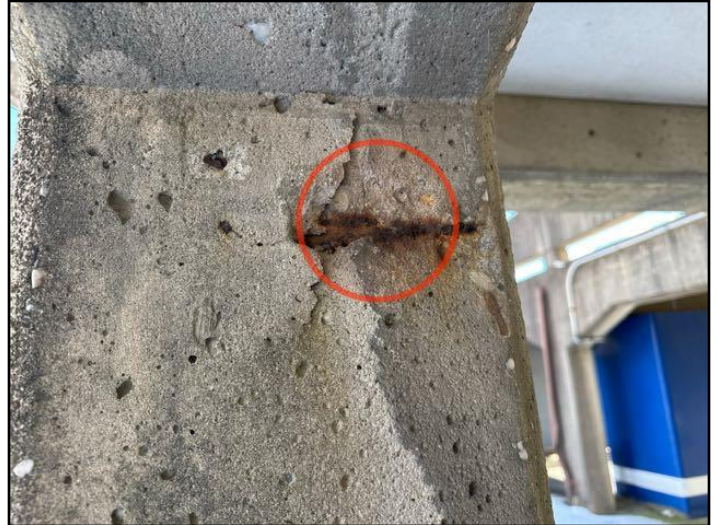
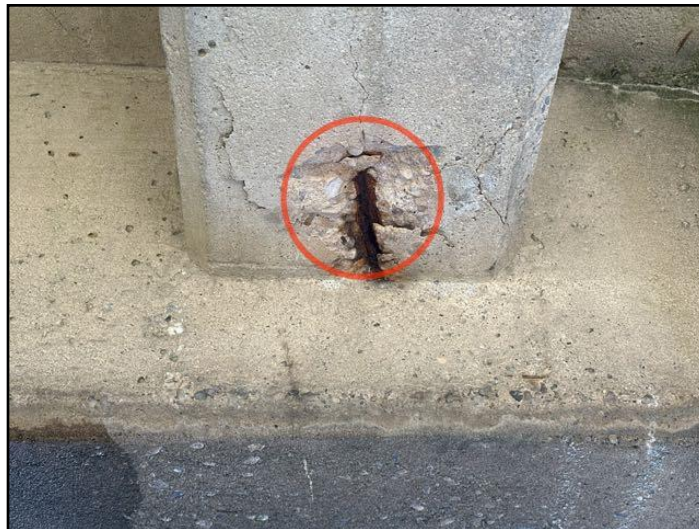
**21. Condition:** • Seal and improve all exposed metal rebar and steel

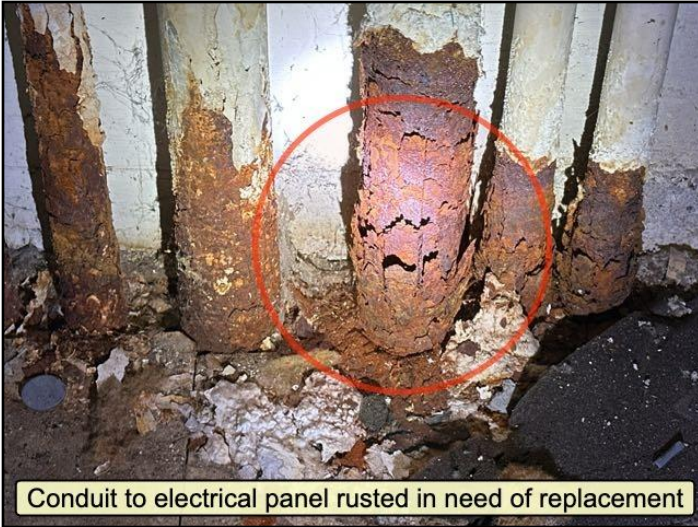
Conduit to electrical panel rusted in need of replacement

*damaged / rusted conduit*

**Task:** Replace

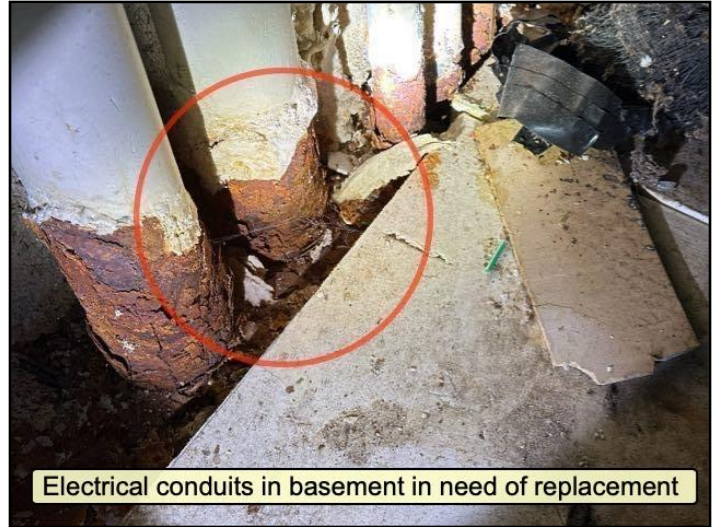
Electrical conduits in basement in need of replacement

*damaged / rusted conduit*

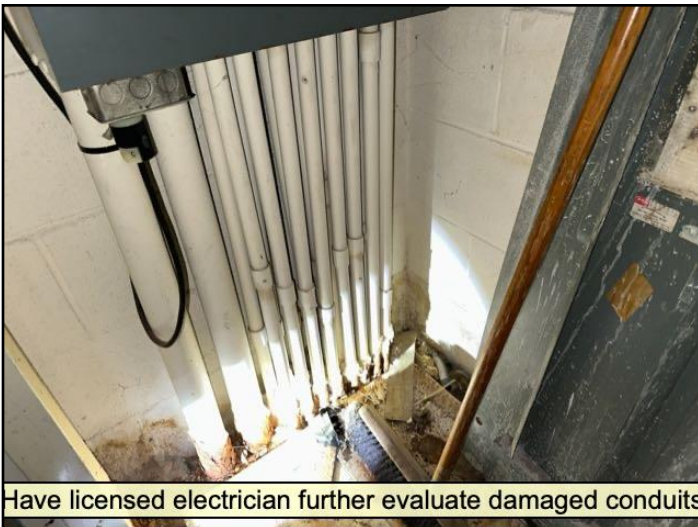
*damaged / rusted conduit*

Have licensed electrician further evaluate damaged conduits

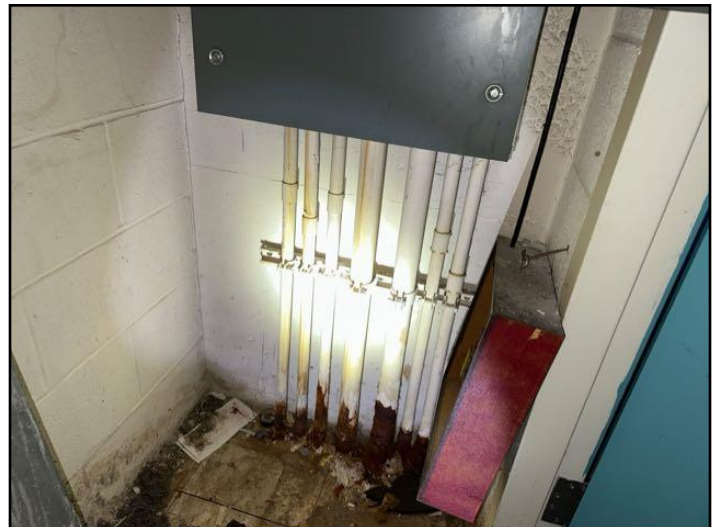
*damaged / rusted conduit***COMMENTS \ Additional**

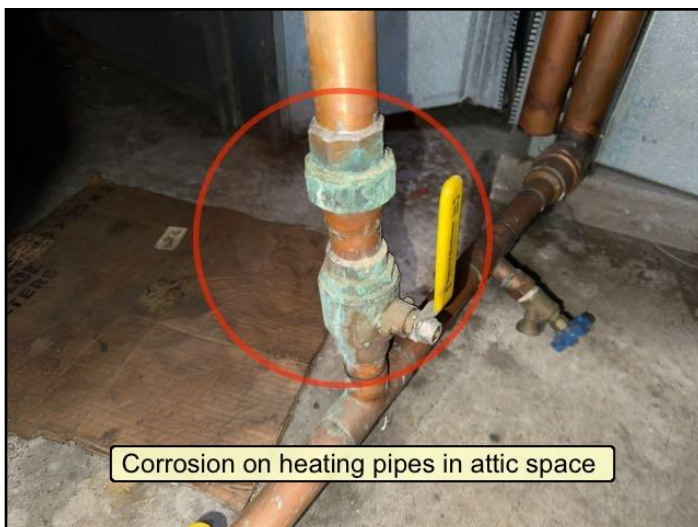
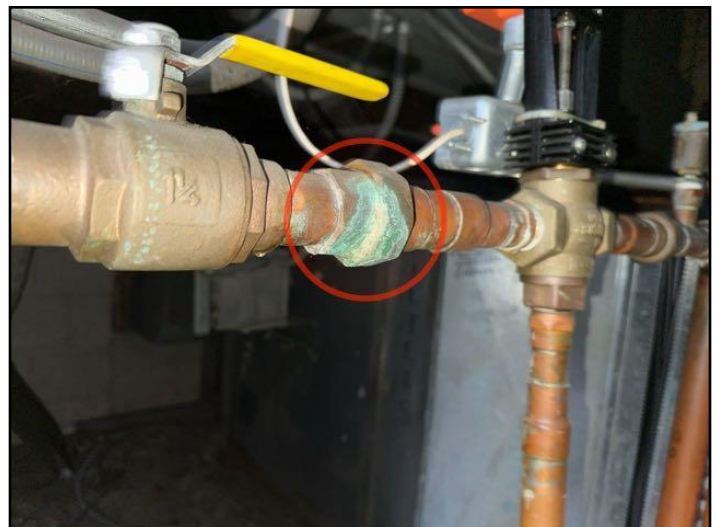
**26. Condition:** • Corrosion on heating pipes in attic space

**Task:** Repair or replace

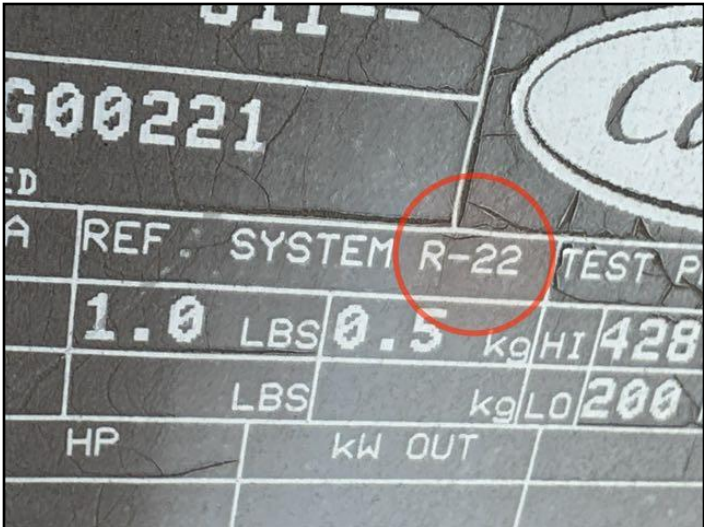
**29. Condition:** • AC is old using R-22 freon in system. This freon will not be available in the near future and is very expensive. Budget for replacement of AC unit when needed.  
Cooling systems are using old R-22 freon  
**Task:** Budget for replacement

AC is old using R-22 freon in system. This...

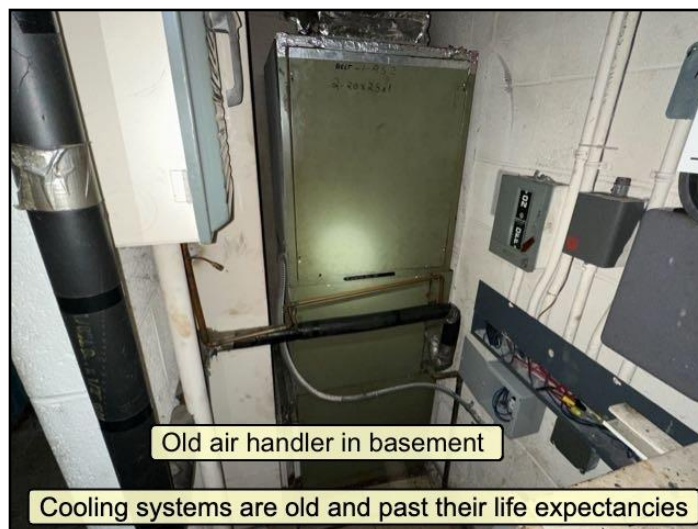
### **31. Condition:** • Past life expectancy

*Past life expectancy*

Recommend further evaluation by a licensed HVAC technician for repair and replacement quotes

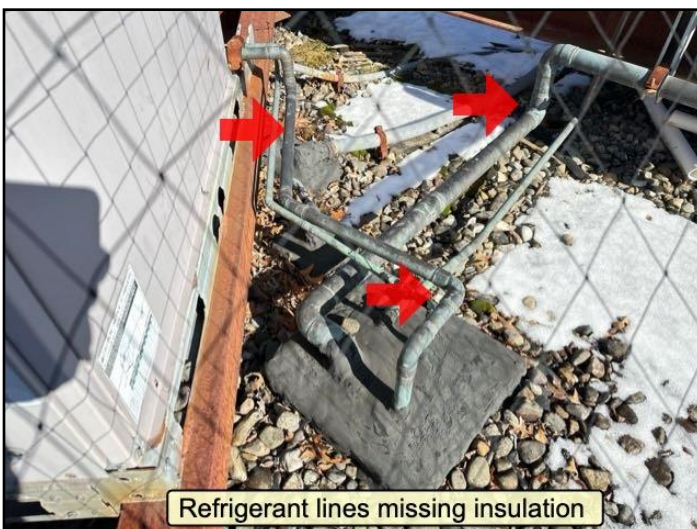
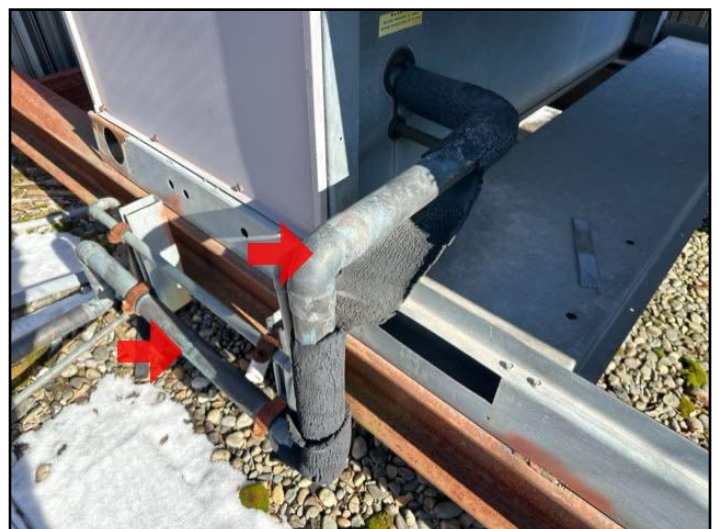
### **33. Condition:** • Insulation - missing

The larger low pressure suction line requires insulation to protect it from condensation. Without insulation around this line, thermal energy is lost and condensation forms, which can both lower efficiency and cause moisture damage to the unit.

*Insulation - missing*

**Task:** Improve

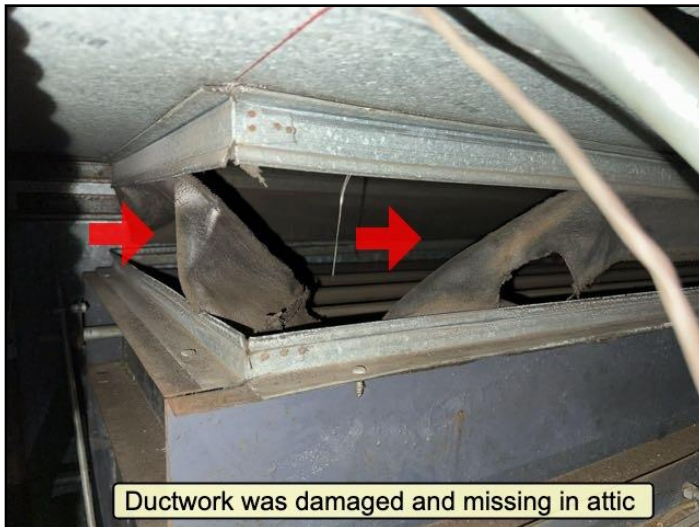
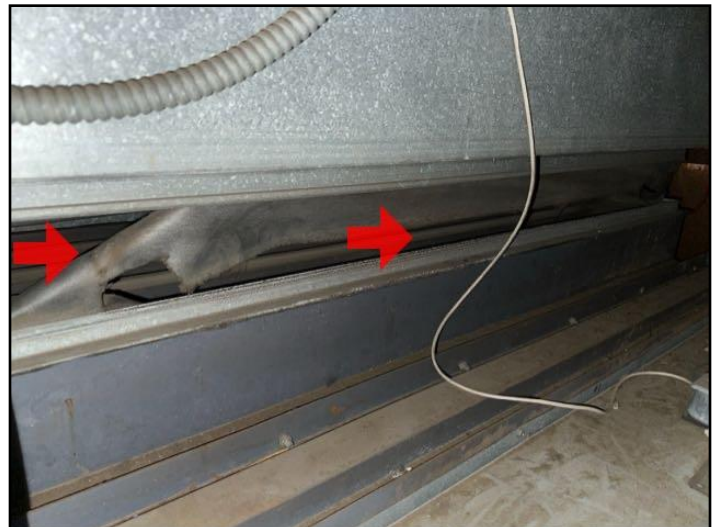
Ductwork was damaged and missing in attic

*Disconnected or leaking*

**Task:** Replace

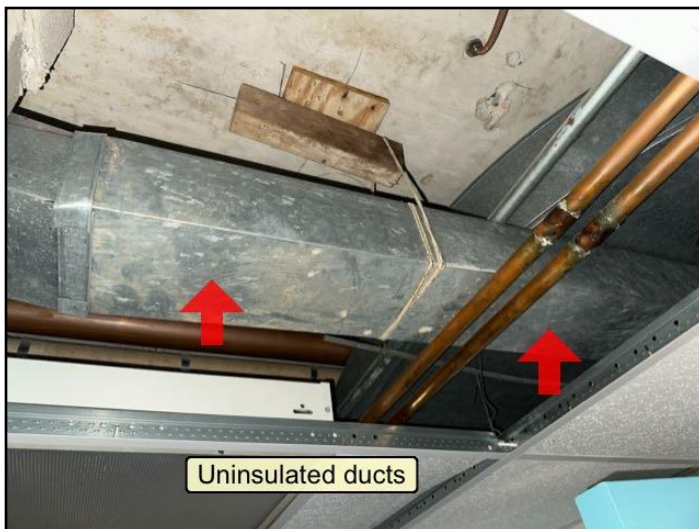
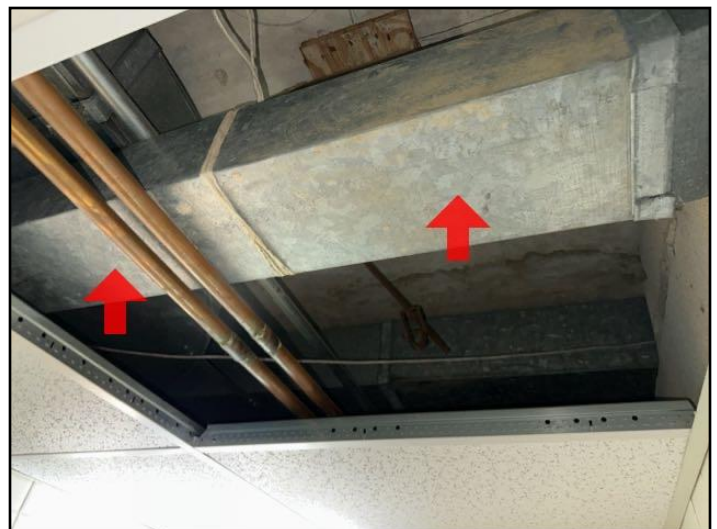
**35. Condition:** • Older uninsulated ducts

*Older uninsulated ducts*

**Task:** Improve

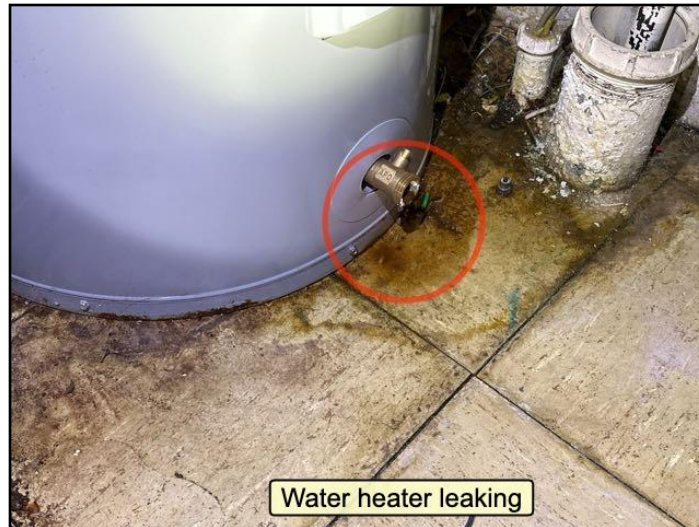
Water heater leaking

*Leak***Inspection Method and Limitations****Inspection limited/prevented by:**

**Implication(s):** Chance of water damage to structure, finishes and contents**Location:** Basement**Task:** Repair or replace

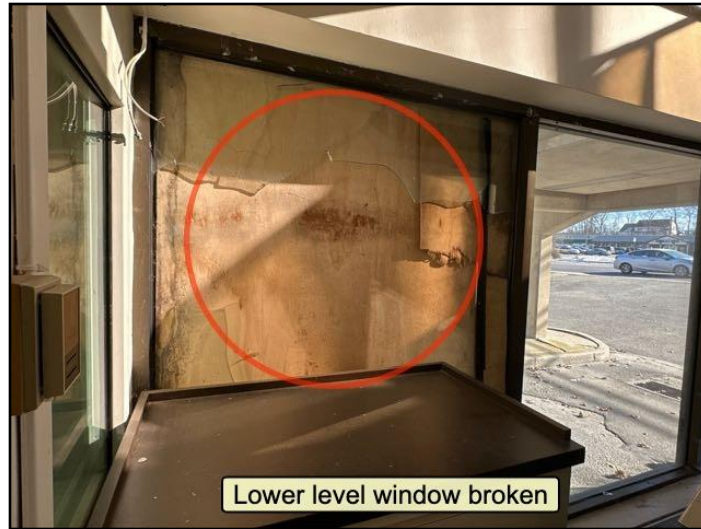
Lower level window broken

*Broken*

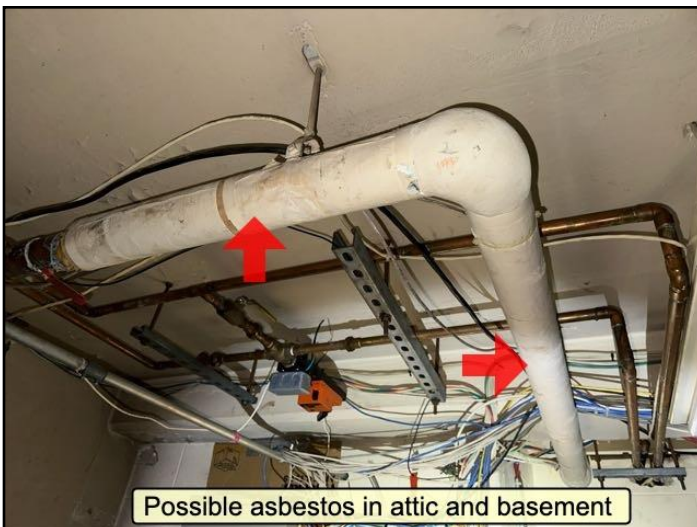
### **42. Condition:** • Possible asbestos containing materials

Asbestos is a fibrous material that was used in many building materials as a fire resistant material, a binder, and a thermal insulator. The very small asbestos fibers can cause cancer and other types of lung disease if inhaled. Demolition or renovation work can disturb asbestos-containing materials, causing the asbestos fibers to be released into the air. Various heating pipes have possible asbestos contain material. Corrective actions related to asbestos should not be undertaken by the property owner, as a general rule. Recommend further evaluation by a licensed environmental specialist company to provide cost of removal.

*Possible asbestos containing materials*
