# INSPECTION REPORT

For the Property at:  
**PORT WASHINGTON, NY 11050**

Inspection Date: Wednesday, May 29, 2024

Prepared by:  
**East Coast Commercial Property Inspections, LLC**

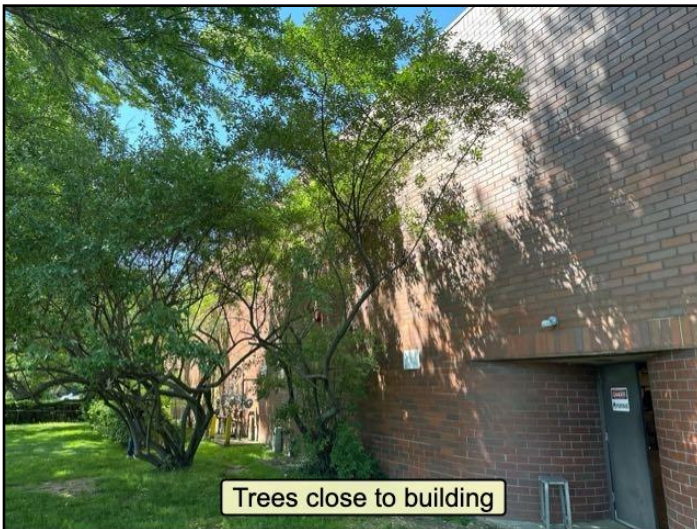
**LANDSCAPING \ #General notes****10. Condition:** • [Trees or shrubs too close to building](#)**Implication(s):** Chance of water damage to structure, finishes and contents | Chance of pests entering building | Material deterioration**Location:** East

*Trees or shrubs too close to building*

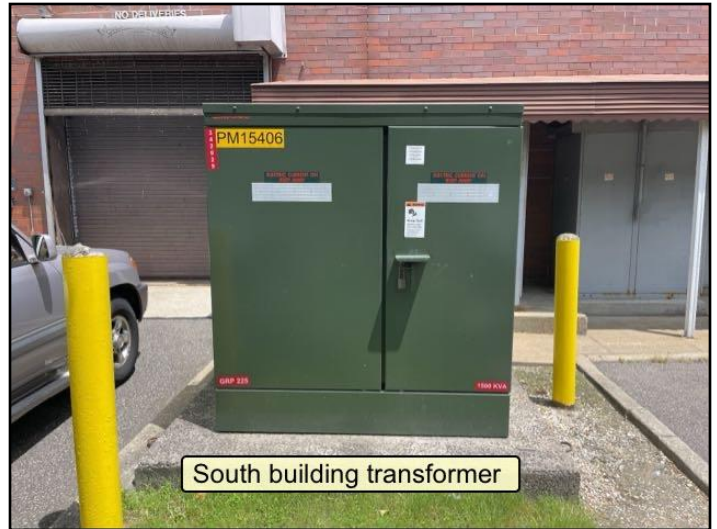
*South building transformer***Main disconnect/service box rating: • NORTH- 2,000 AMPS**

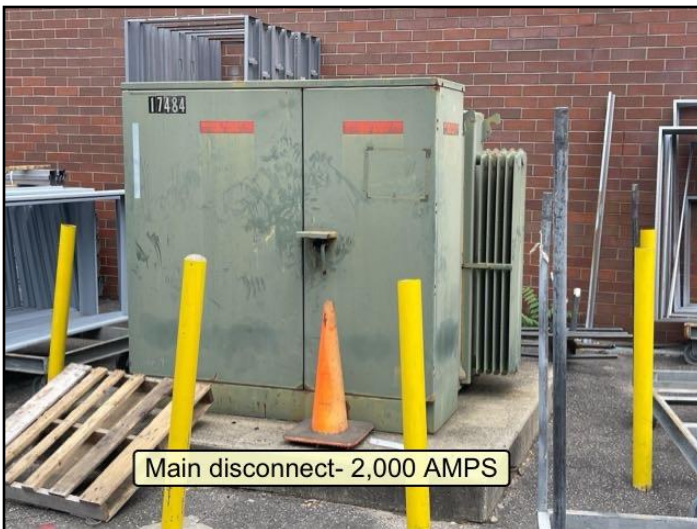
*Main disconnect- 2,000 AMPS*

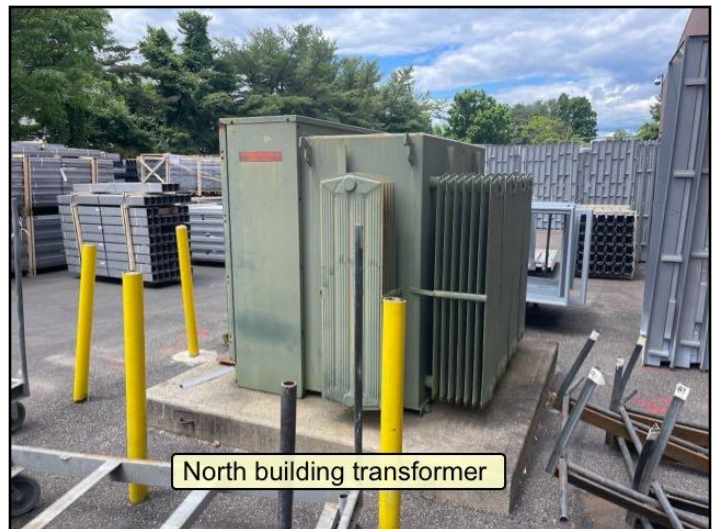
*North building transformer*
