# INSPECTION REPORT

***For the Property at:  
19 Laurel Ave  
HEMPSTEAD, NY 11550***

**Prepared by:** East Coast Commercial Inspections

**Date of Inspection:** March 15, 2026

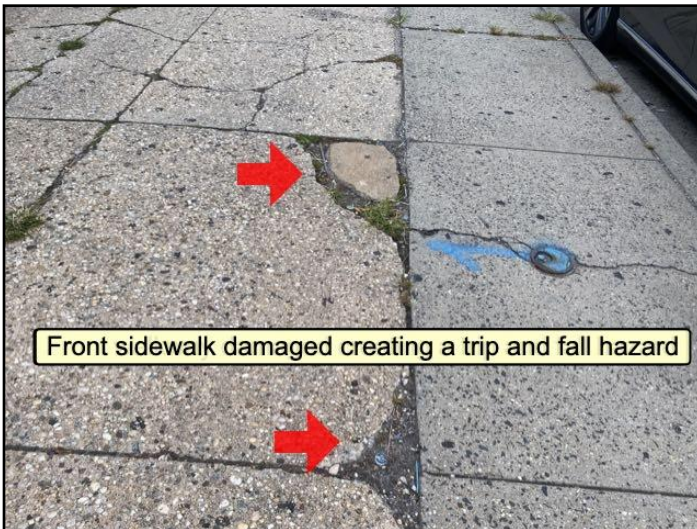
Implication(s): Trip or fall hazard

*Cracked or damaged surfaces*

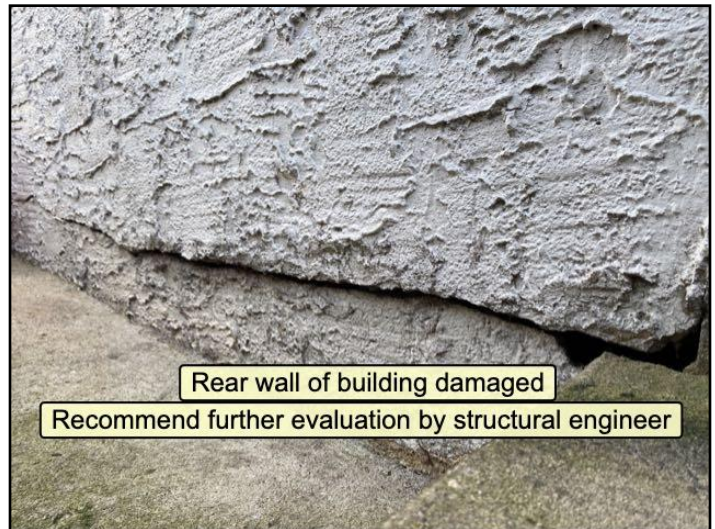
*Bowed, bulging or leaning*

Recommend licensed contractor and / or structural engineer to further evaluate and provide estimate for repair as needed.

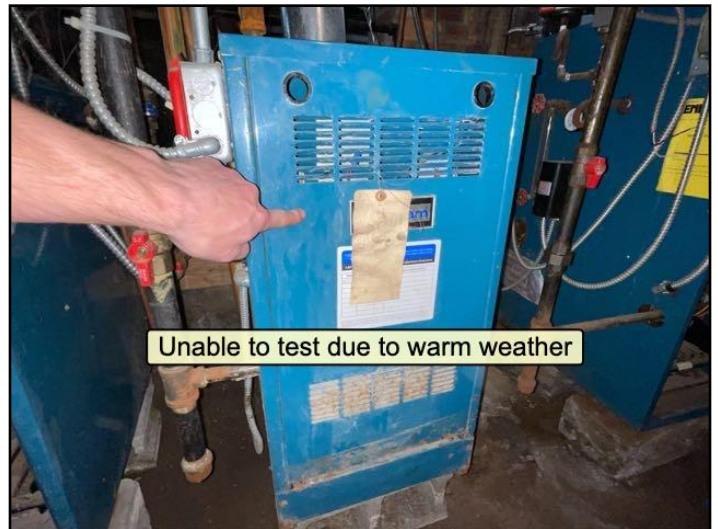
Unable to test due to warm weather

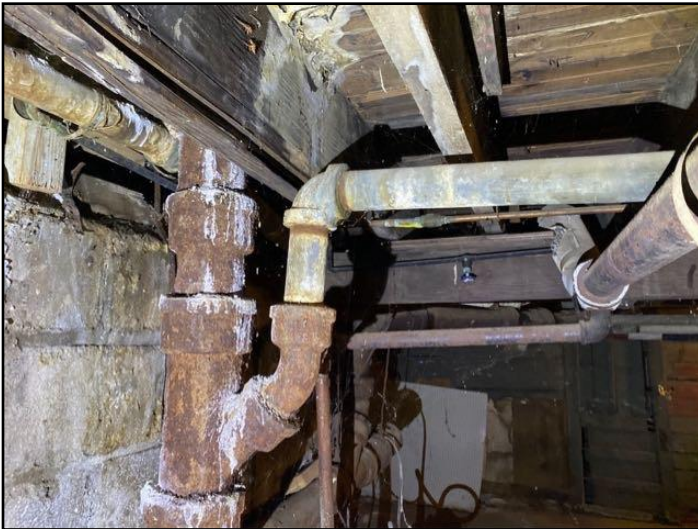
**39. Condition:** • [Split, rusted or damaged](#)

*Split, rusted or damaged*

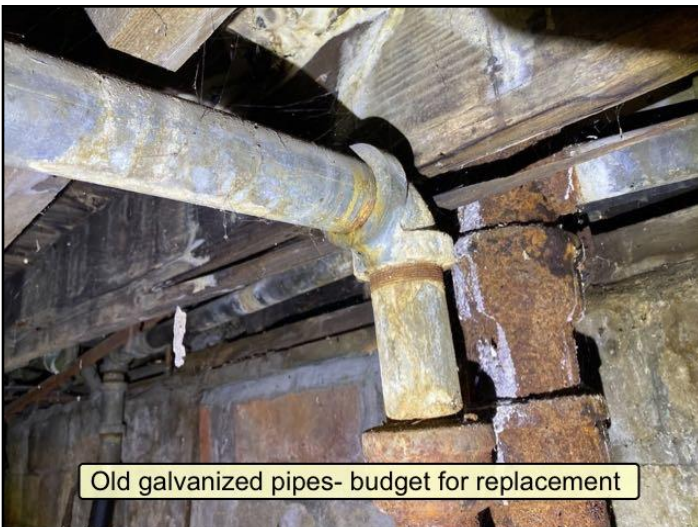
**40. Condition:** • Old galvanized pipes rust from inside out. Budget for replacement during renovations  
Budget for replacement of old galvanized plumbing in the near future. Recommend getting an estimate for replacement by a licensed plumber prior to purchase.

*Old galvanized pipes rust from inside out....*

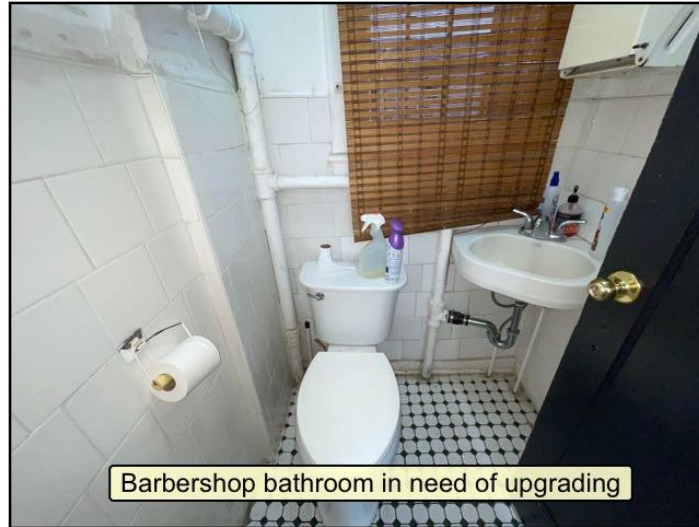
**44. Condition:** • Bathroom in need of upgrading. Recommend replacing old pipe/drains and upgrade electric. Insulate exterior walls.

*Bathroom in need of upgrading. Recommend...*

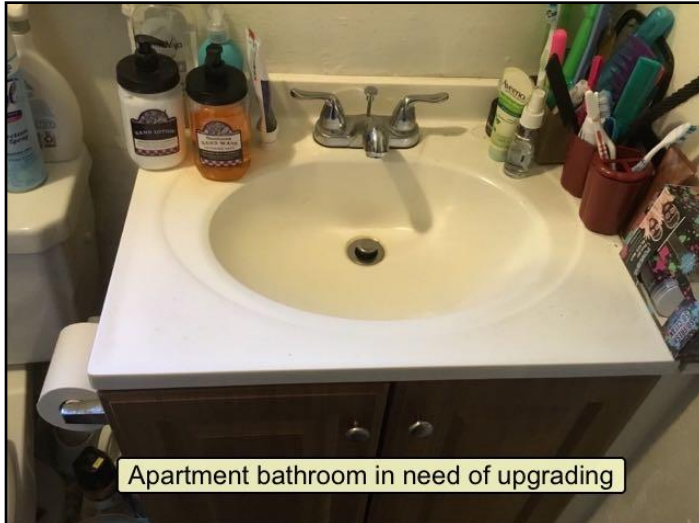
**45. Condition:** • Bathroom in need of upgrading. Recommend replacing old pipe/drains and upgrade electric. Insulate exterior walls.

*Bathroom in need of upgrading. Recommend...*
