# INSPECTION REPORT

***New York City Brownstone Apartments  
145 Heritage Place  
New York, NY 10024***

**Prepared by:** East Coast Commercial Inspections  
**Prepared for:** Julian Perez  
**Inspection:** April 20, 2026  
**Date of Report:** April 22, 2026

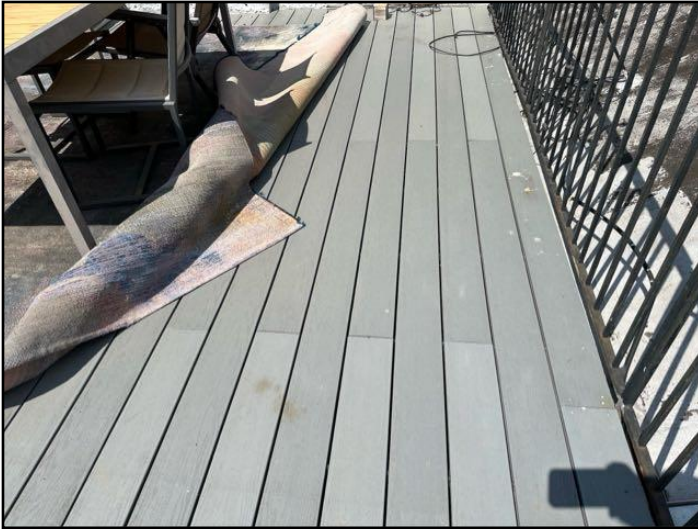
Deck covering roof

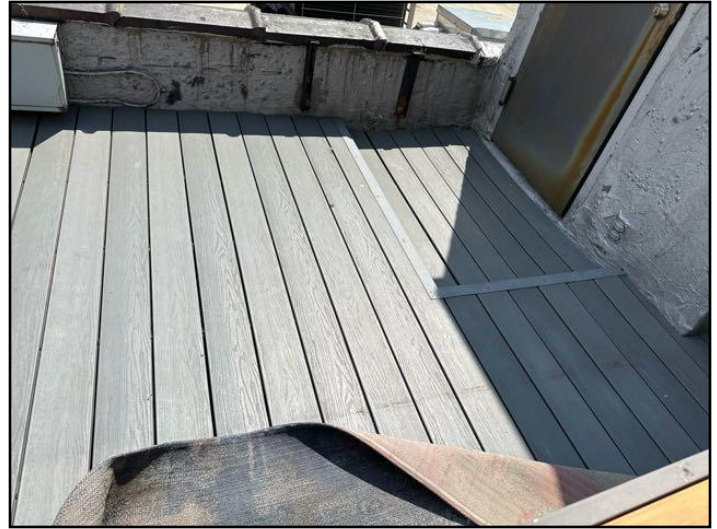
Deck covering roof

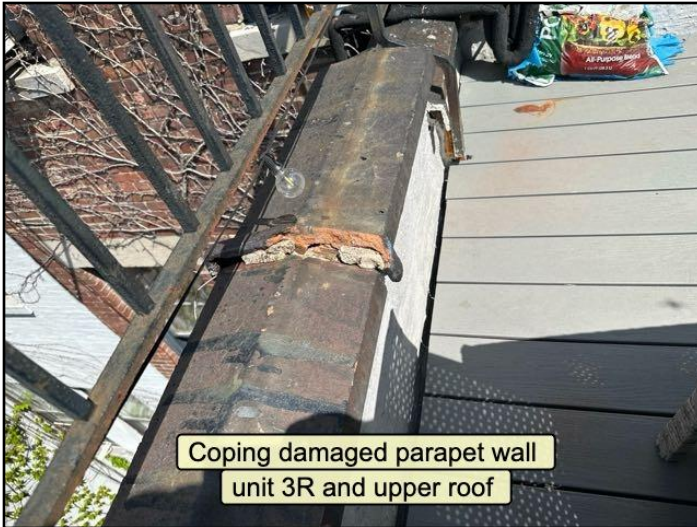
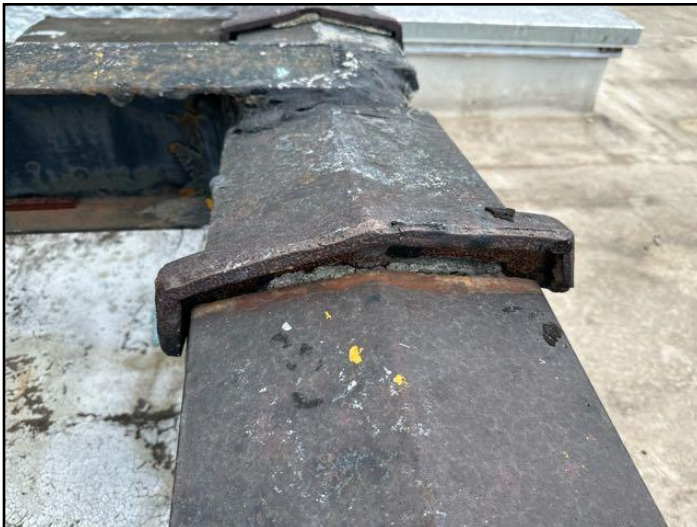
**20. Condition:** • Parapet wall coping damaged

Parapet wall coping damaged

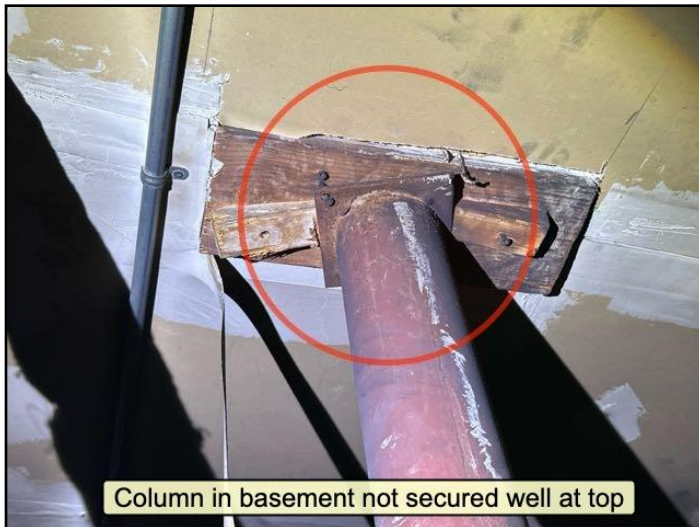
Poorly secured at top or bottom

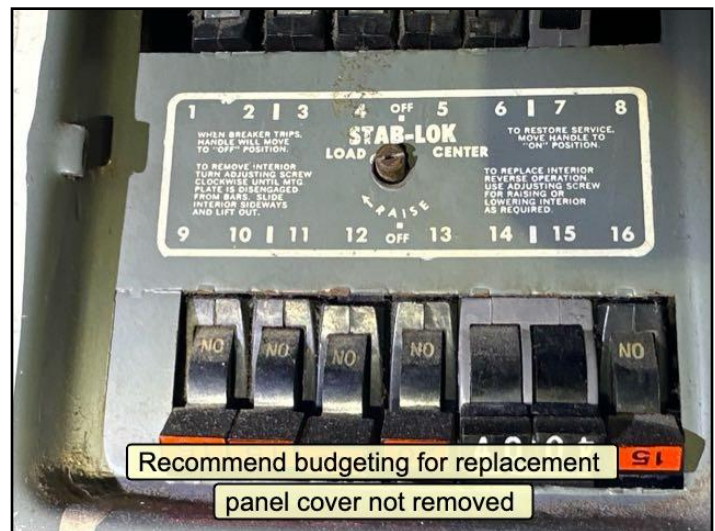
#### 23. Condition: • Old Stab-Lock panel and breakers

Stab-Lok circuit breakers - particularly those manufactured by Federal Pacific Electric - have been noted as a serious safety hazard in homes. Stab-Lok circuit breakers are dangerous because they do not function properly as circuit breakers. The circuit "breaker," which is the switch that is supposed to flip and interrupt current flow when an issue is detected, does not function properly in these panels.. The circuit breakers are not effective for addressing issues like overloaded circuits and short circuits. Because the breakers may not trip when an issue is detected, this can damage home electrical systems, and even increase the risk of an electrical fire.

Old Stab-Lock panel and breakers

**Task:** Replace

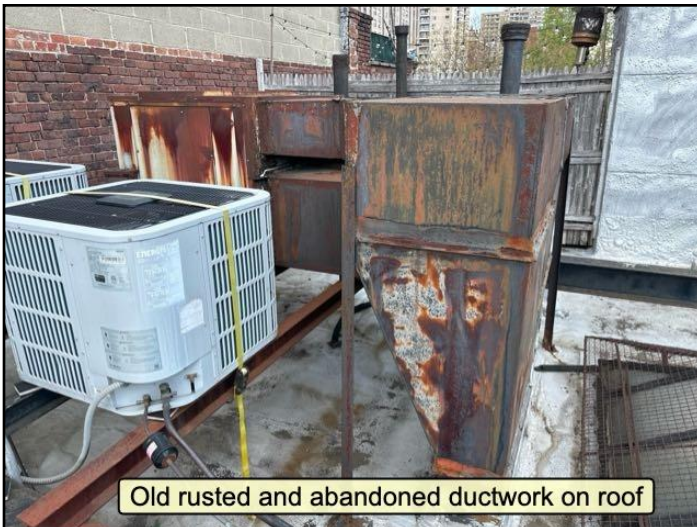
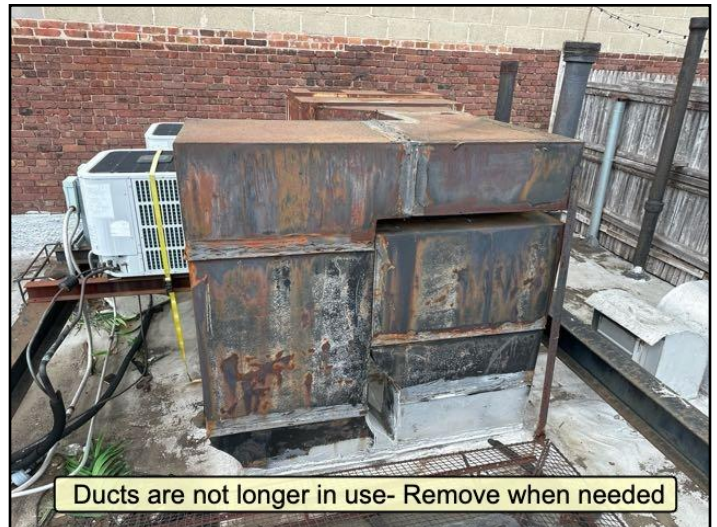
**45. Condition:** • Older uninsulated ducts

Older uninsulated ducts

**Task:** Remove

**Time:** As needed

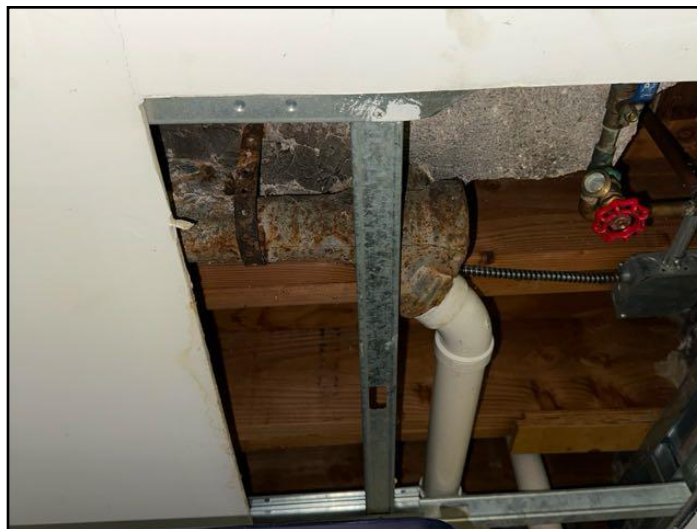
Old galvanized drains

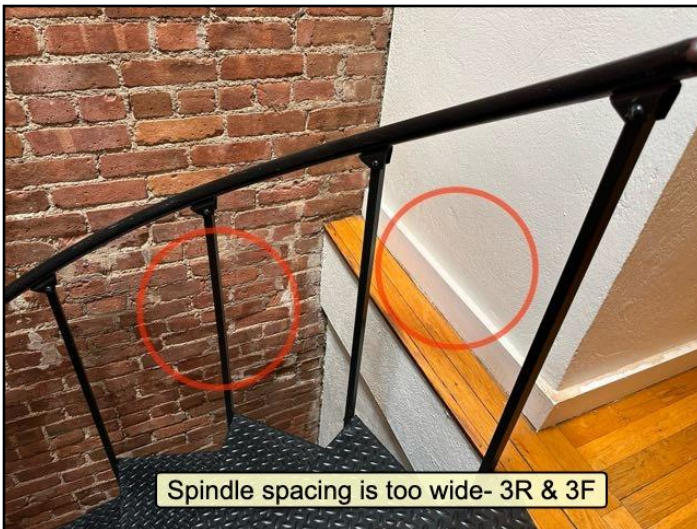
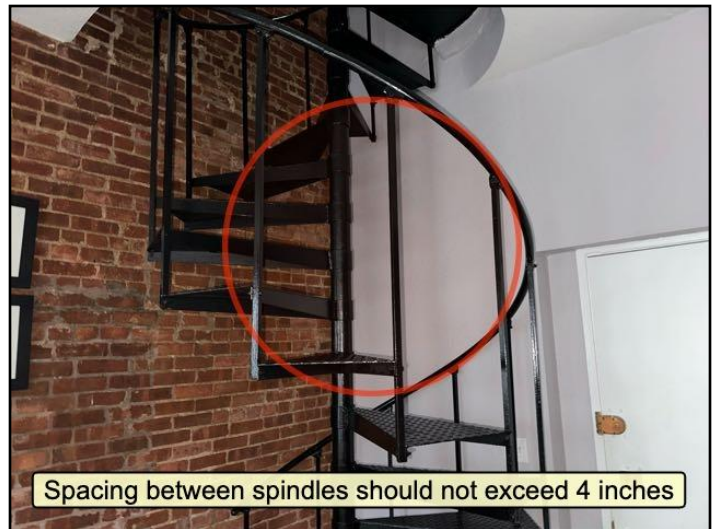
**63. Condition:** • Handrails too wide

Handrails too wide

**Task:** Improve

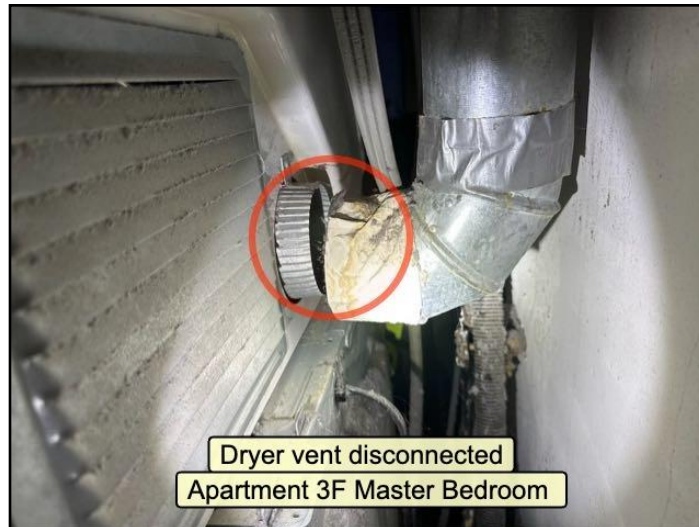
**67. Condition:** • Dryer vent disconnected

**Implication(s):** Chance of damage to finishes and structure | Equipment not operating properly | Fire hazard | Odors, molds, etc.

*Dryer vent disconnected*

**Task:** Improve
