# INSPECTION REPORT

For the Property at:  
**FARMINGDALE, NY 11735**

Inspection Date: Wednesday, December 28, 2022

Prepared by:  
**East Coast Commercial Property Inspections, LLC**

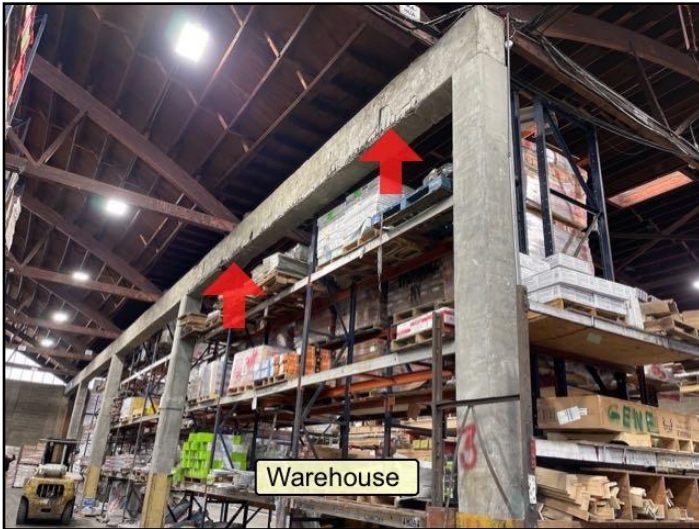
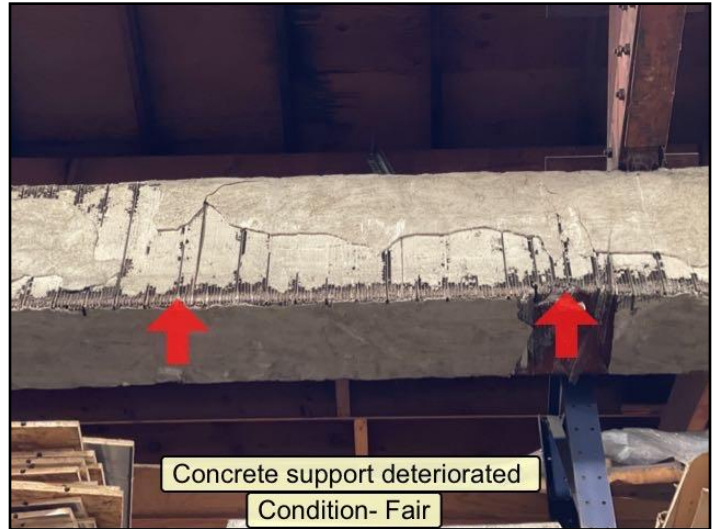
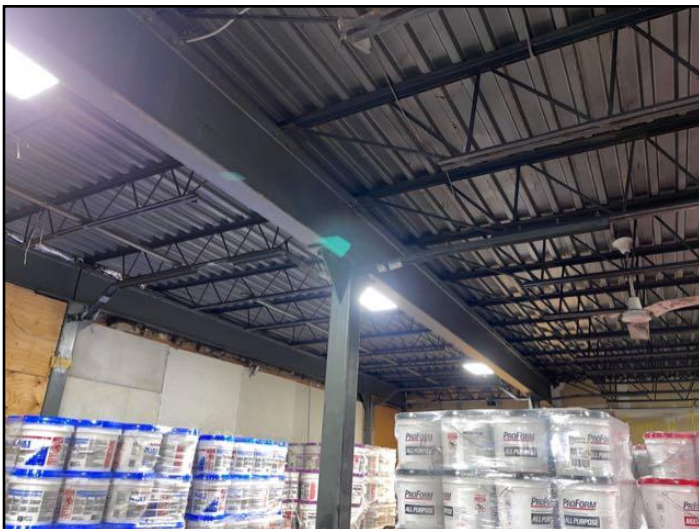
- General view of structure
- Concrete supports deteriorated
