# INSPECTION REPORT

For the Property at:  
**ISLANDIA, NY 11749**

Inspection Date: Tuesday, July 30, 2024

Report No. 1046

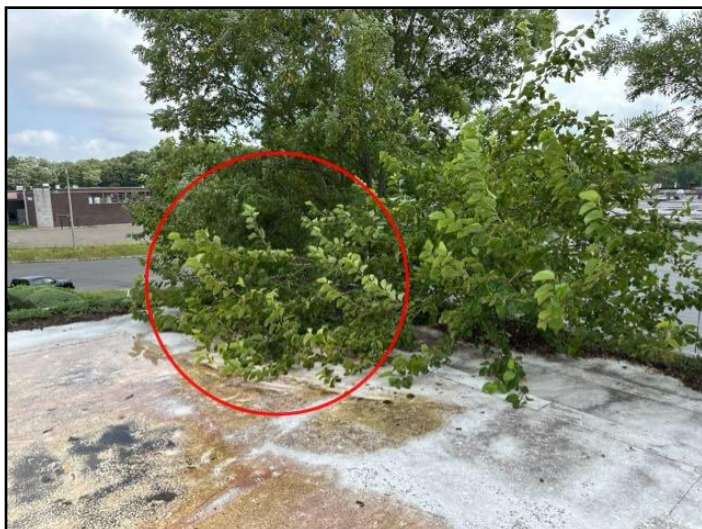
### 3. Condition: • [Tree branches touching roof](#)

Tree branches touching roof

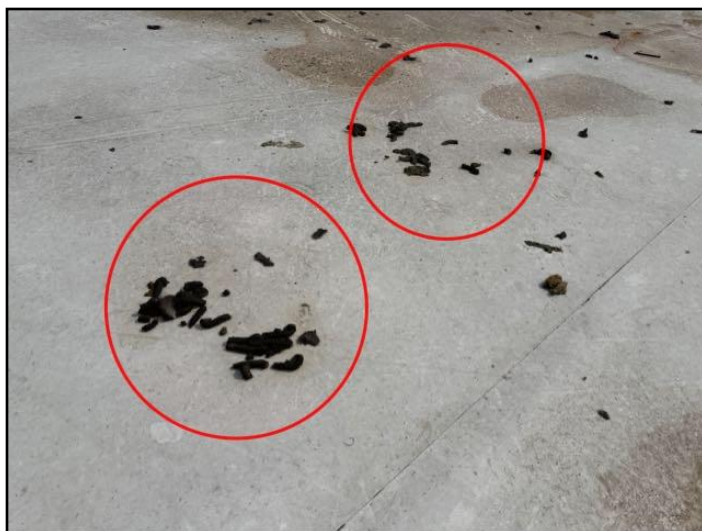
## 4. Condition: • [Debris/oil on roof](#)

Debris/oil on roof

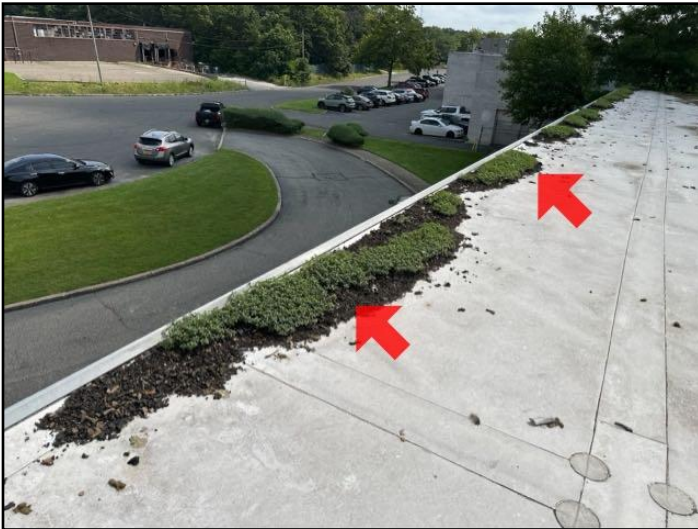
Debris/oil on roof

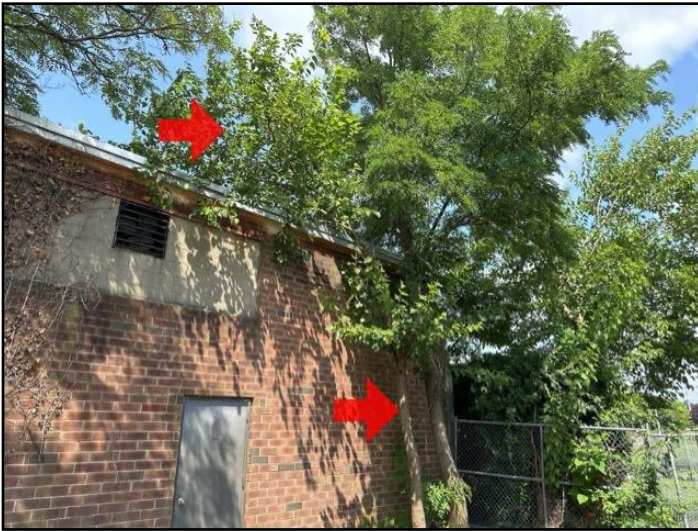
12. Condition: • [Trees or shrubs too close to building](#)

Implication(s): Chance of water damage to structure, finishes and contents | Chance of pests entering building | Material deterioration

*Trees or shrubs too close to building*
