# INSPECTION REPORT

***For the Property at:  
1477 Middletown Road  
LAKE GROVE, NY 11755***

**Prepared by:** East Coast Commercial Inspections

**Date of Inspection:** January 28, 2026

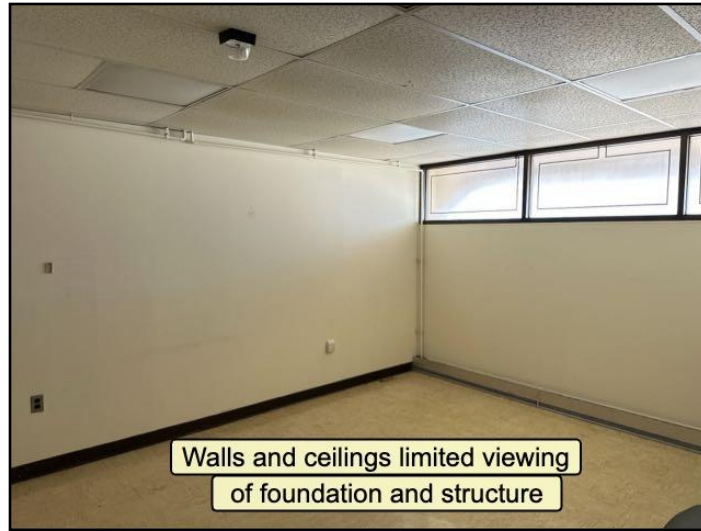
*Basement finished walls and ceilings*

- Finished living space unable to do a visual inspection.
- Ceiling, wall and floor coverings
- Carpet/furnishings

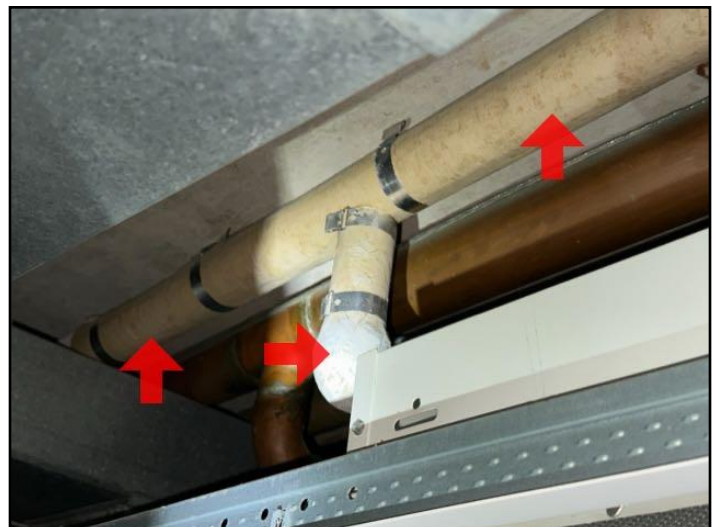
### **42. Condition:** • Possible asbestos containing materials

Asbestos is a fibrous material that was used in many building materials as a fire resistant material, a binder, and a thermal insulator. The very small asbestos fibers can cause cancer and other types of lung disease if inhaled. Demolition or renovation work can disturb asbestos-containing materials, causing the asbestos fibers to be released into the air. Various heating pipes have possible asbestos contain material. Corrective actions related to asbestos should not be undertaken by the property owner, as a general rule. Recommend further evaluation by a licensed environmental specialist company to provide cost of removal.

**Implication(s):** Health hazard

*Possible asbestos containing materials*
