# INSPECTION REPORT

For the Property at:  
**PORT WASHINGTON, NY 11050**

Inspection Date: Wednesday, May 29, 2024

Prepared by:  
**East Coast Commercial Property Inspections, LLC**

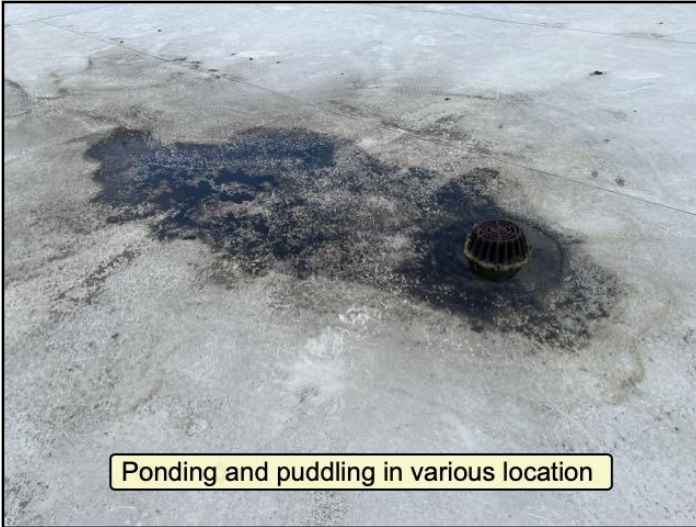
**Flat roofing material:** • RUBBER ROOF EPDM -PONDING AND PUDDLE ARE DRAIN

Ponding and puddling in various location

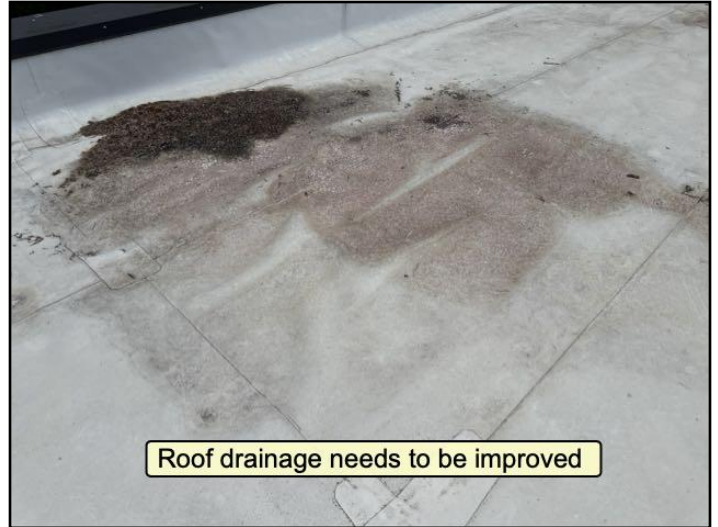
Roof drainage needs to be improved

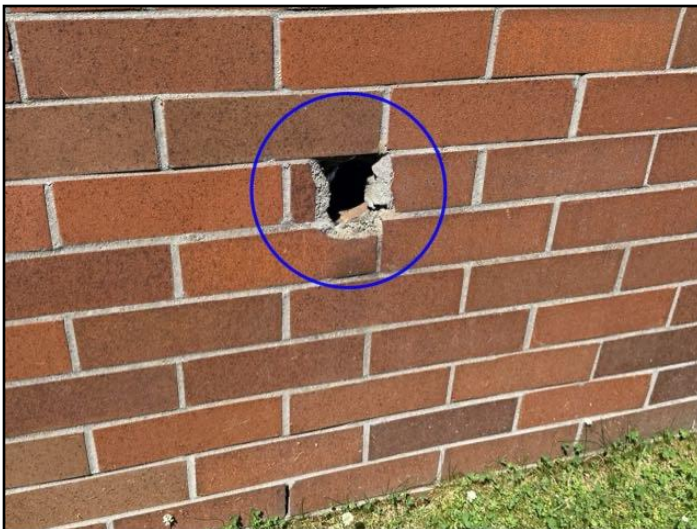
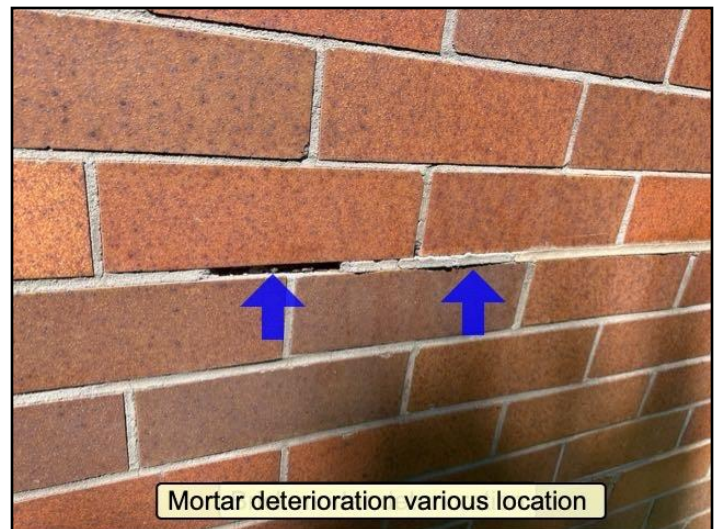
Location: EAST

5. Condition: • [Mortar deterioration](#)

Implication(s): Chance of water entering building | Weakened structure | Chance of structural movement

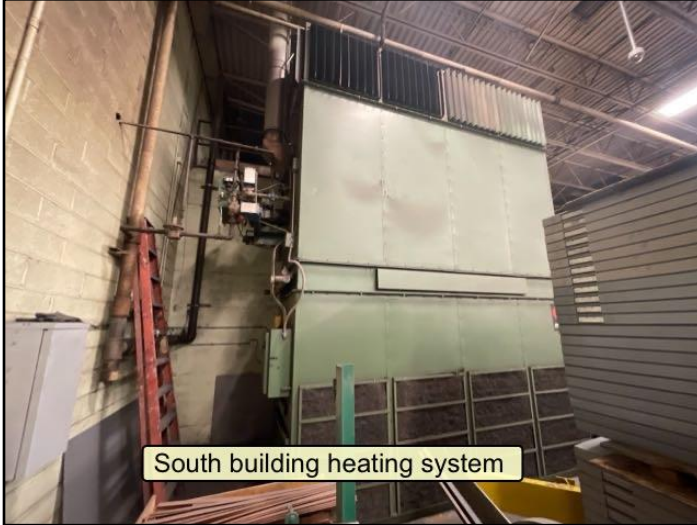
South building heating system

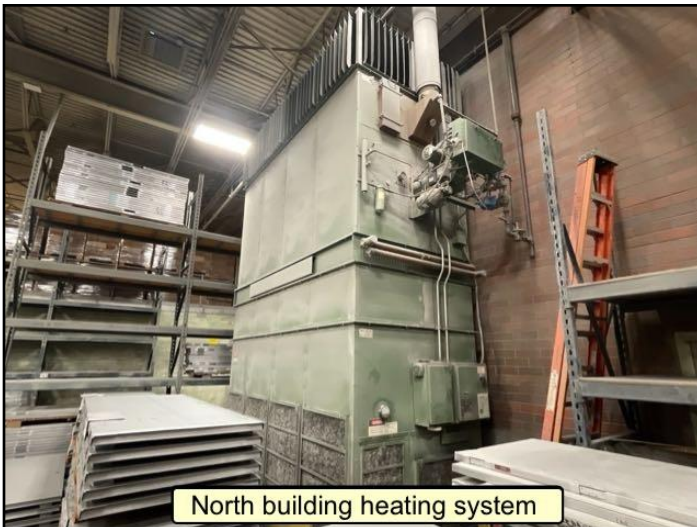
North building heating system

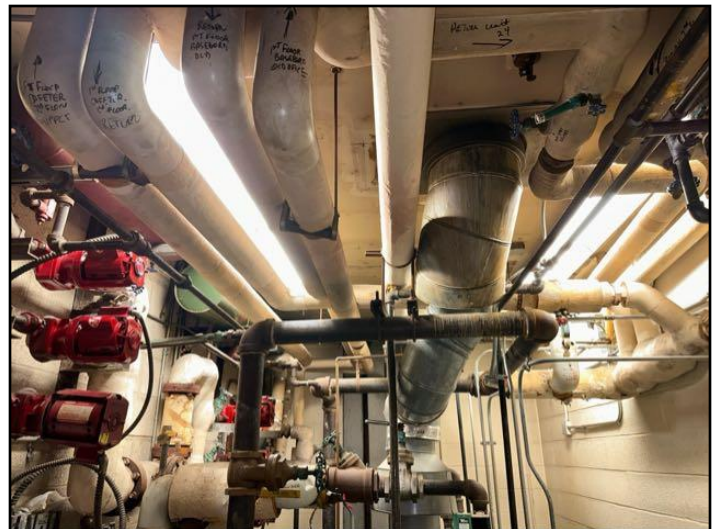
Boiler room

**General:** • BOILER ROOM

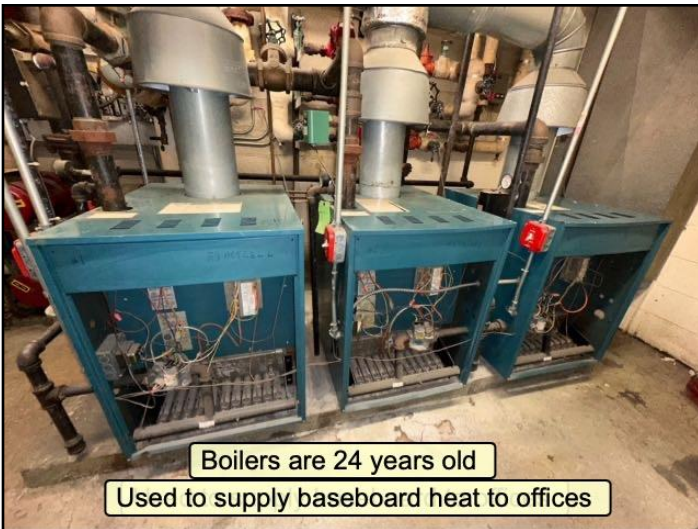
Burnham

Boilers are 24 years old

Used to supply baseboard heat to offices
