# INSPECTION REPORT

***For the Property at:  
19 Laurel Ave  
HEMPSTEAD, NY 11550***

**Prepared by:** East Coast Commercial Inspections

**Date of Inspection:** March 15, 2026

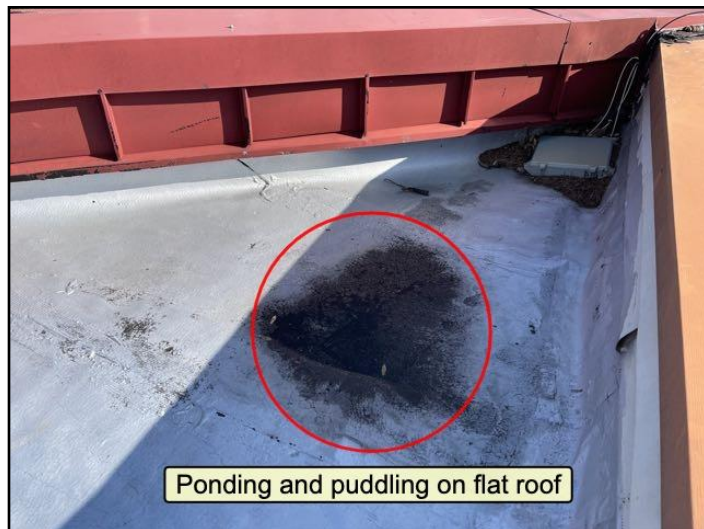
Recommend licensed roofing contractor provide estimate for repair or replacement of flat roof prior to contract signing

Blisters

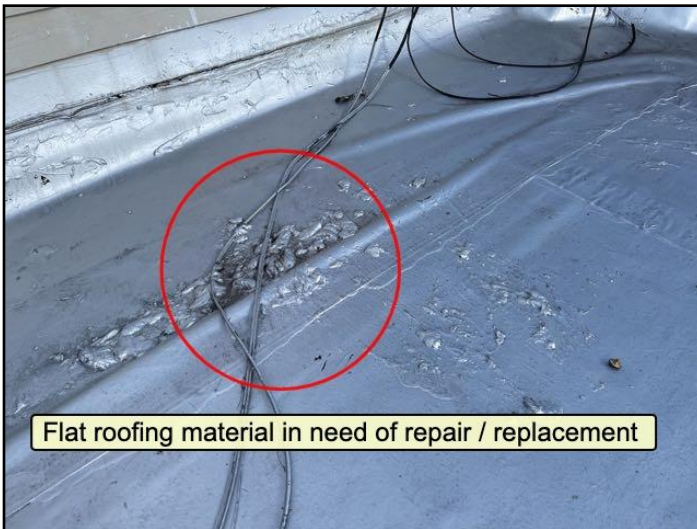
Blisters

Flat roofing material in need of repair / replacement

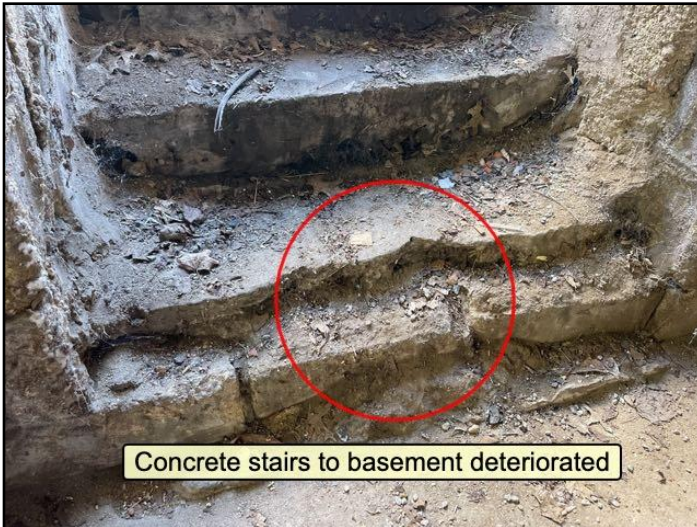
Concrete stairs to basement deteriorated

Masonry or concrete cracking

Recommend getting an estimate from a mason to properly repair front and rear steps to basement

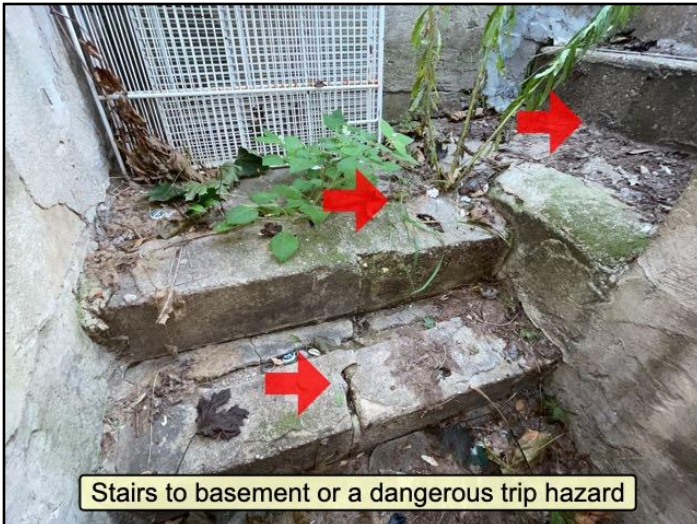
Stairs to basement or a dangerous trip hazard

Masonry or concrete cracking

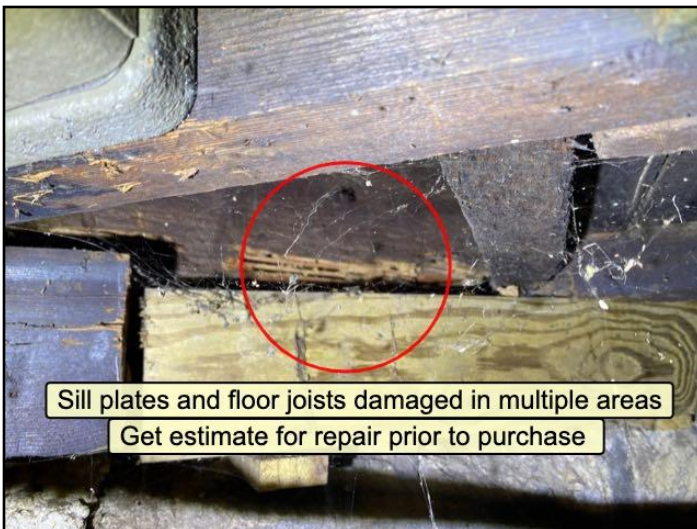
Termite damage to sill plates and rim joists in basement. Recommend further evaluation by a licensed contractor to determine if any hidden damaged exists. Get estimate for repair prior to purchase.

Termite damage

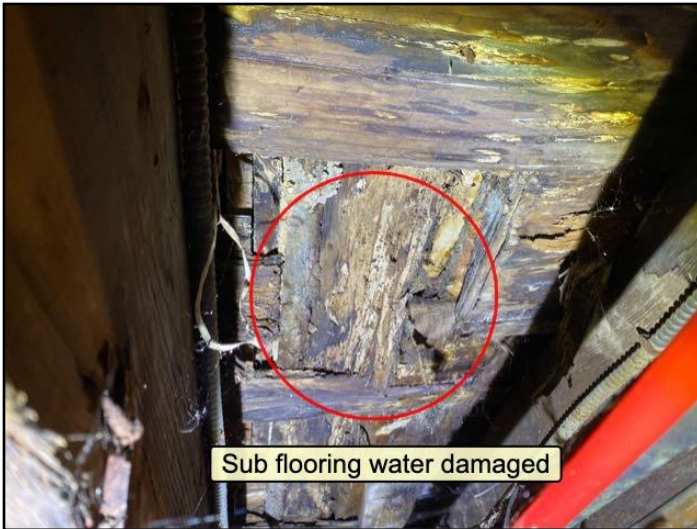
17. Condition: • Damaged

*Damaged*

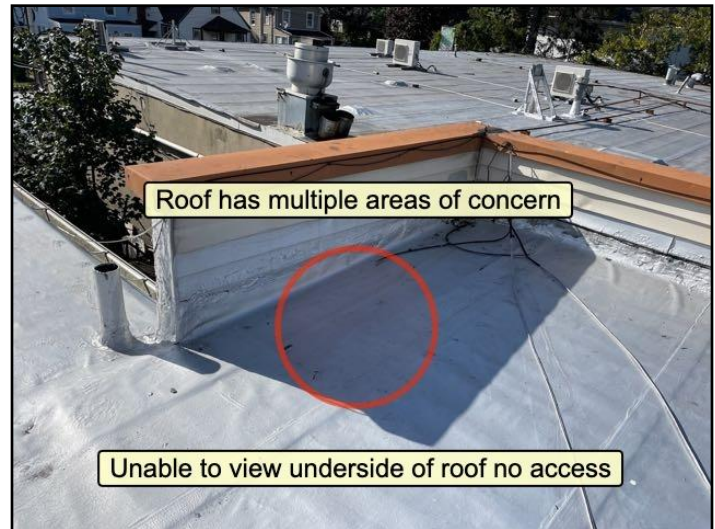
SOFT SPOT

Recommend roofing contractor further evaluate and advise best course of action

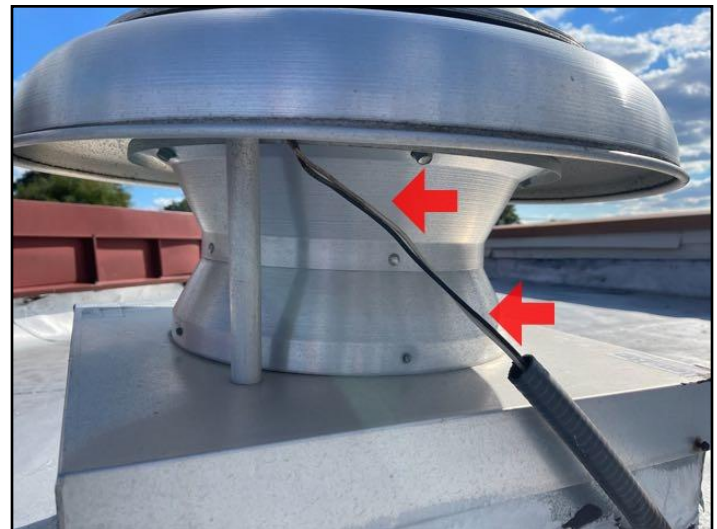
WIRES EXPOSED

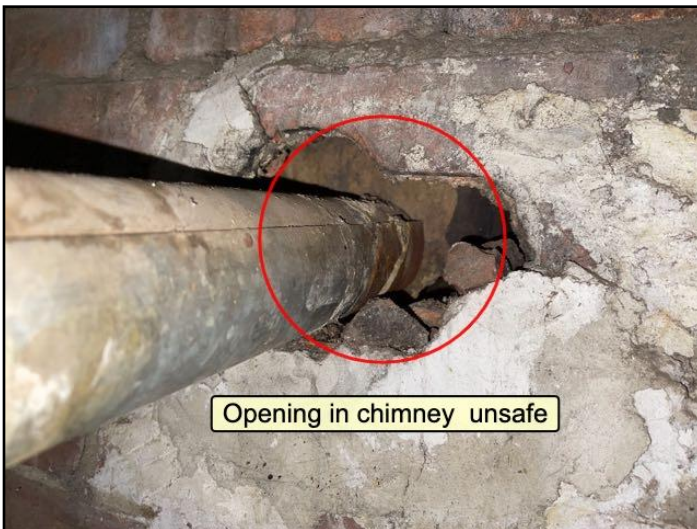
32. Condition: • [Poor connections](#)

Implication(s): Hazardous combustion products entering home

Poor connections

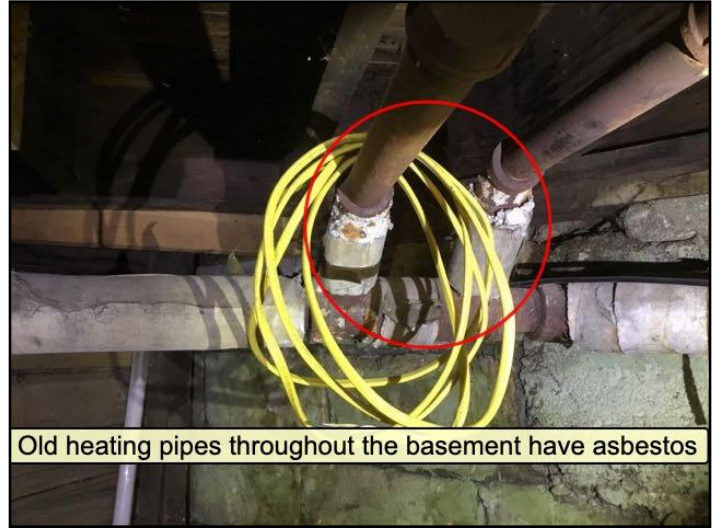
33. Condition: • Old steam pipes may have been insulated with asbestos containing material. Ask home owner for disclosure of insulation removal. Heating pipes behind plaster walls may still have asbestos containing materials. Further evaluation by a Environmental specialists is recommended.

Old steam pipes may have been insulated wit...

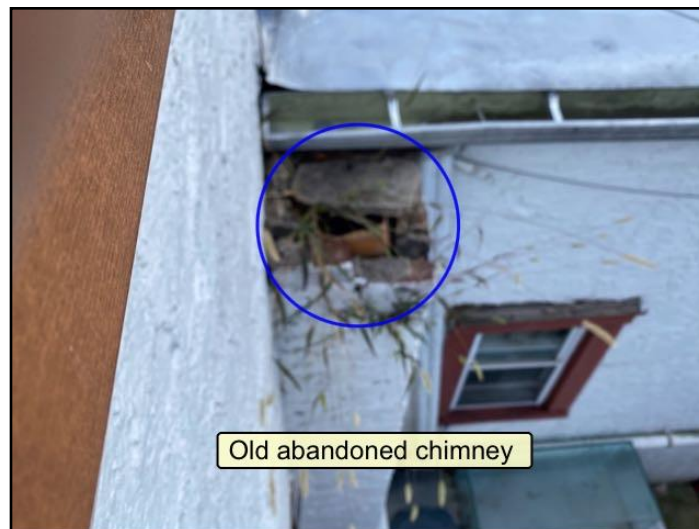
Old abandoned chimney

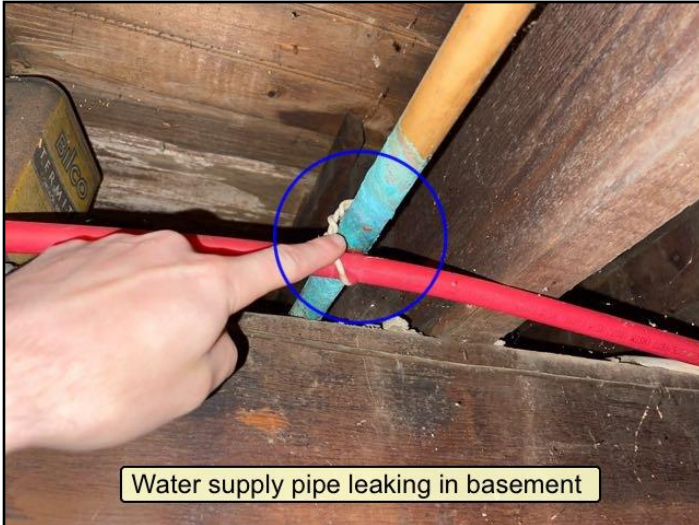
35. Condition: • [Leak](#)

Implication(s): Chance of water damage to structure, finishes and contents | System inoperative

Leak

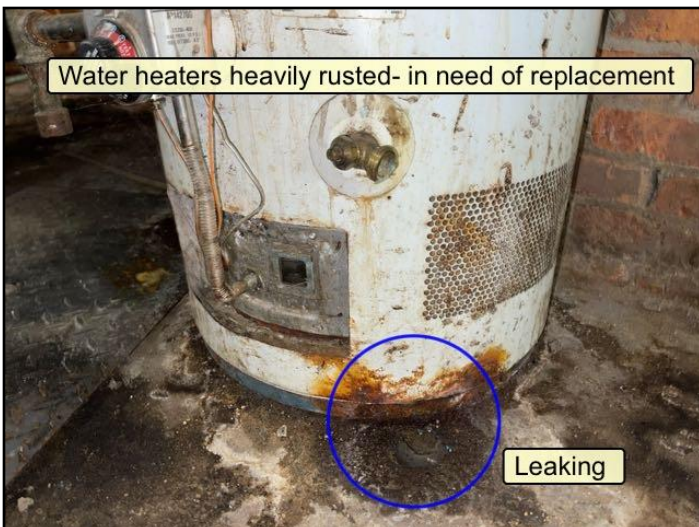
36. Condition: • Rust

Implication(s): System inoperative | No hot water

Rust

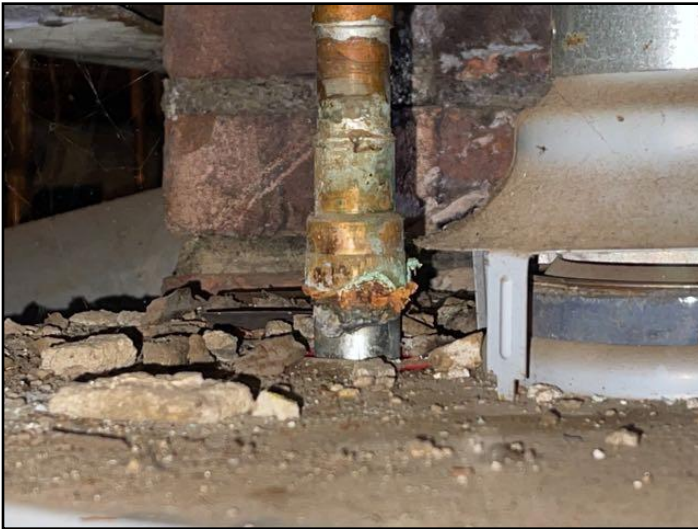
Rust

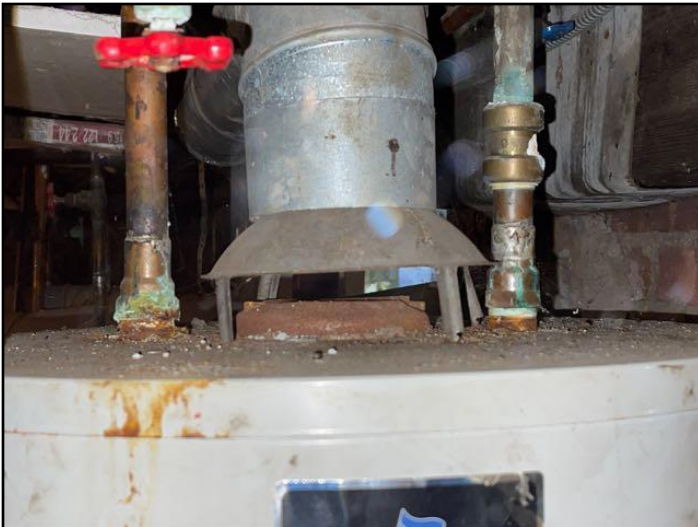
Rust

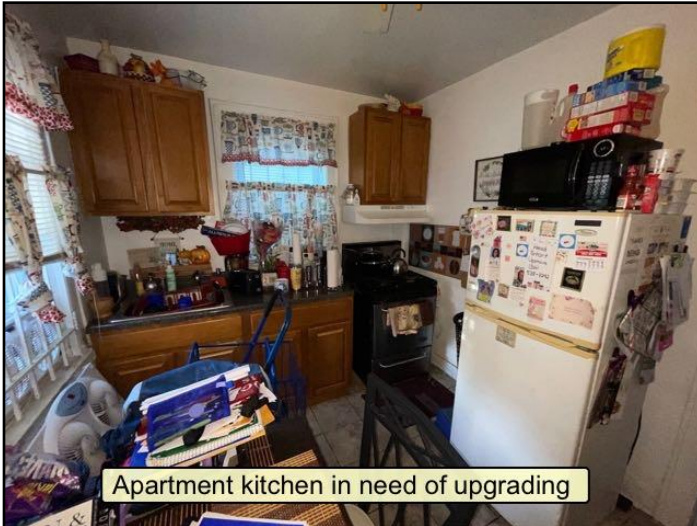
42. Condition: • Kitchen in need of upgrading

*Kitchen in need of upgrading*
