# INSPECTION REPORT

***New York City Brownstone Apartments  
145 Heritage Place  
New York, NY 10024***

**Prepared by:** East Coast Commercial Inspections  
**Prepared for:** Julian Perez  
**Inspection:** April 20, 2026  
**Date of Report:** April 22, 2026

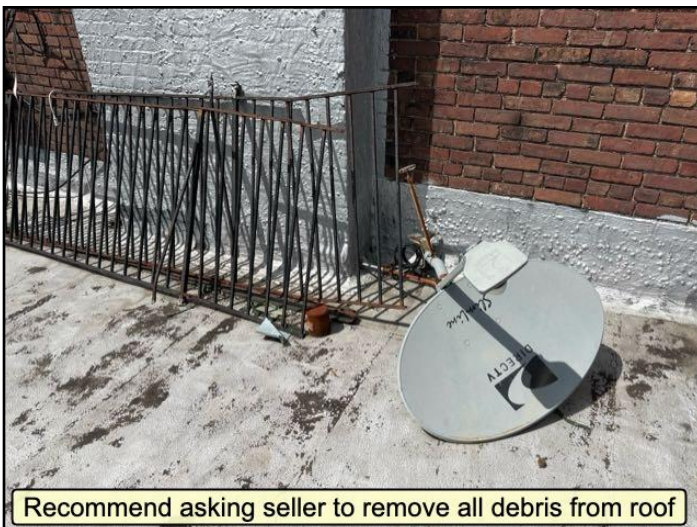
**3. Condition:** • Debris/ Moss

Recommend asking seller to remove all debris from roof

Debris/ Moss

Potential to cause leaks

**Task:** Remove

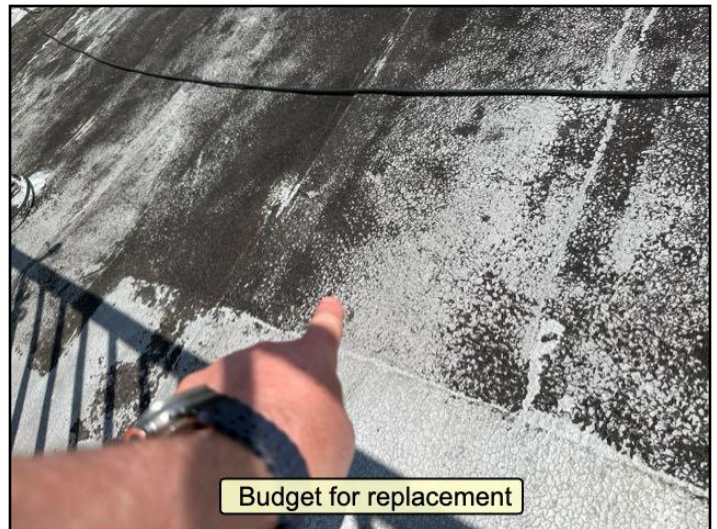
Alligatoring

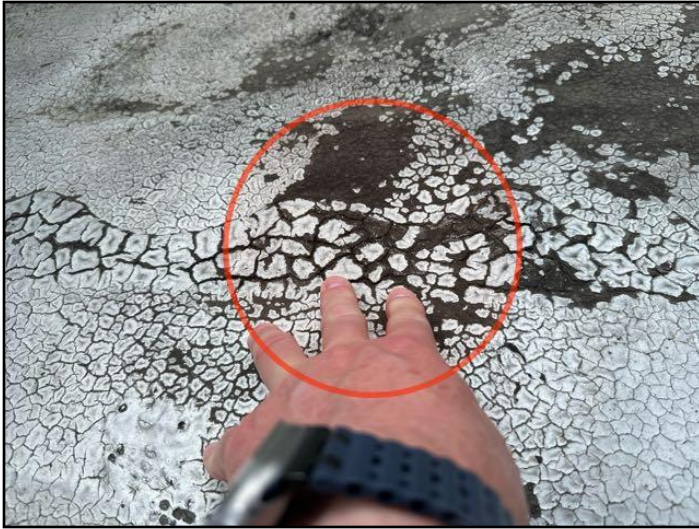
Alligatoring

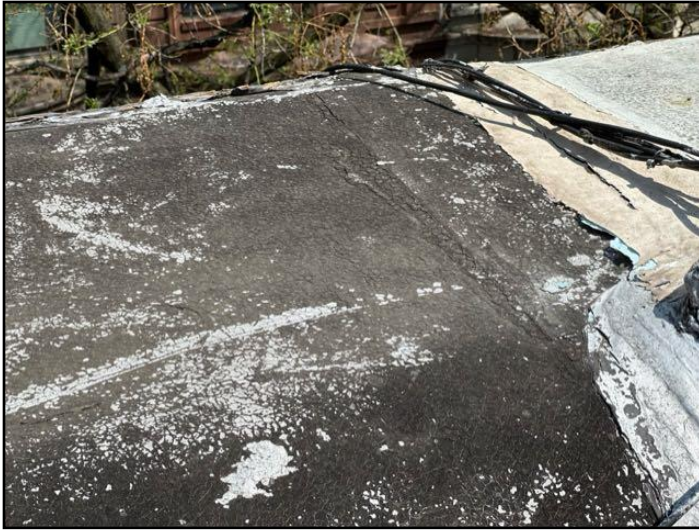
*Past life expectancy*

**Task:** Replace

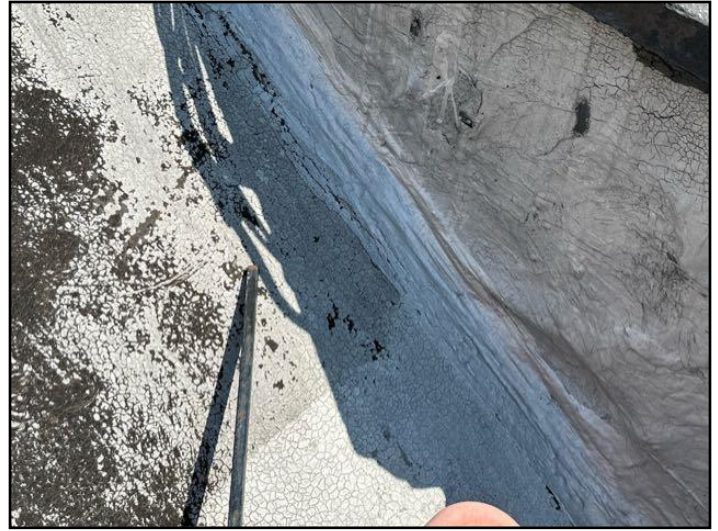
*Past life expectancy*

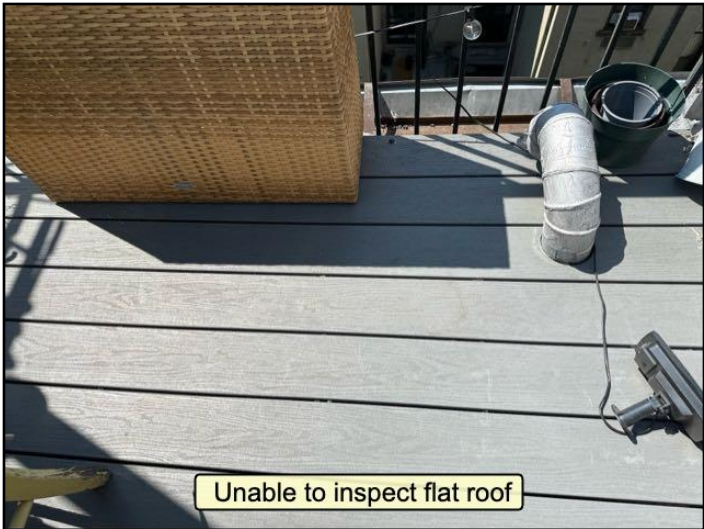
Unable to inspect flat roof

Deck covering roof

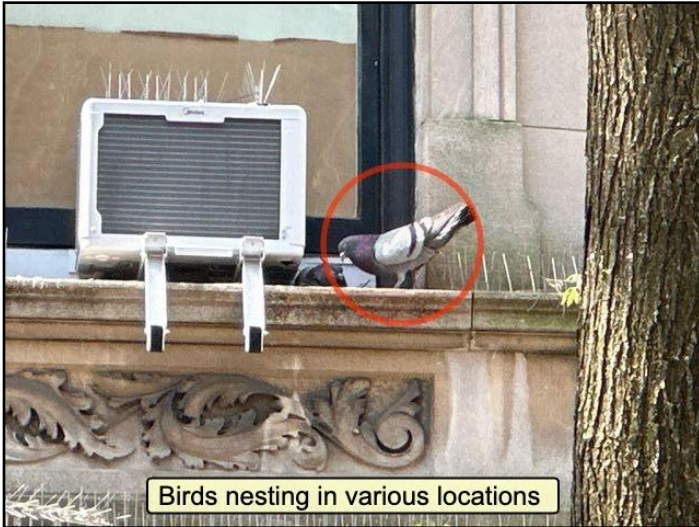
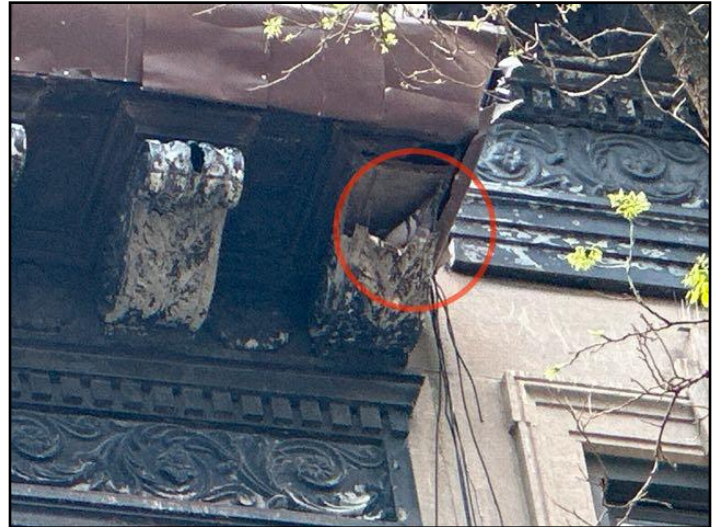
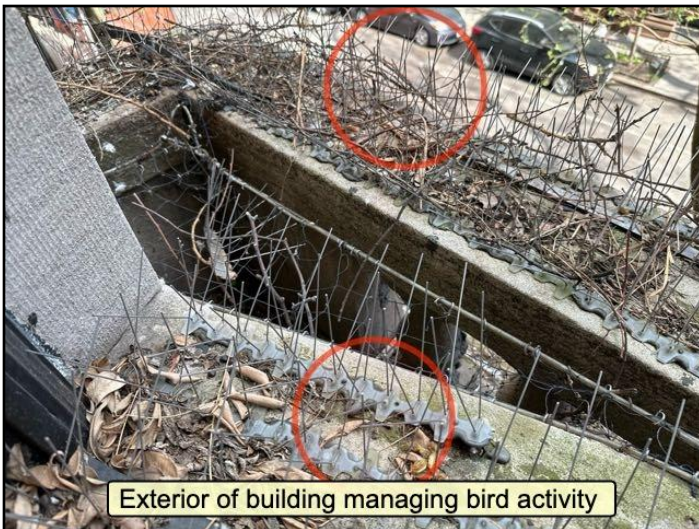
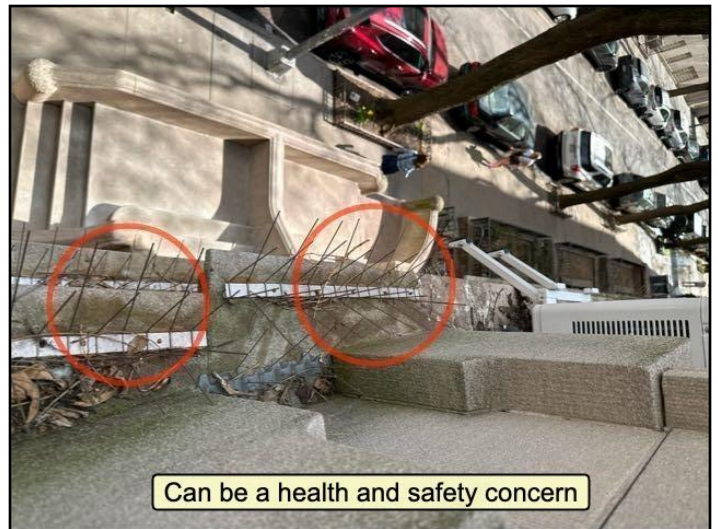
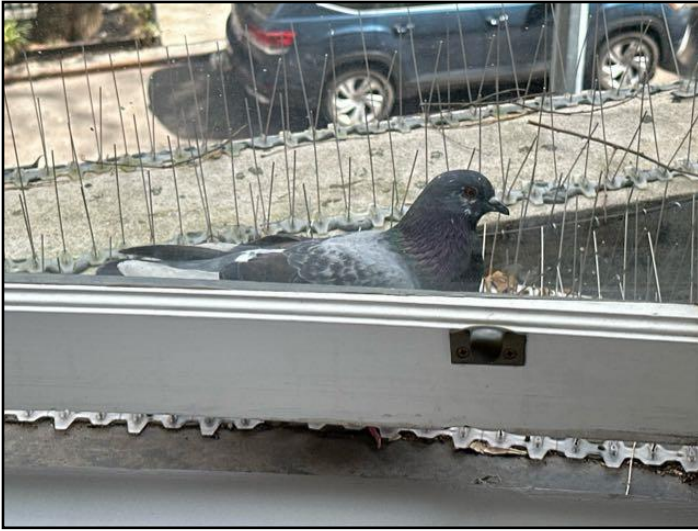
**RECOMMENDATIONS \ General****9. Condition:** • Birds nesting**Location:** Front**Task:** Improve

*Birds nesting*

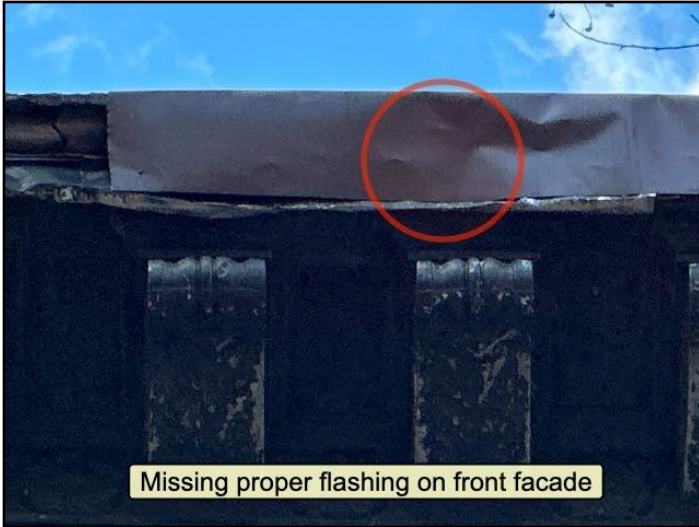
Missing proper flashing on front facade

Flashings missing

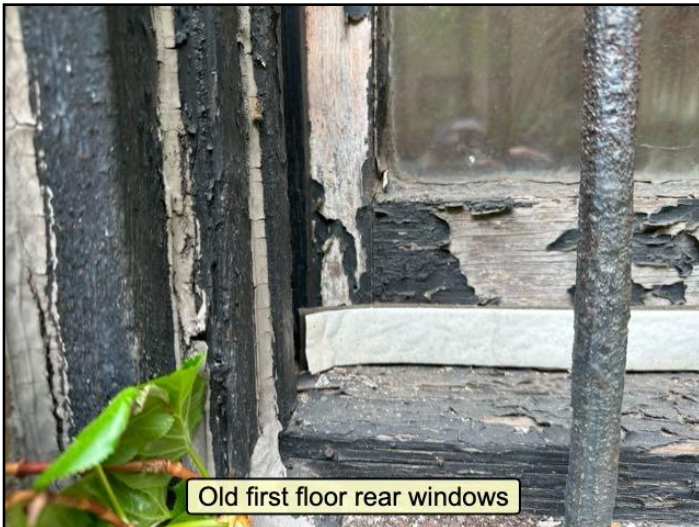
Old first floor rear windows

Old budget for replacement

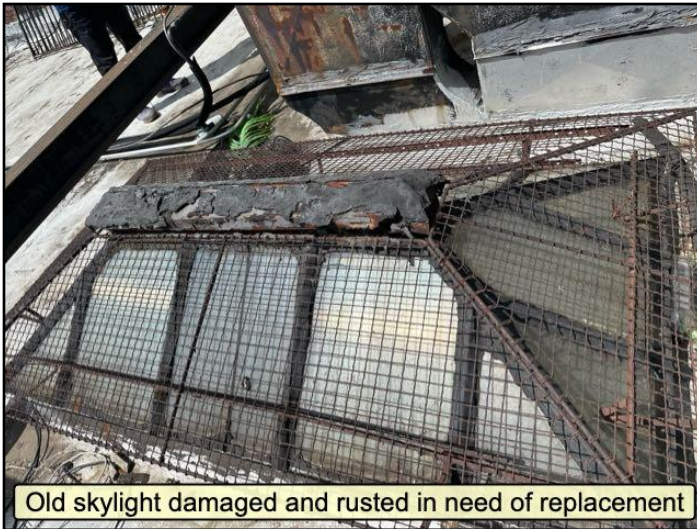
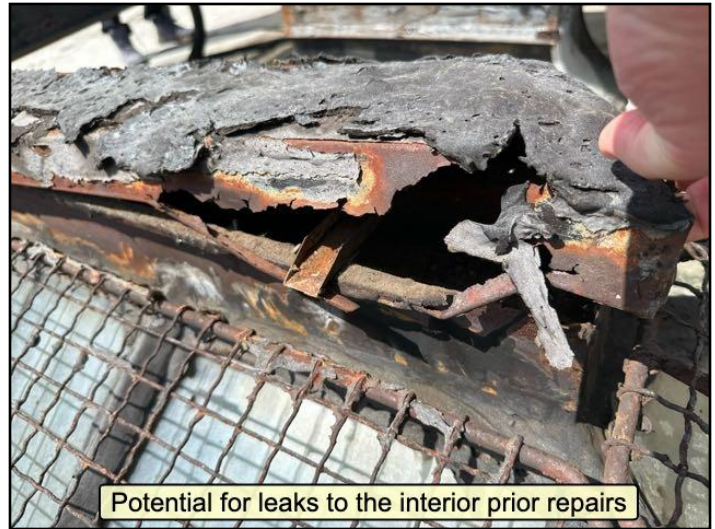
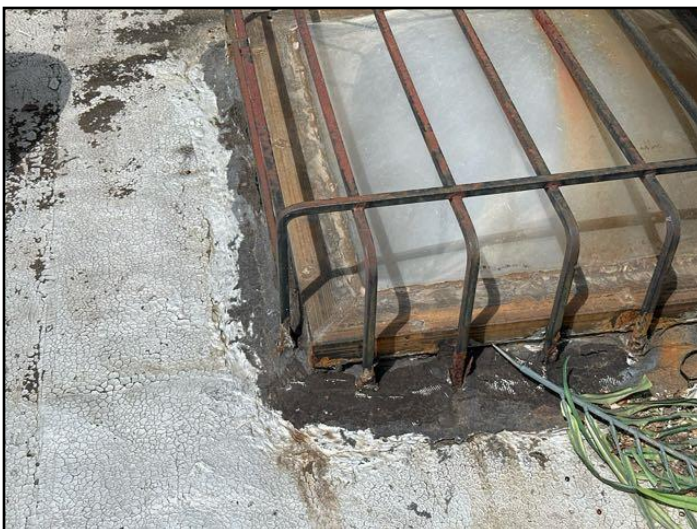
Old

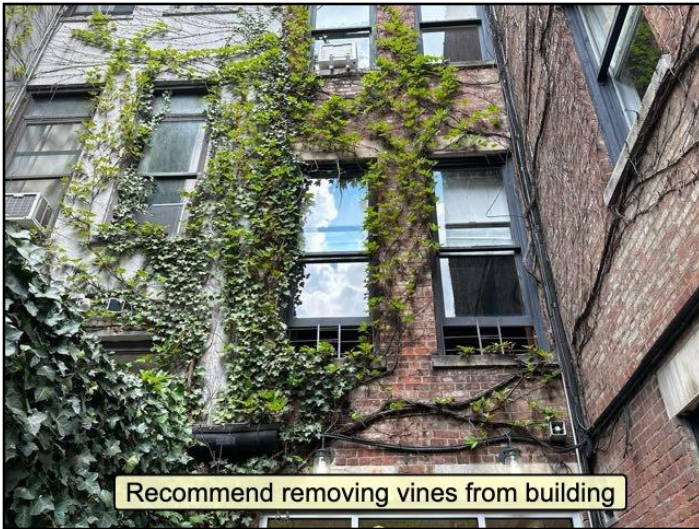
*Vines on building*

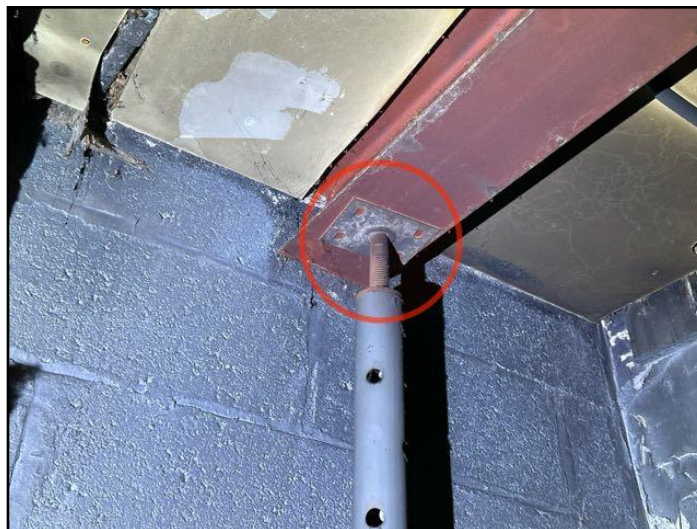
**Condition:** • Temporary support

*Temporary support*

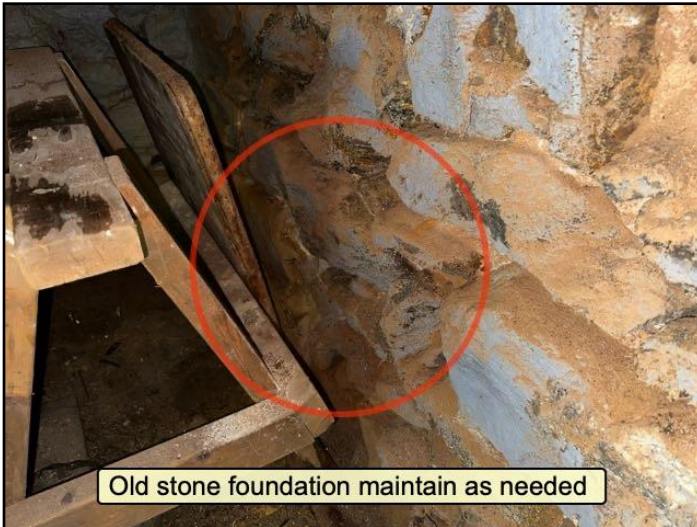
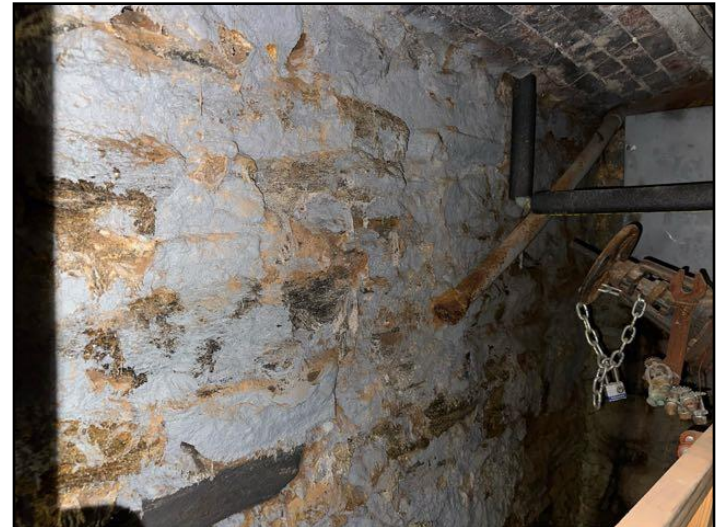
Old Stone foundation - improve as needed

Stone

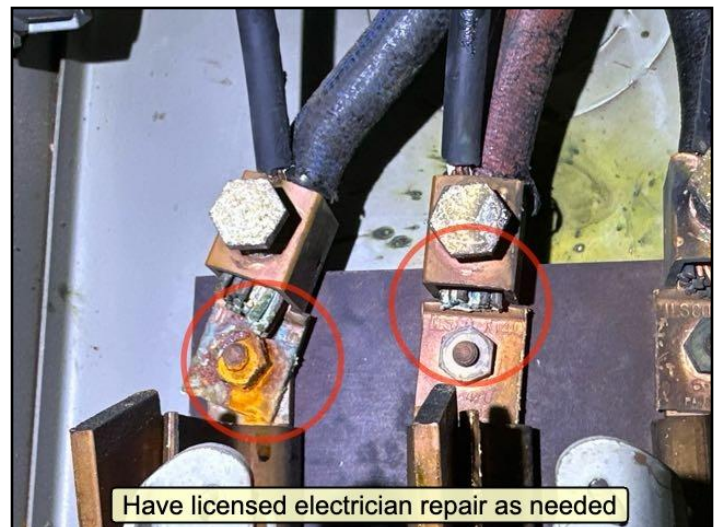
#### 24. Condition: • Oxidation

Oxidation

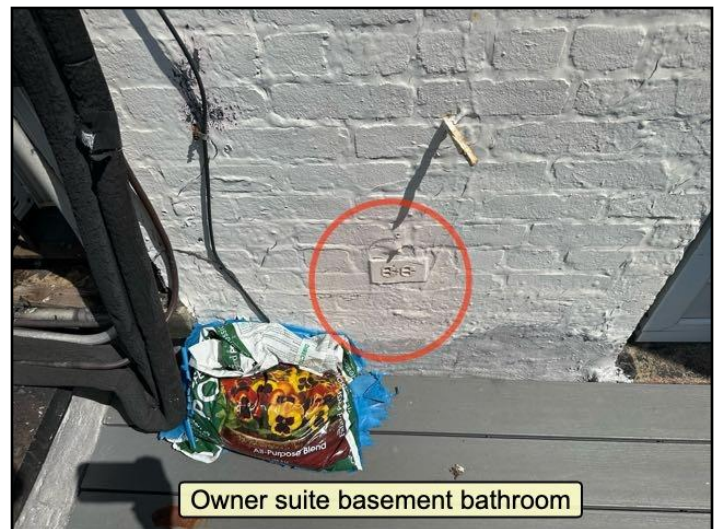
*Exposed***DISTRIBUTION \ Outlets****29. Condition:** • [Inoperative](#)**Implication(s):** Equipment inoperative**Location:** 3R rear deck /Owner suite basement bathroom

*Inoperative*

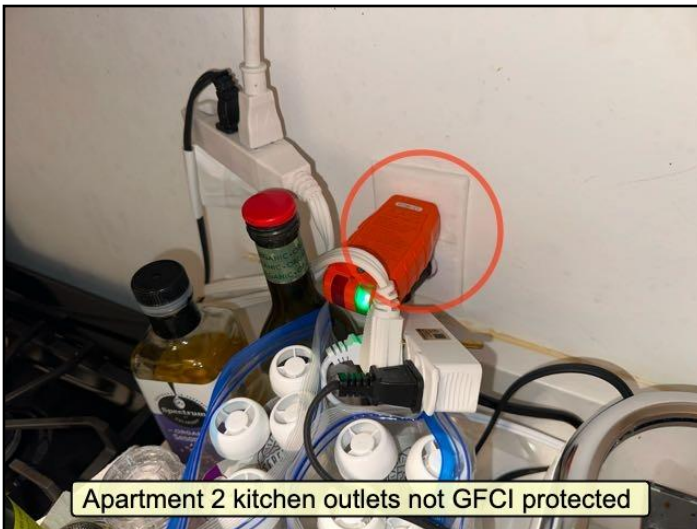
*Ungrounded***32. Condition:** • [No GFCI/GFI \(Ground Fault Circuit Interrupter\)](#)

Apartment 2 kitchen outlets not GFCI protected

No GFCI/GFI (Ground Fault Circuit...

**Task:** Improve

**Time:** As soon as practical

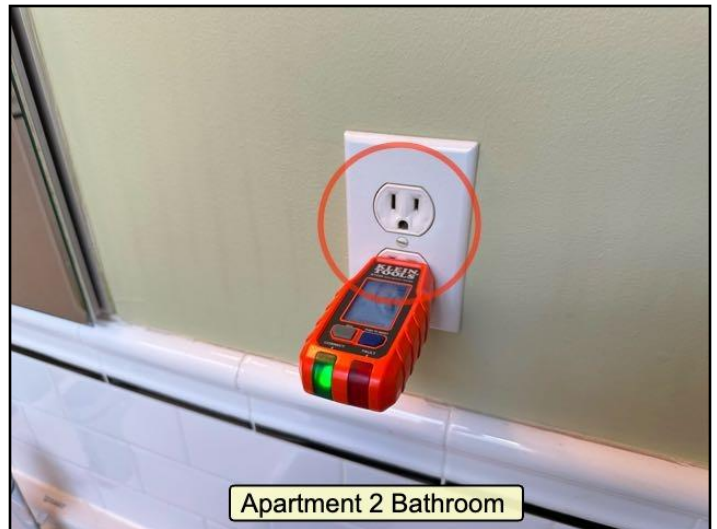
Apartment 2 Bathroom

No GFCI/GFI (Ground Fault Circuit...

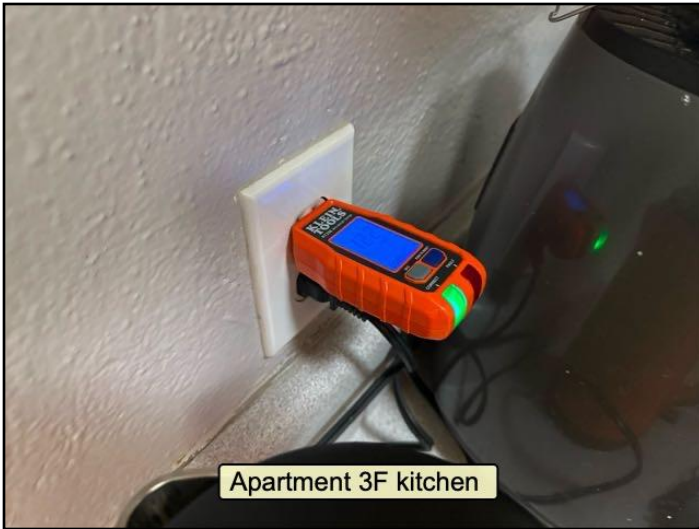
Apartment 3F kitchen

No GFCI/GFI (Ground Fault Circuit...

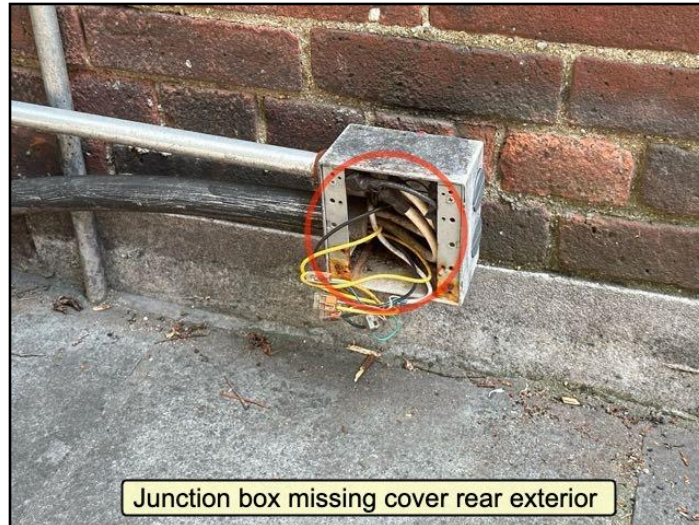
**DISTRIBUTION \ Cover plates****34. Condition:** • [Loose](#)**Implication(s):** Electric shock

*Loose***DISTRIBUTION \ Lights****35. Condition:** • [Inoperative](#)**Implication(s):** Inadequate lighting**Location:** First Floor Rear Bathroom**Task:** Repair or replace

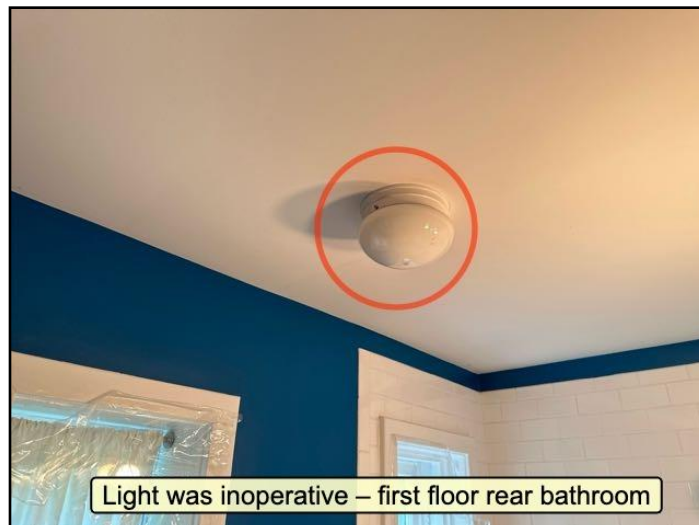
*Inoperative***COMMENTS \ Additional****36. Condition:** • See Home Reference Book located on last page of report for additional information and understanding of the systems in your home.

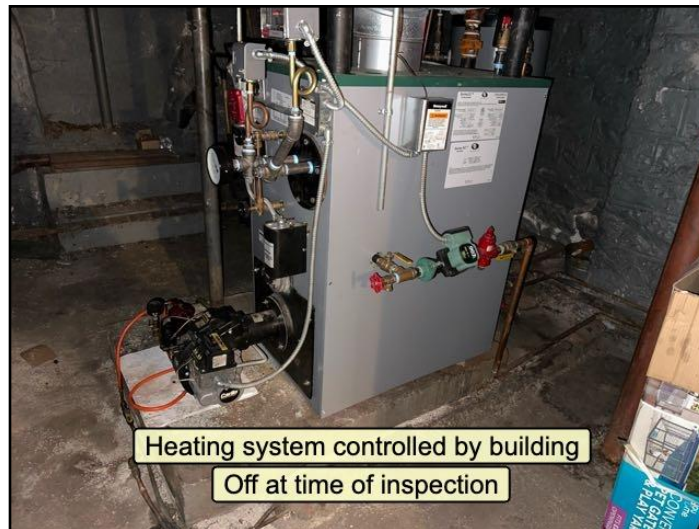
- Heat is controlled by building- Unable to test

*Heat is controlled by building- Unable to...*

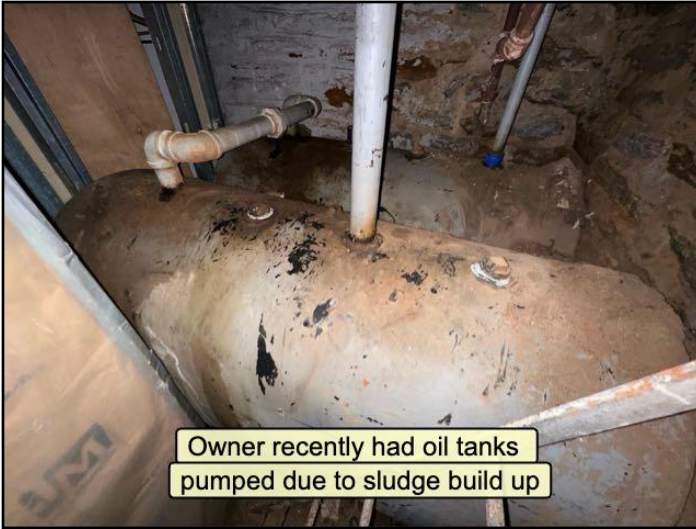
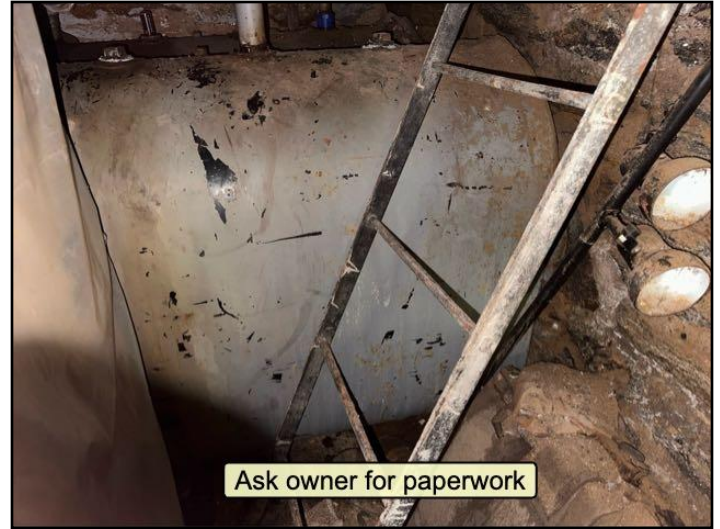
Old

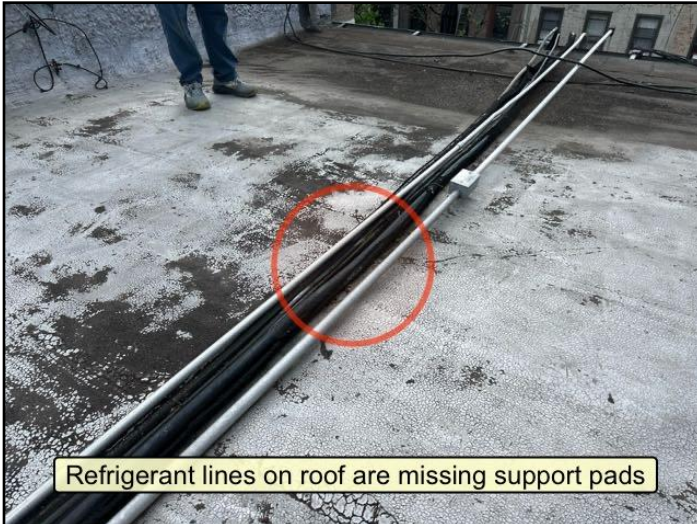
#### 44. Condition: • Refrigerant lines on roof are missing support pads

Missing support

**Task:** Provide

**Time:** As soon as practical

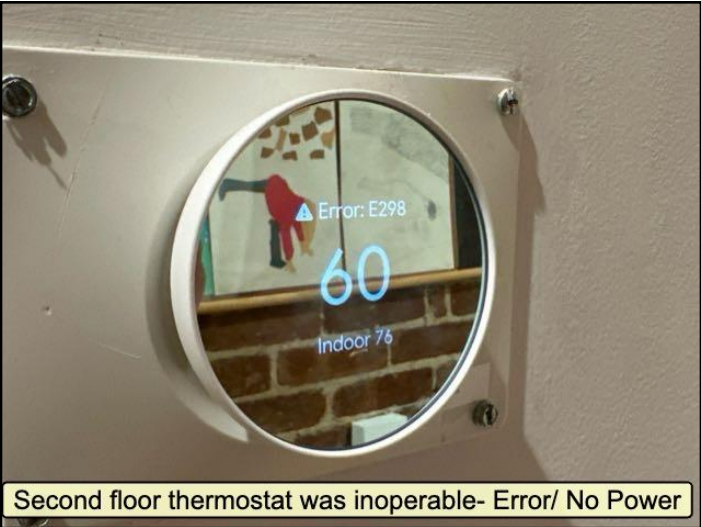
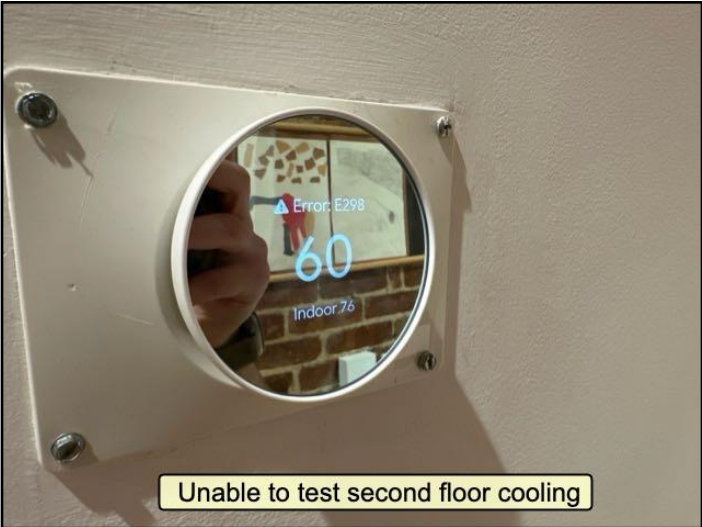
- Thermostat inoperable

Thermostat inoperable

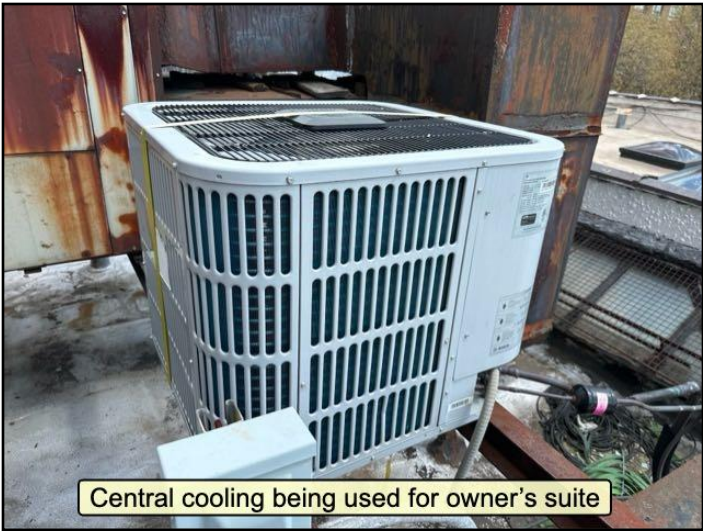
Central cooling being used for owner's suite

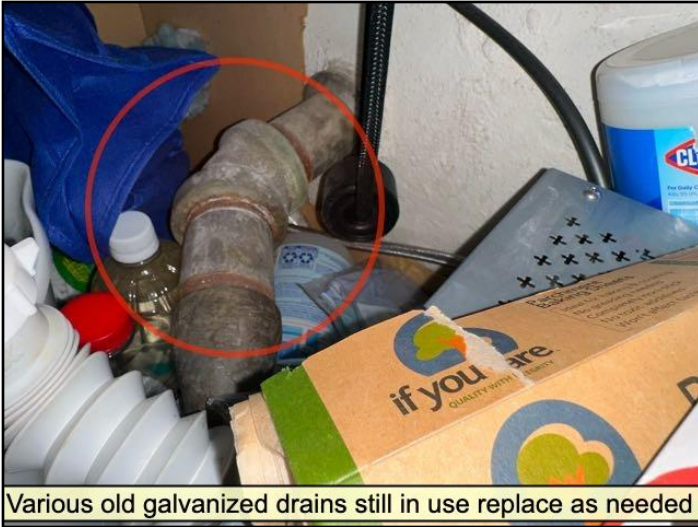
**49. Condition:** • Old galvanized drains

Various old galvanized drains still in use replace as needed

**Task:** Replace

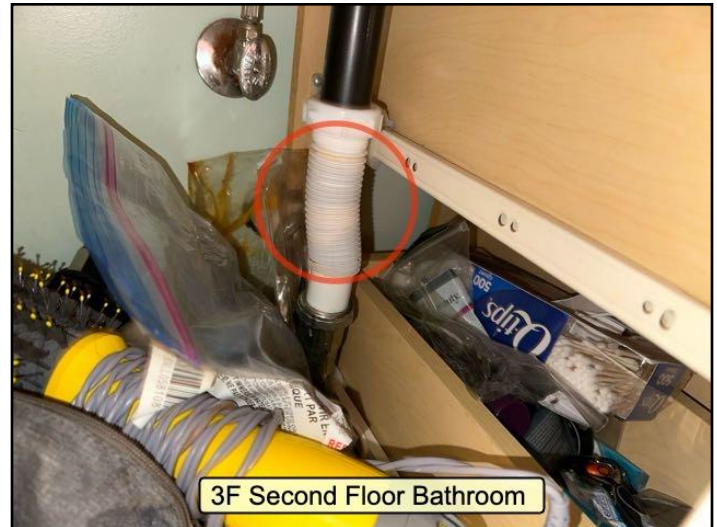
3F Second Floor Bathroom

The flexible, corrugated drain pipe observed under the sink is a temporary plumbing material that can trap debris and restrict water flow, increasing the risk of clogs and odors. Replacement with solid, smooth-wall PVC or ABS piping is recommended for improved durability and proper drainage performance.

Temporary plumbing materials

**Task:** Replace

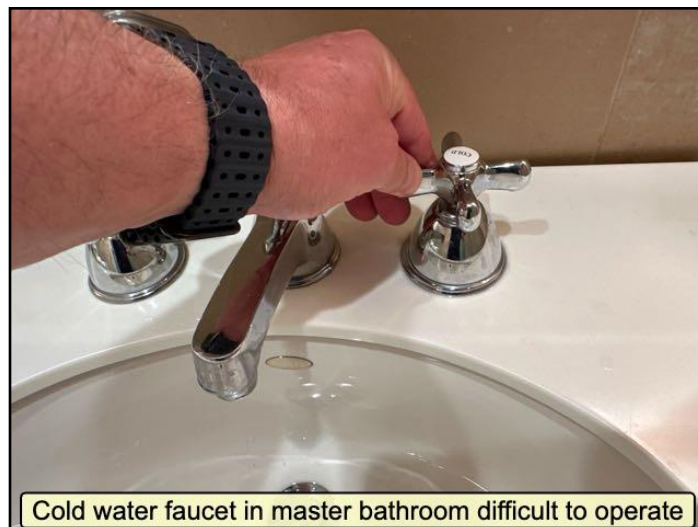
**Implication(s):** System inoperative or difficult to operate

Cold water faucet in master bathroom difficult to operate

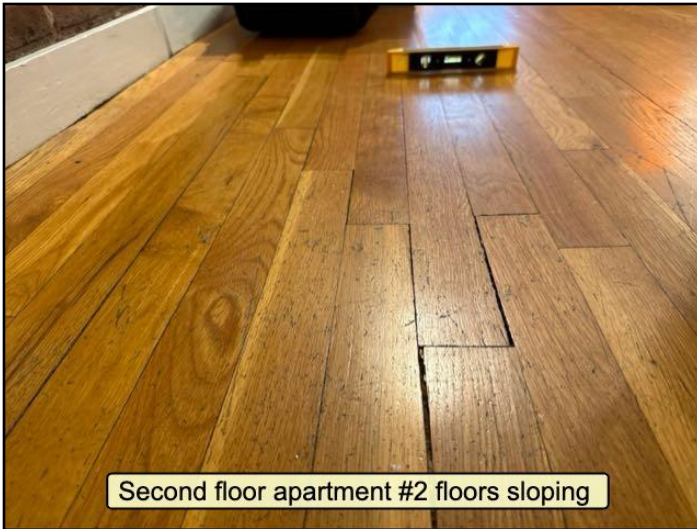
**58. Condition:** • Floors have sloping/settling this is common in older houses

Second floor apartment #2 floors sloping

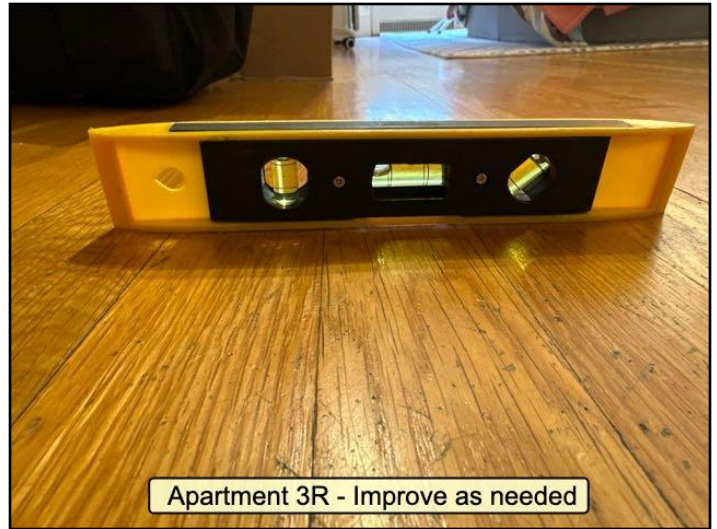
Apartment 3R - Improve as needed

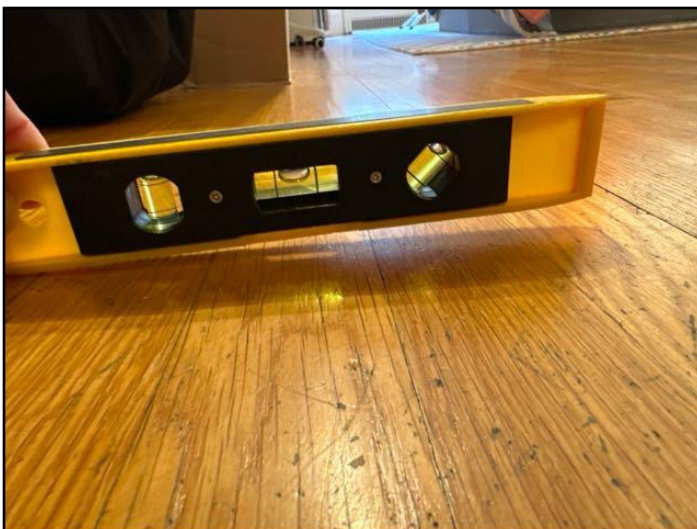
Floors have sloping/settling this is common...

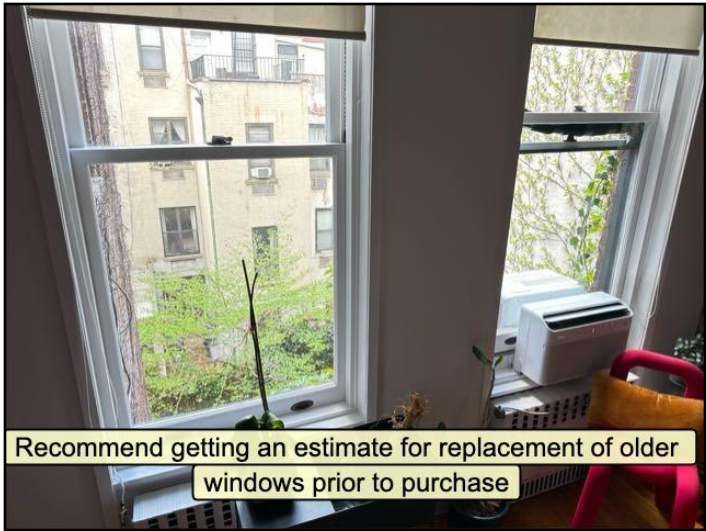
**59. Condition:** • Older windows

Older windows

**Task:** Budget for replacements

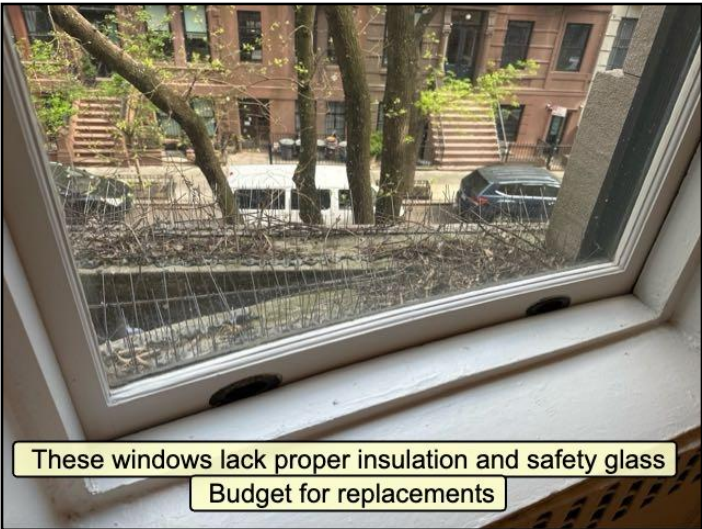
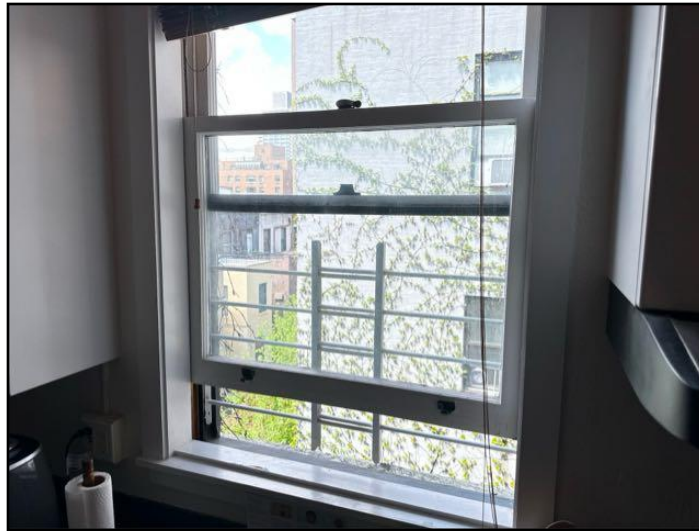
**60. Condition:** • Old single pane glass

Old single pane glass

**Task:** Upgrade/ replace

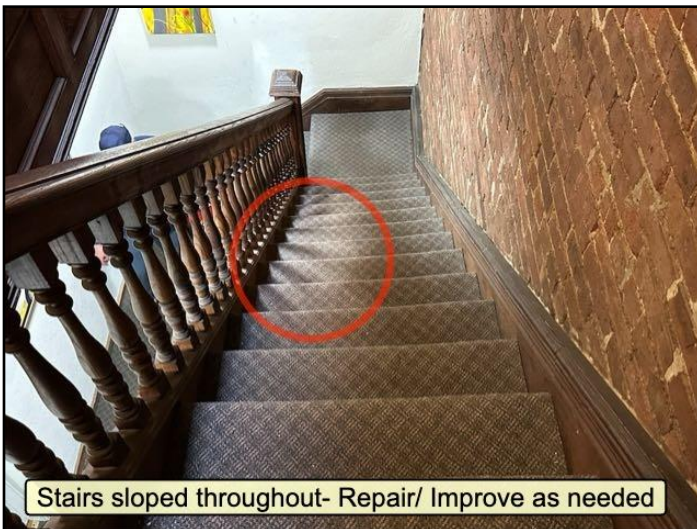
61. Condition: • [Sloped](#)

Implication(s): Trip or fall hazard

*Sloped*

Task: Improve

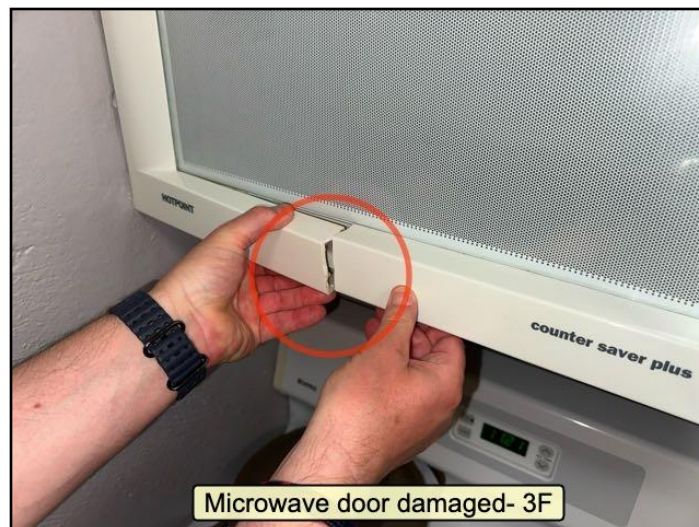
**Location:** Apt 3F Kitchen

**65. Condition:** • Damaged

Damaged

**Task:** Repair or replace

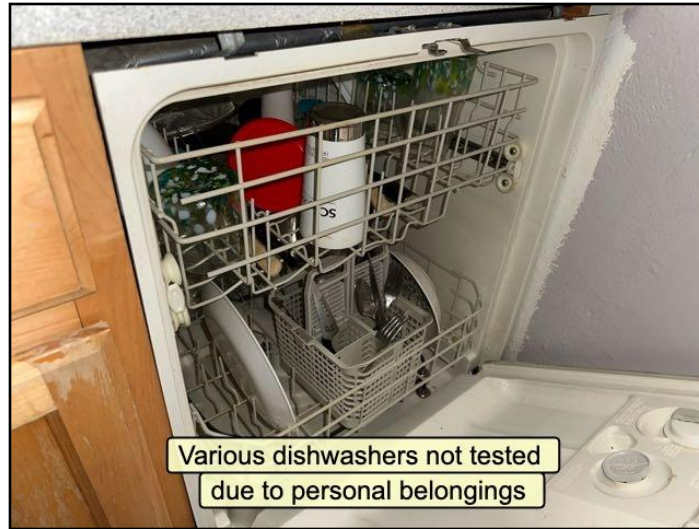
*Dishwasher*

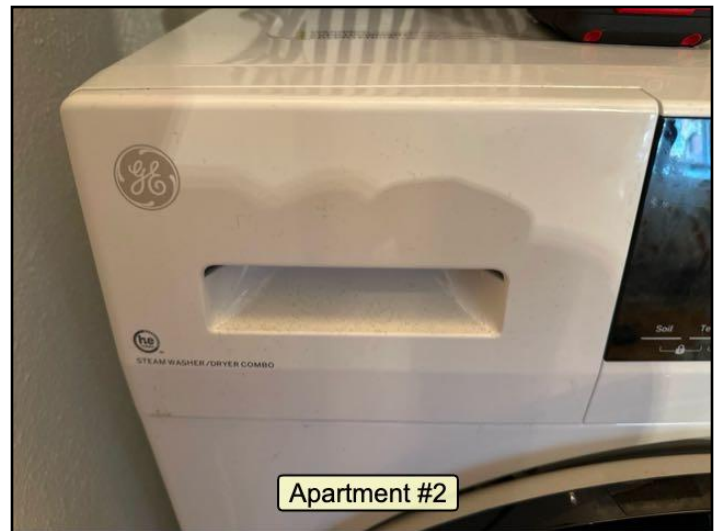
*Washer and Dryer not tested*

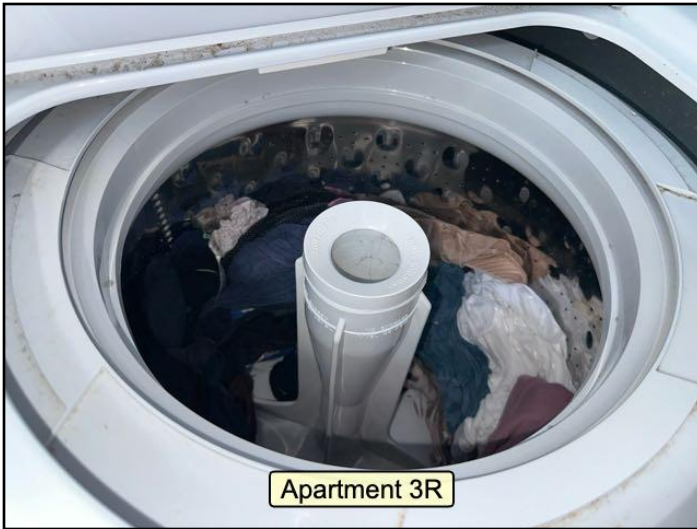
Washer and Dryer not tested

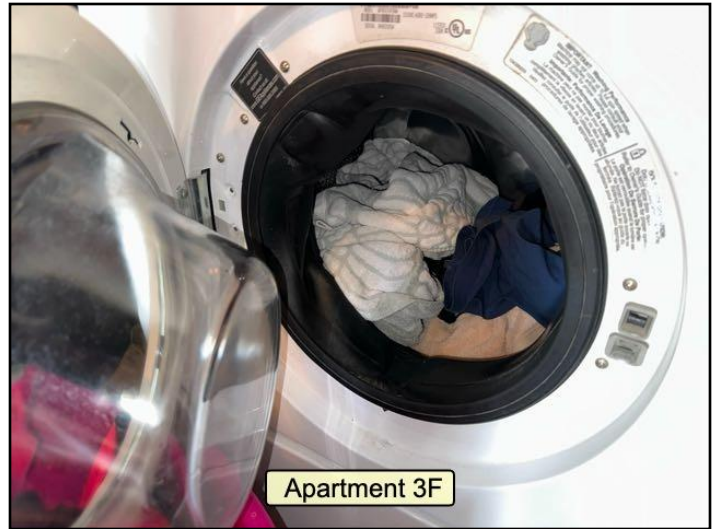
Washer and Dryer not tested
