# INSPECTION REPORT

For the Property at:  
**FARMINGDALE, NY 11735**

Inspection Date: Wednesday, December 28, 2022

Prepared by:  
**East Coast Commercial Property Inspections, LLC**

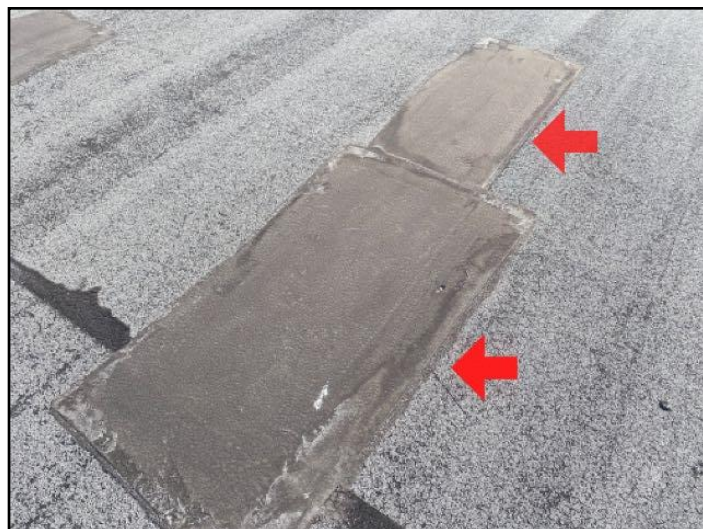
Roof patched in multiple areas - Poor

Patched

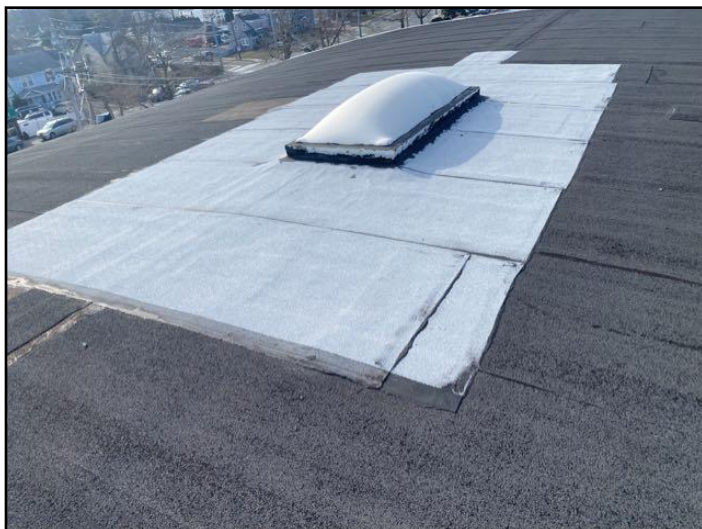
Patched

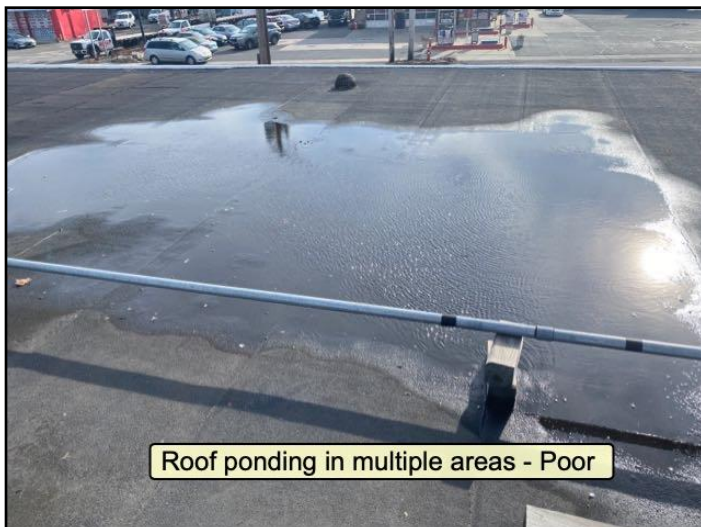
Ponding

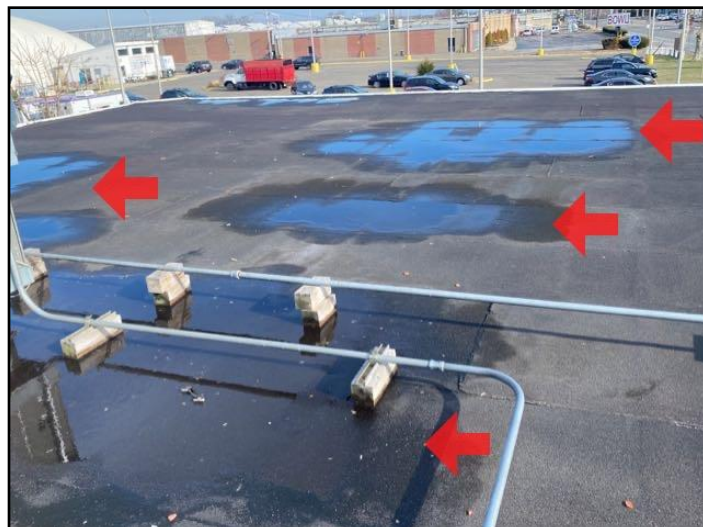
Ponding

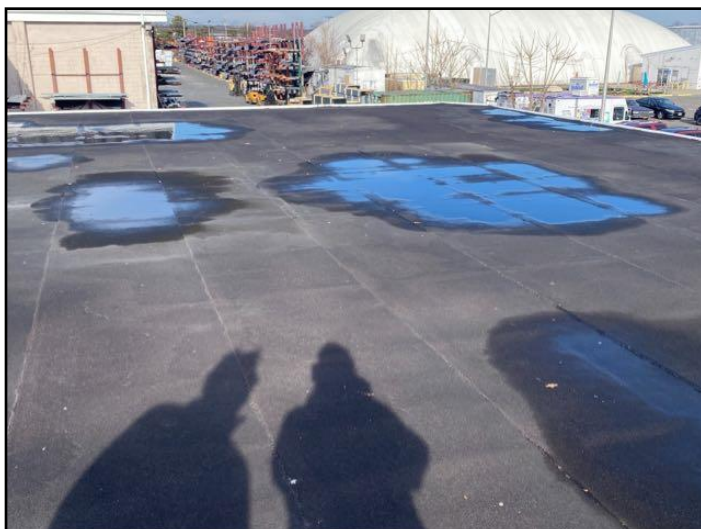
Ponding

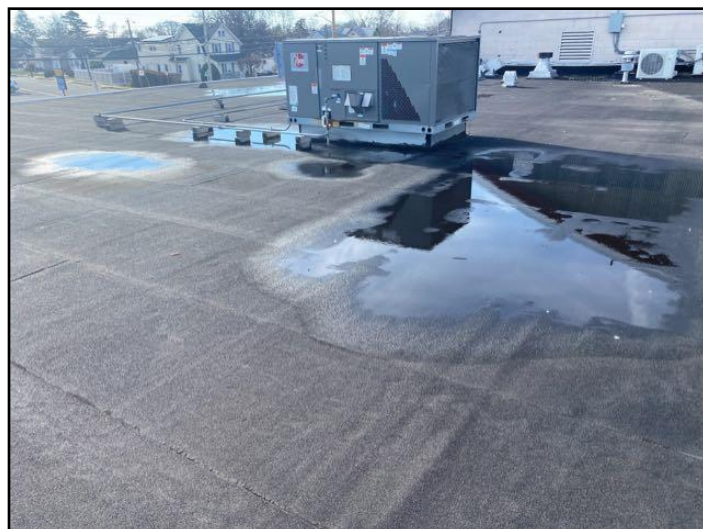
Ponding

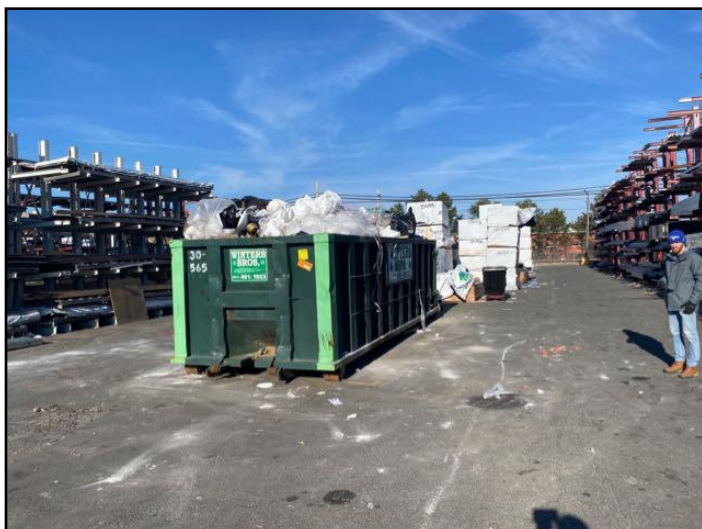
North Lot

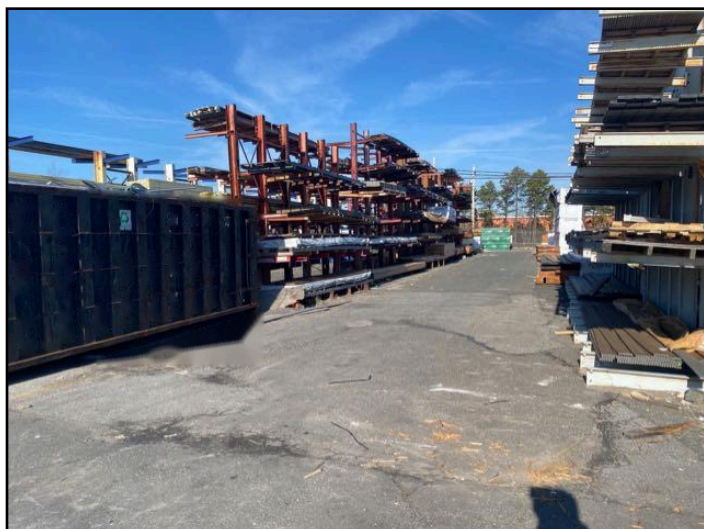
North Lot

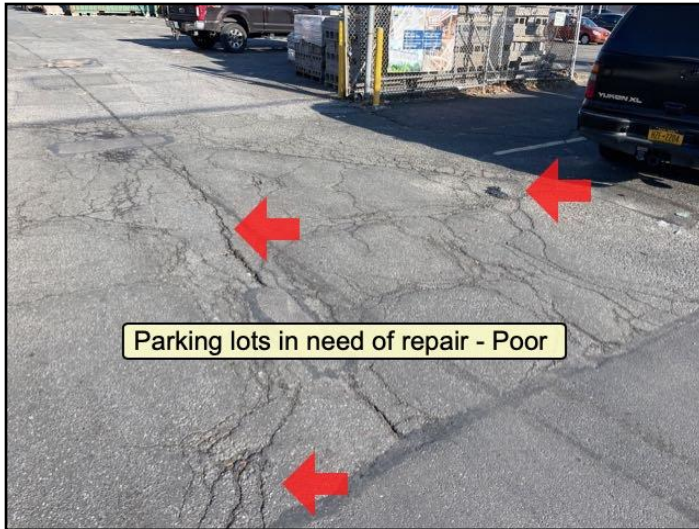
## General: • Parking Lot - Poor

Parking lot

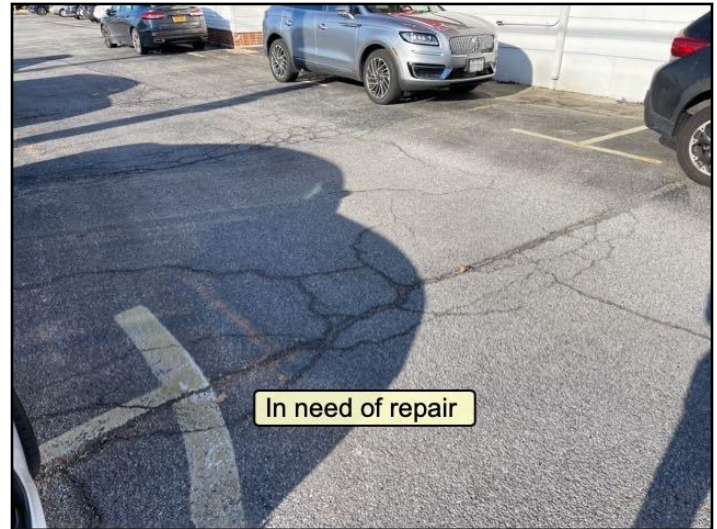
Parking lot

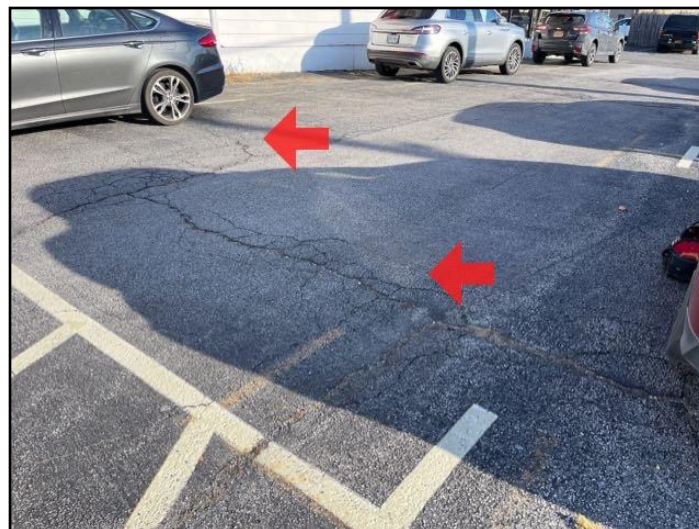
Parking lot

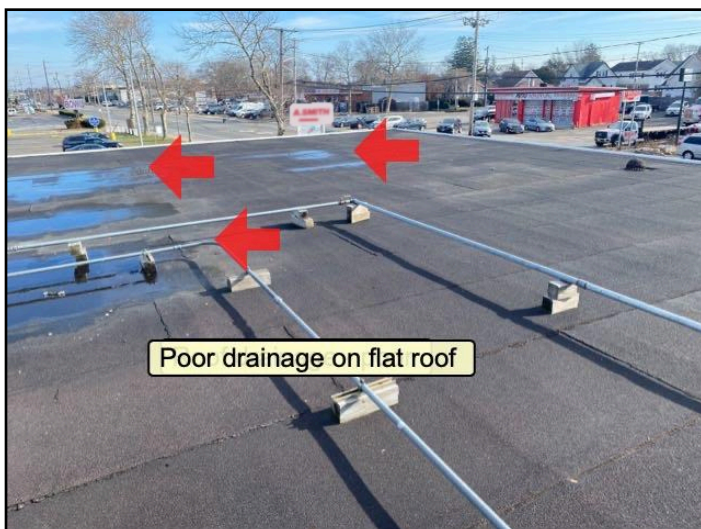
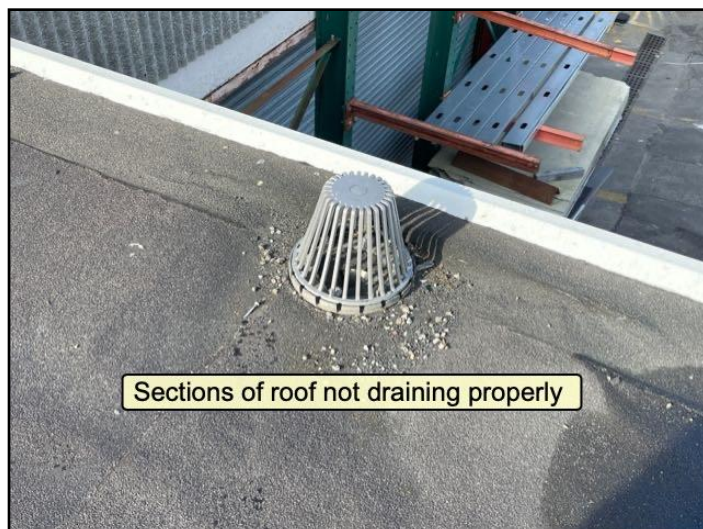
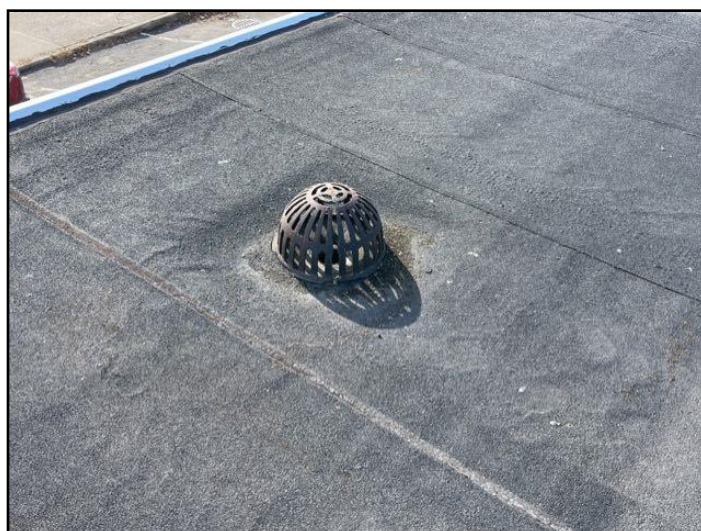
## Gutter & downspout material: • Roof drainage - Poor

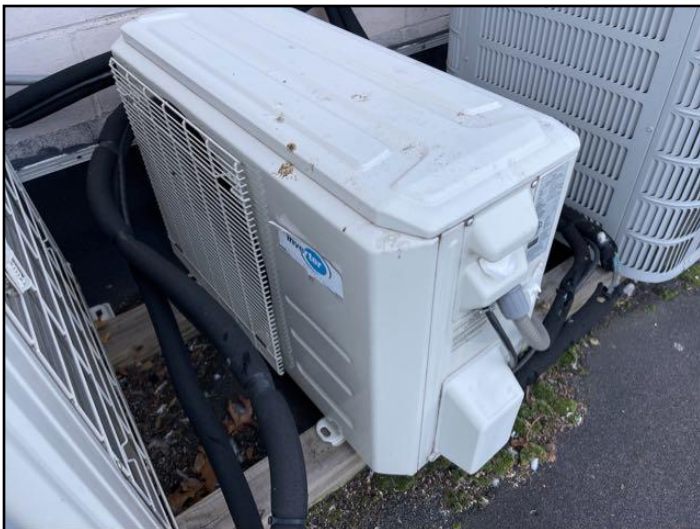
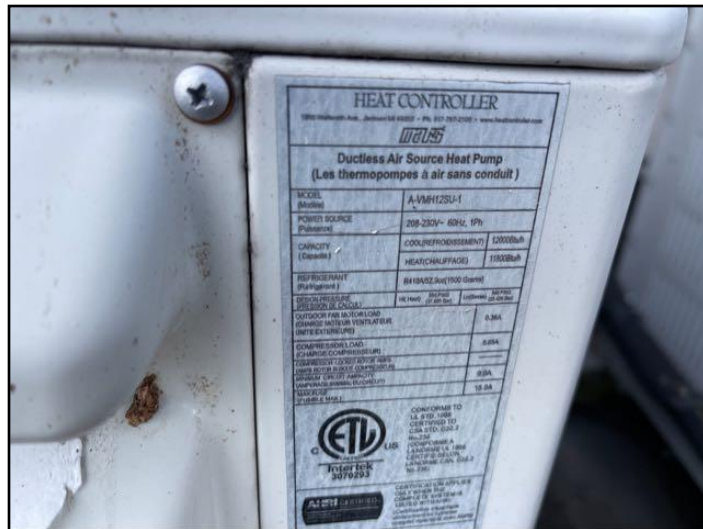
One unit located near the front parking lot was rusting.

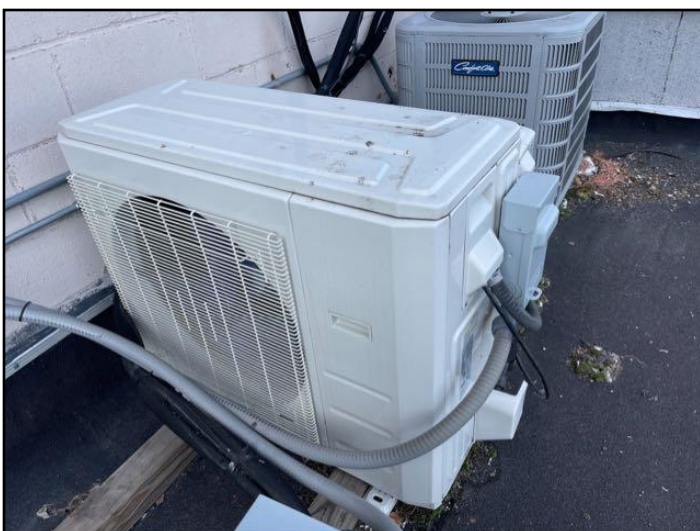
Ductless (Mini split) system

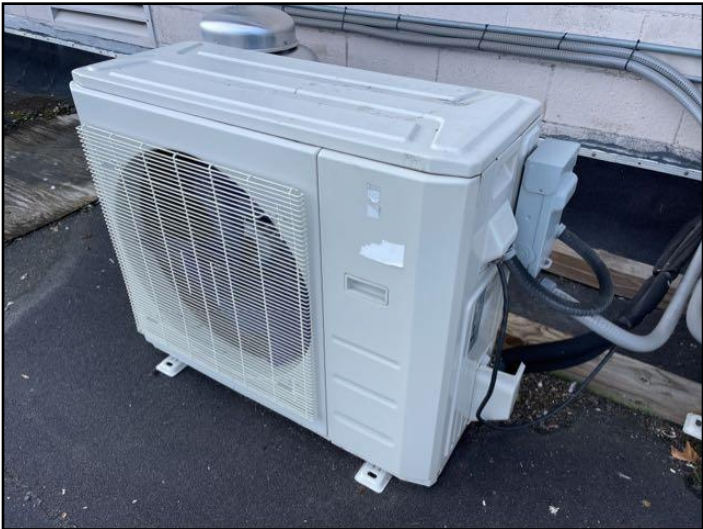
Ductless (Mini split) system

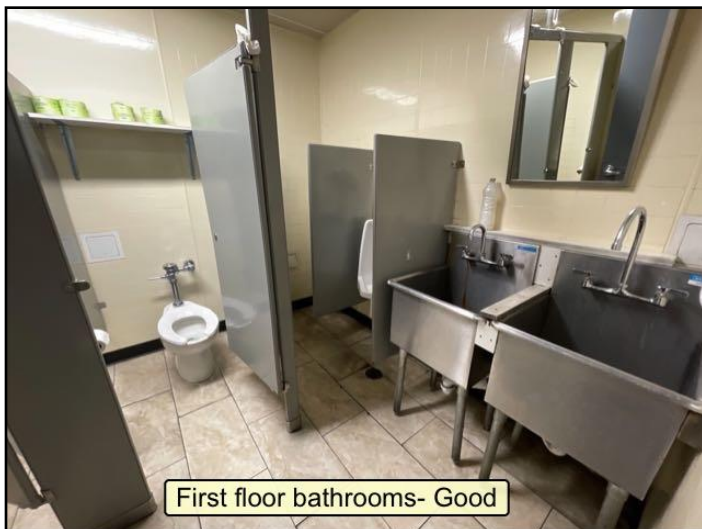
First floor bathroom

All interior spaces were in good condition. Including offices, retail space, bathrooms, conference rooms, kitchens and utility rooms. Occupants limited inspection of most interior spaces. Inspection was mostly visual.

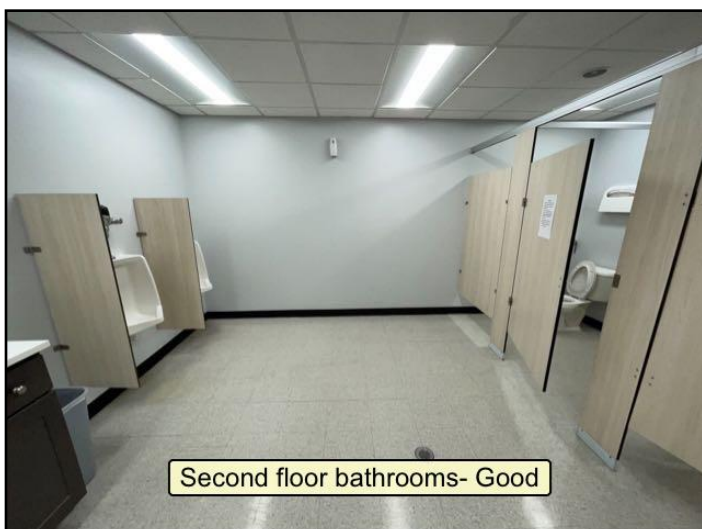
Second floor bathroom

Second floor bathrooms- Good

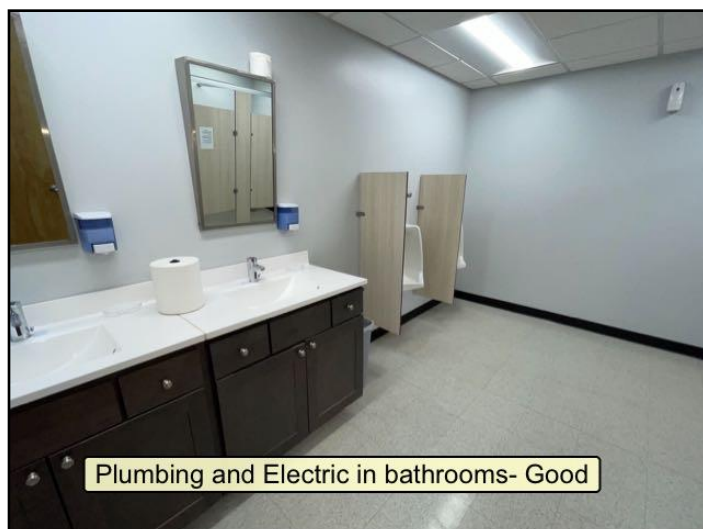
Second floor bathroom

Plumbing and Electric in bathrooms- Good

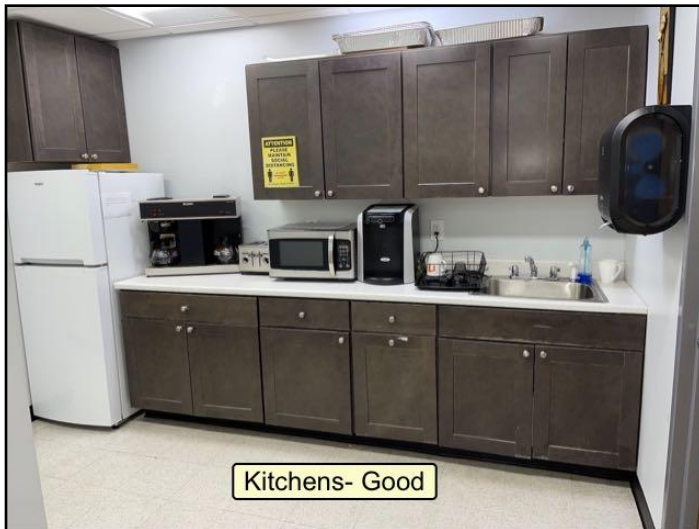
Kitchens- Good
