# INSPECTION REPORT

For the Property at:  
**ISLANDIA, NY 11749**

Inspection Date: Tuesday, July 30, 2024

Report No. 1046

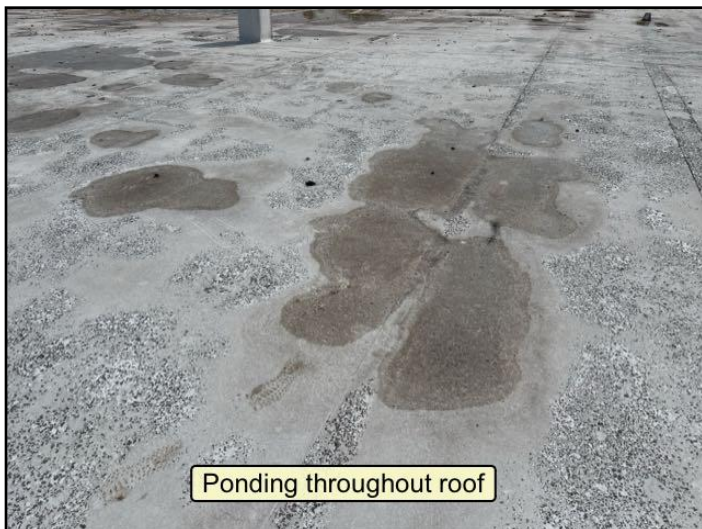
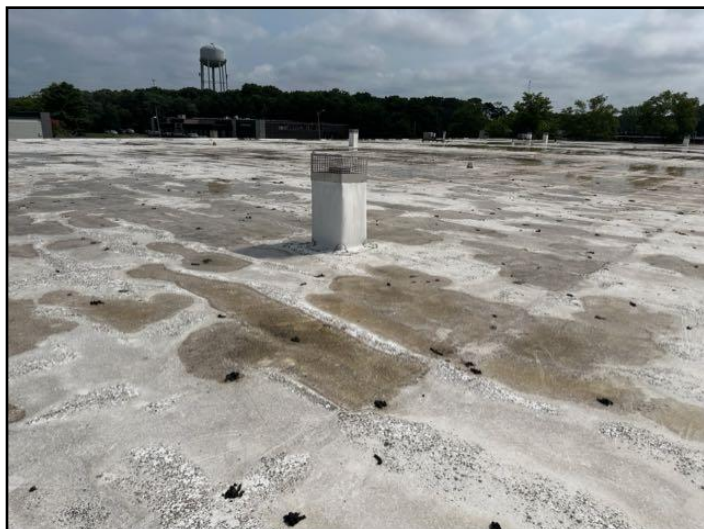
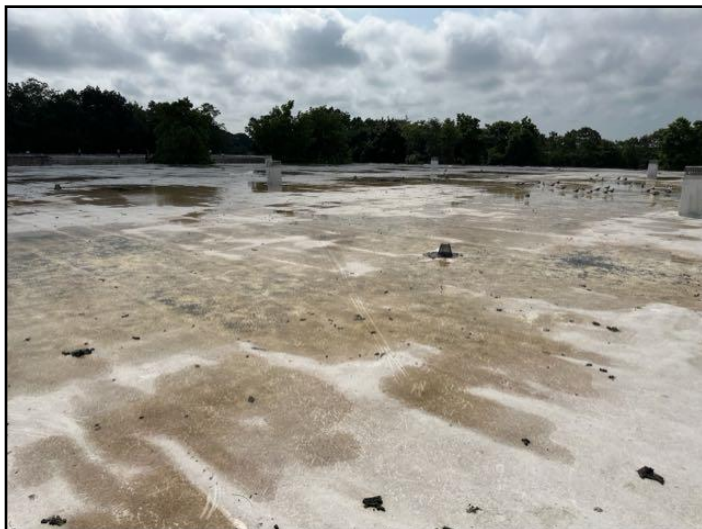
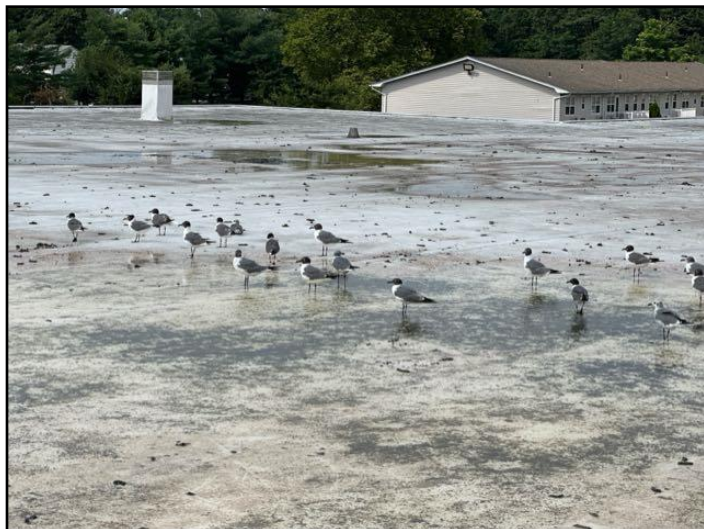
## 5. Condition: • [Ponding](#)

**Implication(s):** Chance of water damage to structure, finishes and contents

Ponding

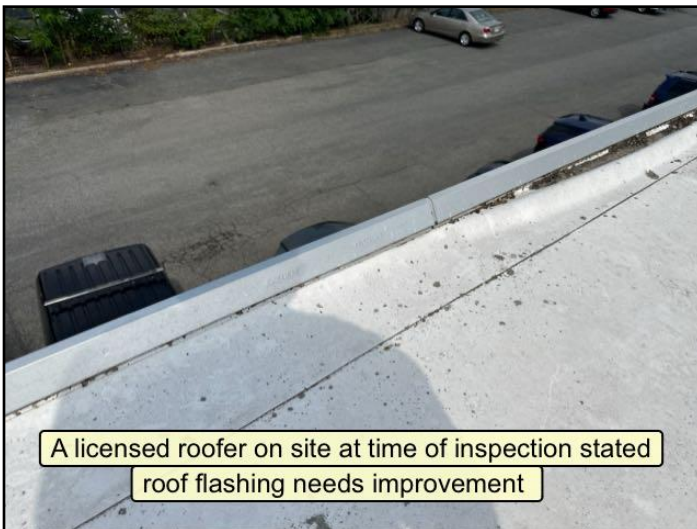
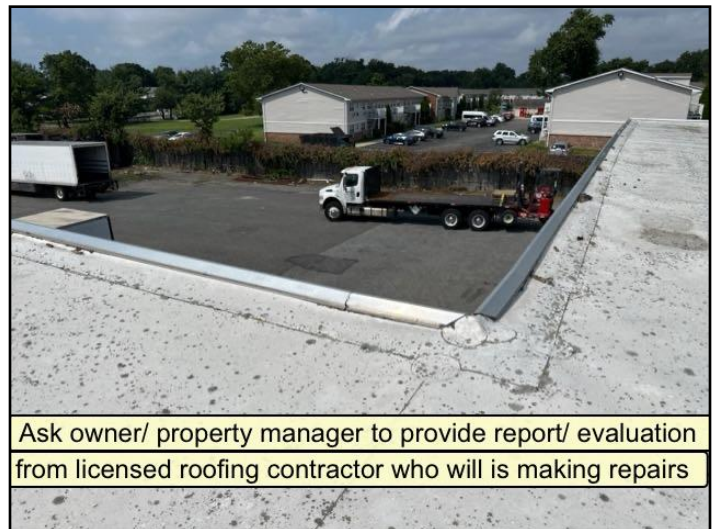
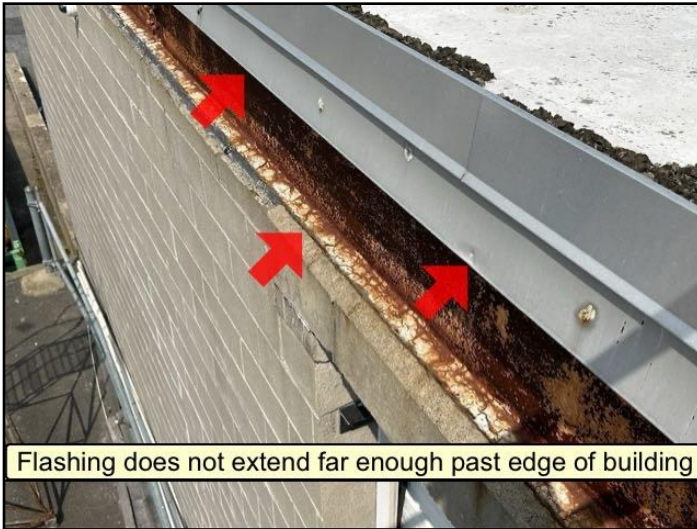
Metal flashing needs improvement

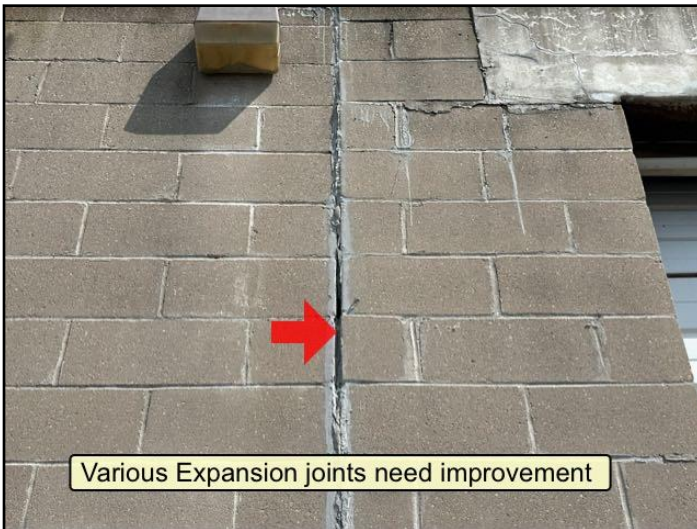
10. Condition: • Expansion joints

Expansion joints

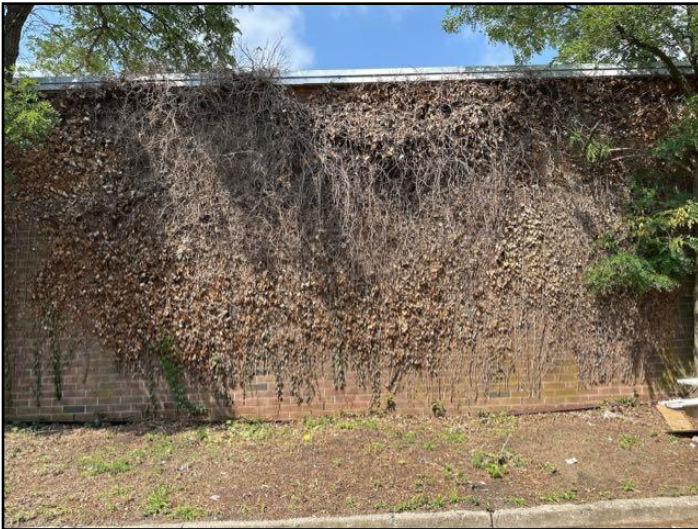
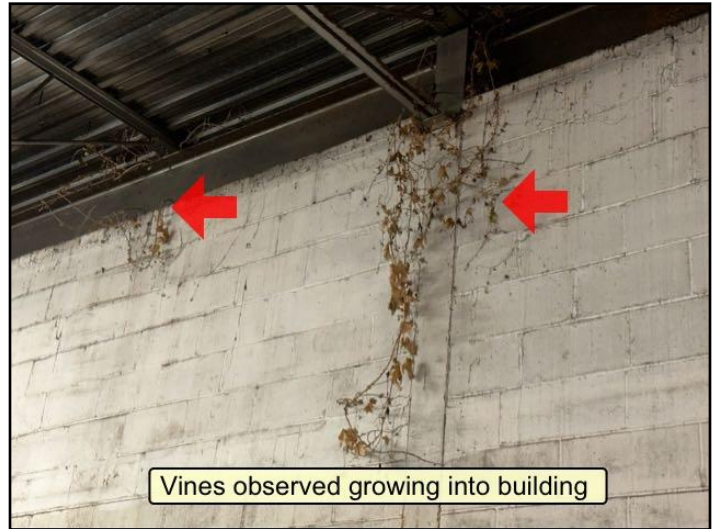
**13. Condition:** • Vines on building

Vines on building

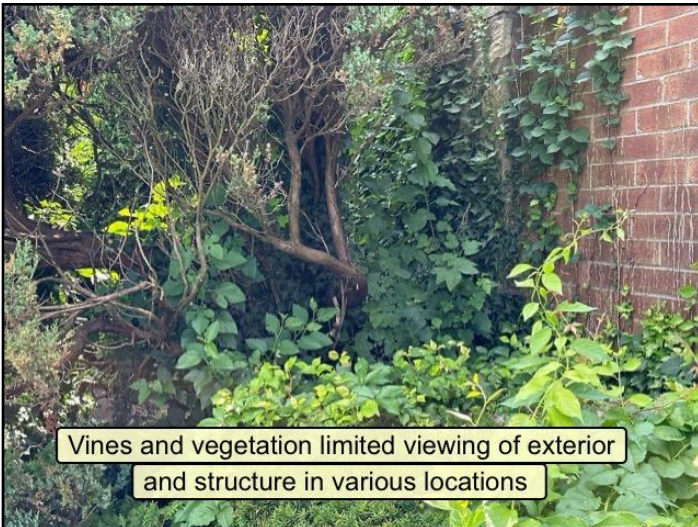
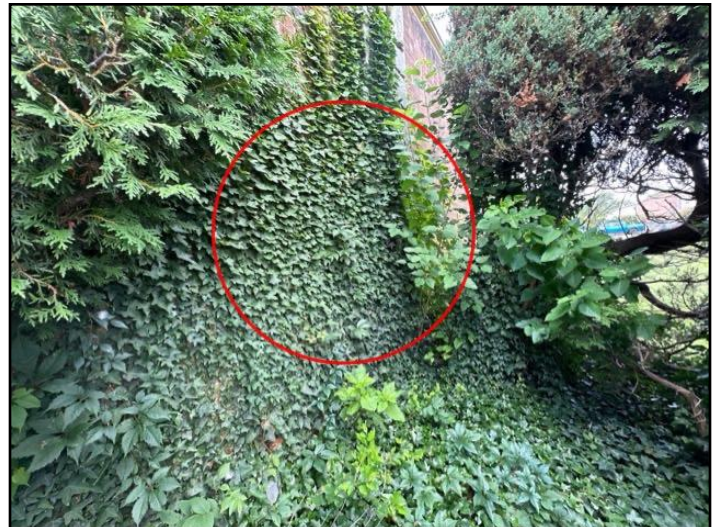
- Vines/shrubs/trees against wall

Vines/shrubs/trees against wall

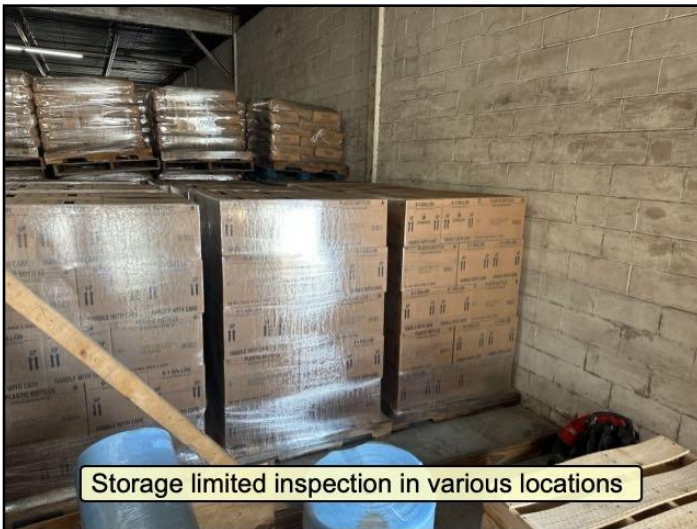
Storage limited inspection in various locations

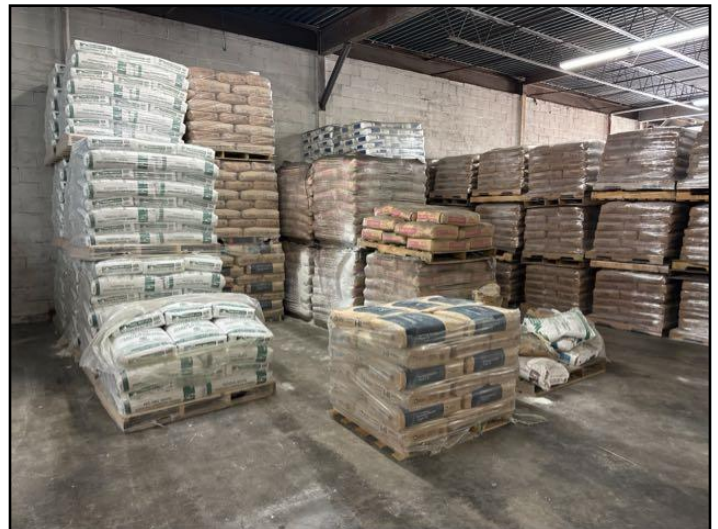
Stored items limited viewing

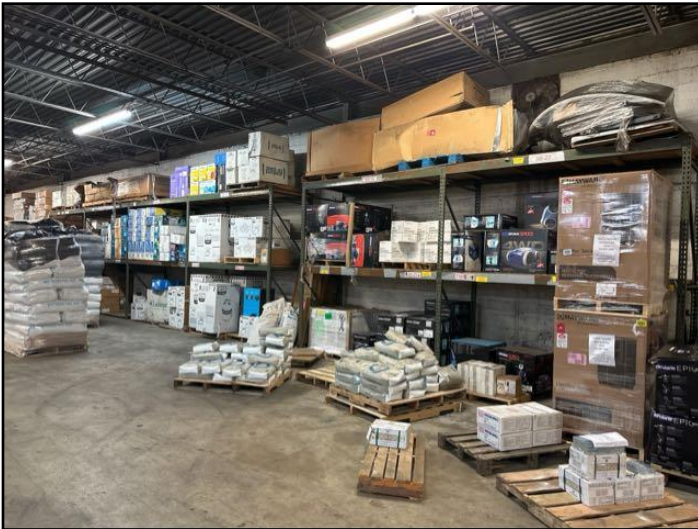
Stored items limited viewing

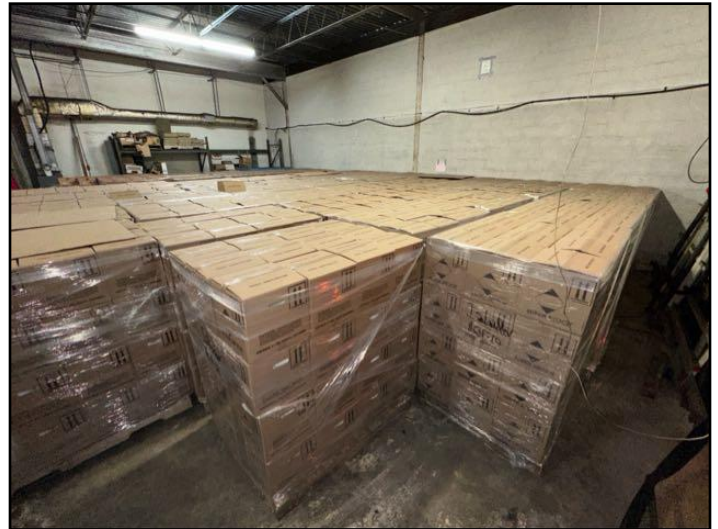
Stored items limited viewing

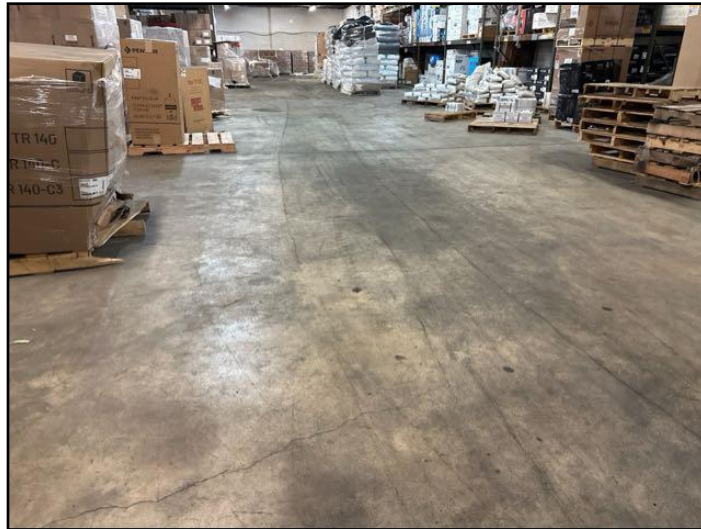
**General:** • Concrete slab was in good condition overall

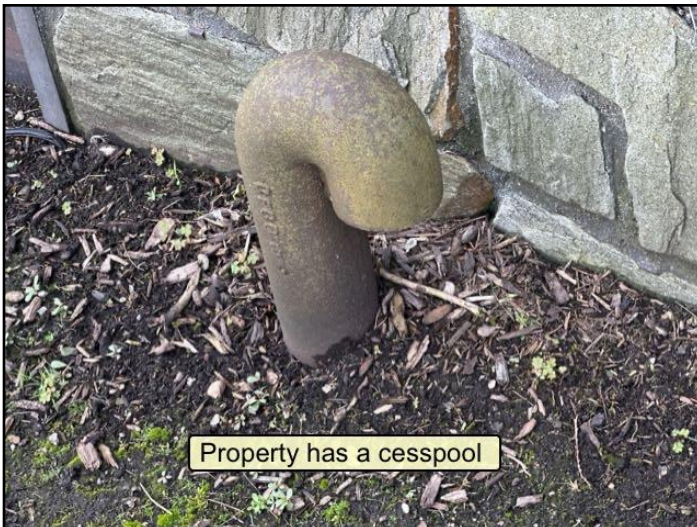
Property has a cesspool
