# INSPECTION REPORT

***For the Property at:  
1477 Middletown Road  
LAKE GROVE, NY 11755***

**Prepared by:** East Coast Commercial Inspections

**Date of Inspection:** January 28, 2026

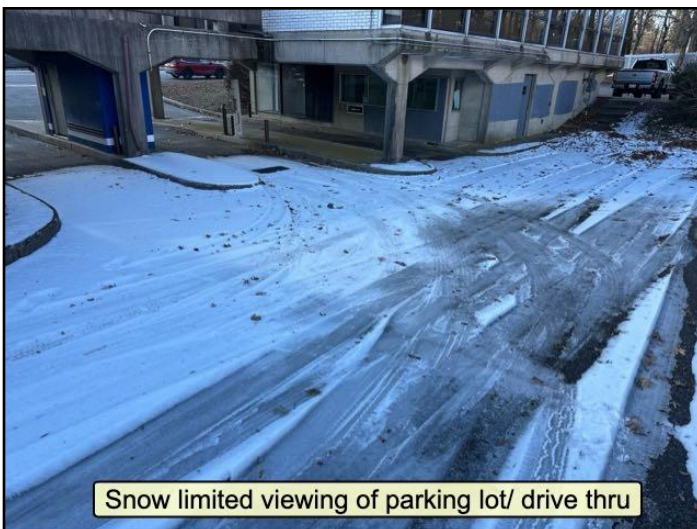
- Snow / ice / frost
- Snow limited viewing of parking lot/ drive thru

*Snow / ice / frost*

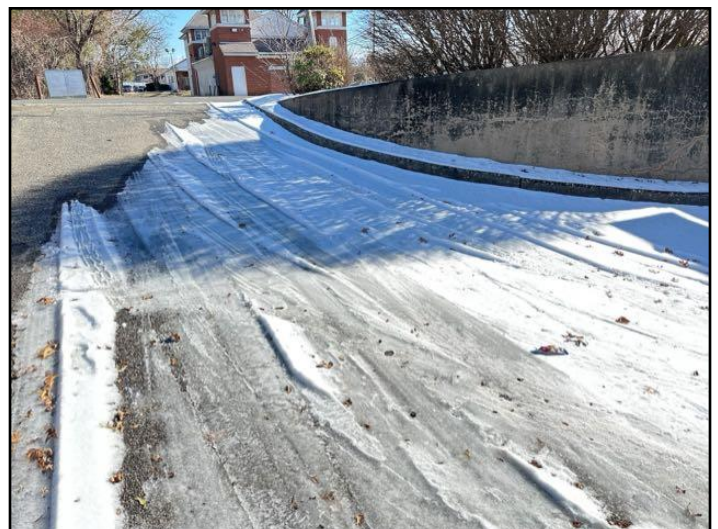
*Snow / ice / frost*

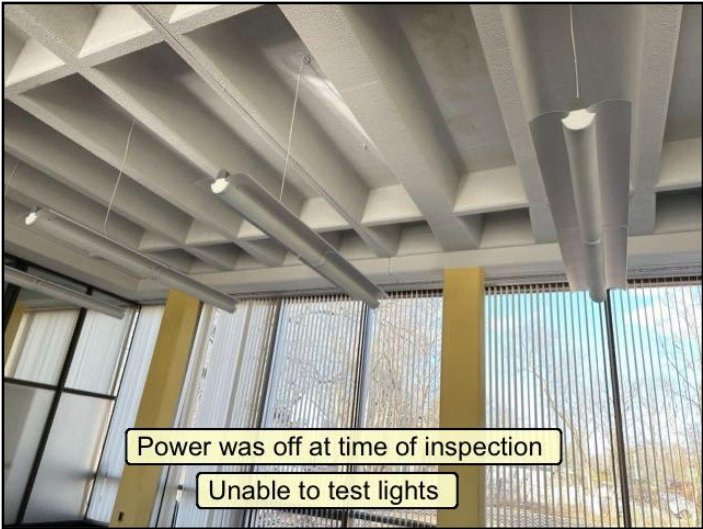
Power was off at time of inspection  
Unable to test lights

Power was off

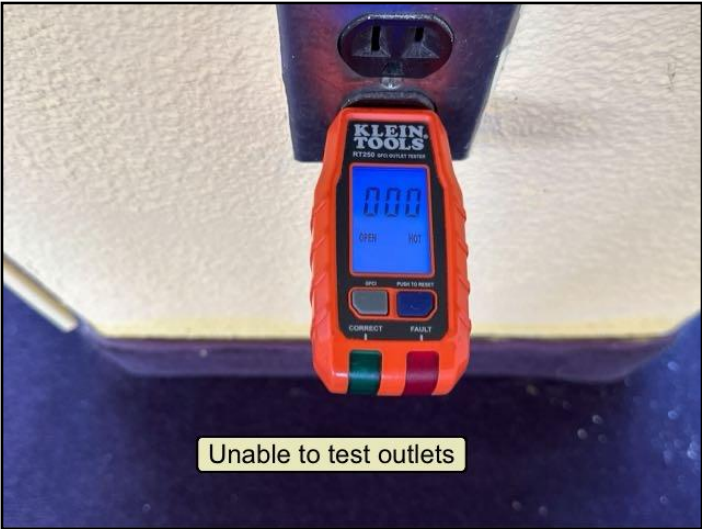
Unable to test outlets

Power was off

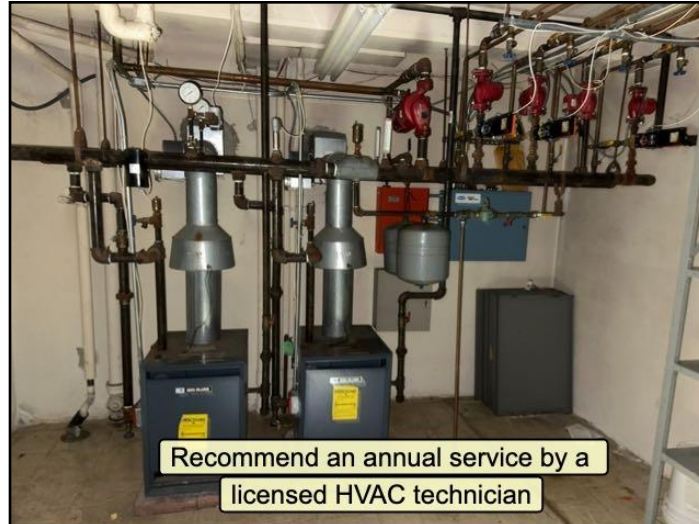
**25. Condition:** • Recommend an annual service contract with a licensed heating contractor.  
Recommend an annual service by a licensed HVAC technician

*Recommend an annual service contract with a...*

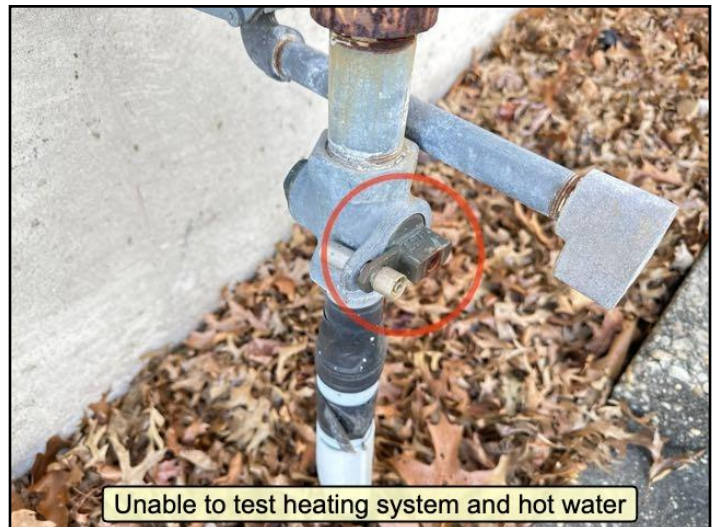
Unable to test heating system and hot water

Gas was shut off at time when inspection.

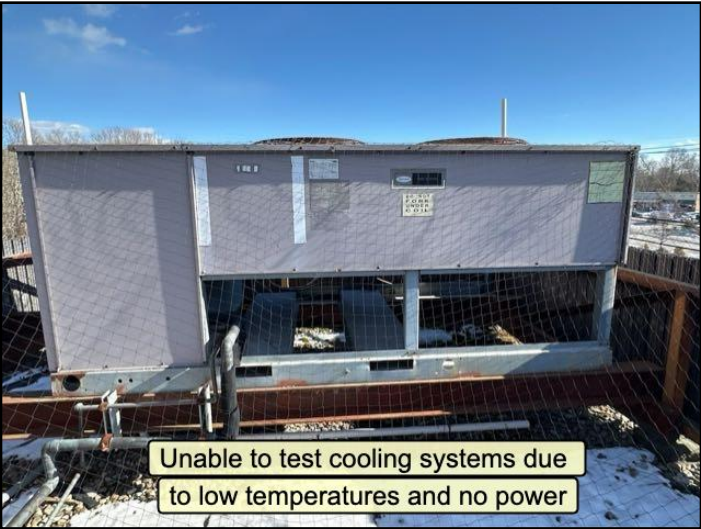
Power turned off

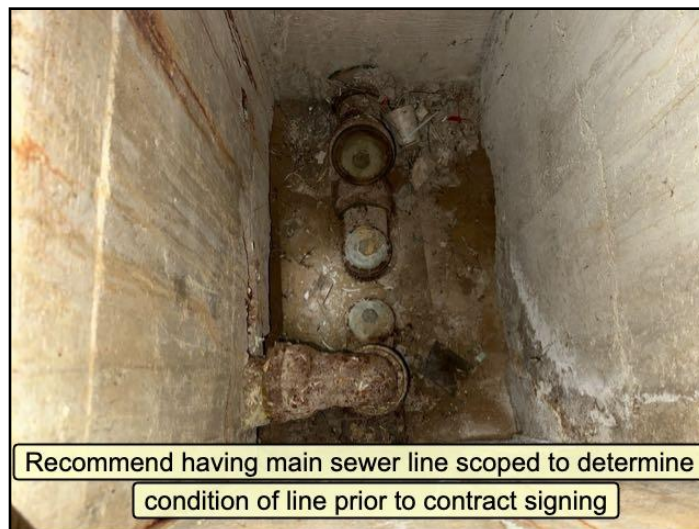
#### Old clay pipe sewer issues - shift, collapse, roots, silt

**Condition:** • Scope main sewer line

RECOMMEND HAVING MAIN SEWER LINE SCOPED TO DETERMINE CONDITION OF LINE PRIOR TO CONTRACT SIGNING.

*Scope main sewer line*

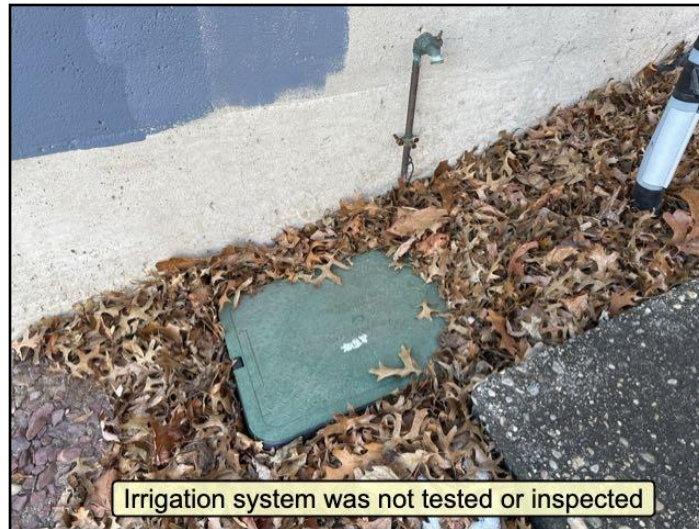
Irrigation system was not tested or inspected

*Landscape irrigation systems*
